APPENDIX 17

Site Inspection Photographs

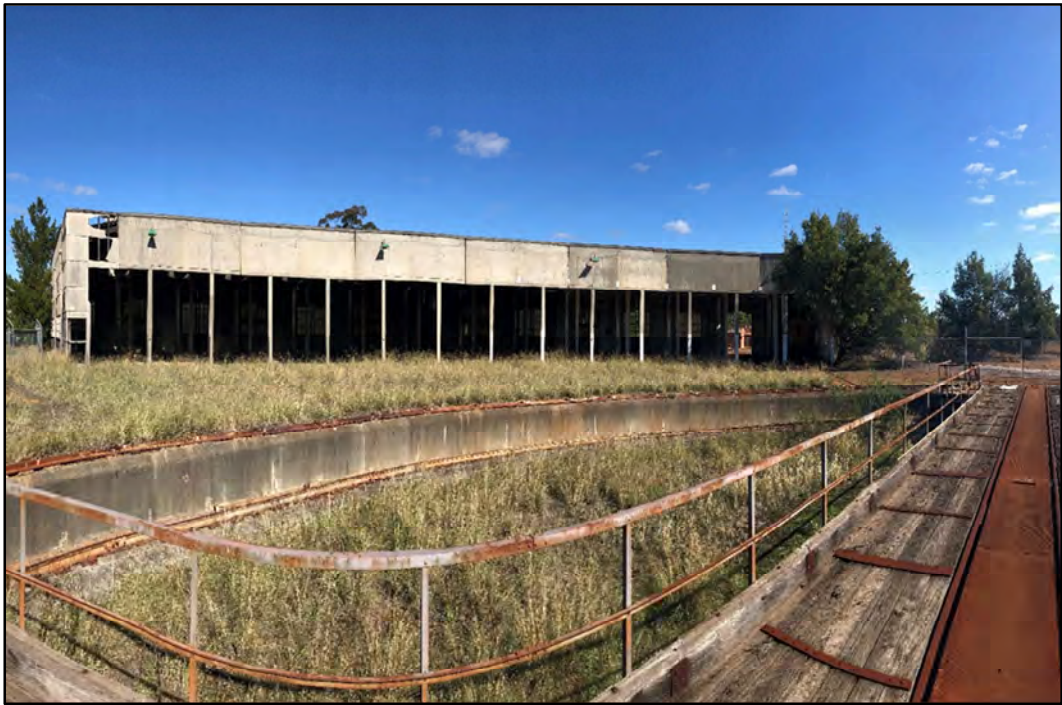
Plate 1: The Roundhouse taken from the Turntable. Photograph taken facing west

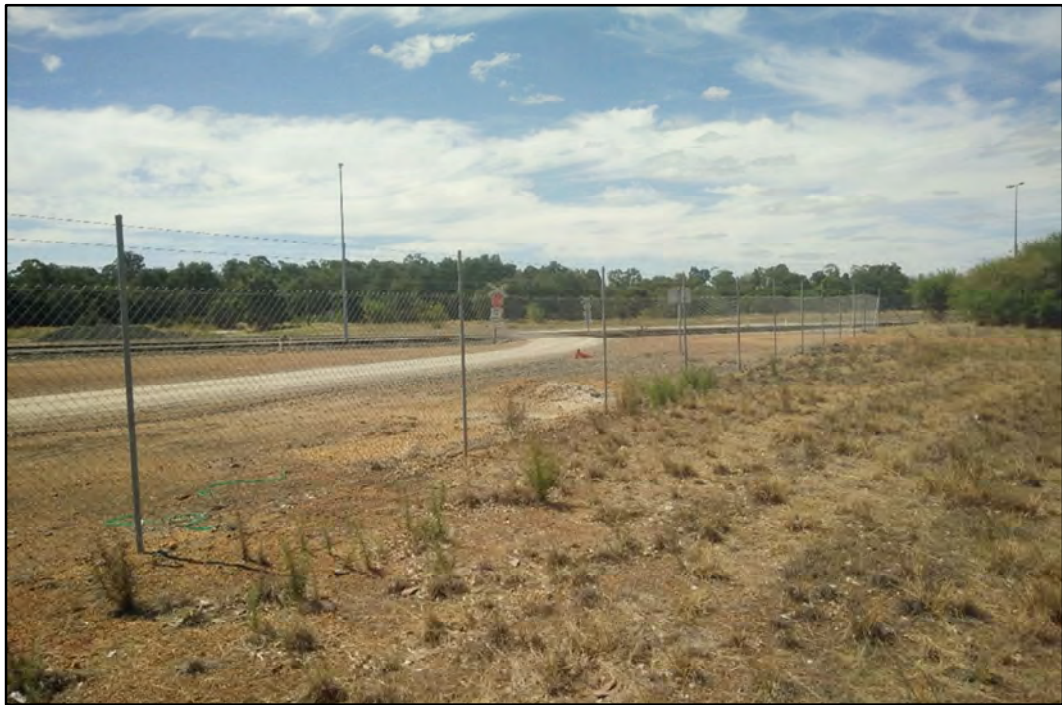
Plate 2: Representative photo of the cyclone fencing on the northern Site boundary.

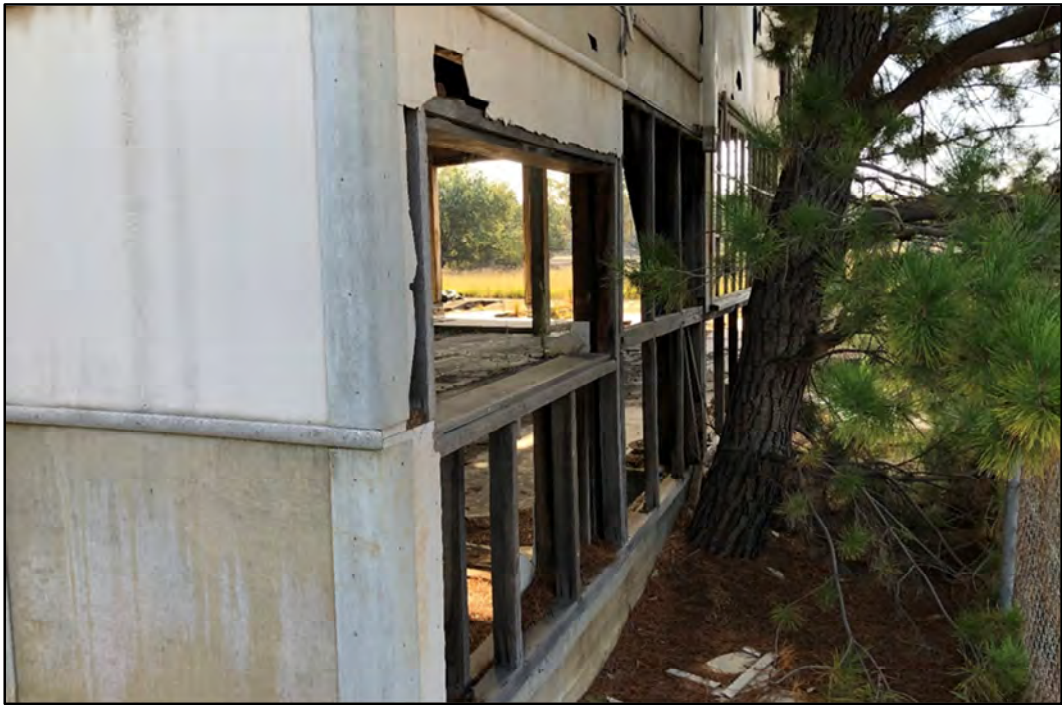
Plate 3: Damaged ACM cladding on the Roundhouse with ACM fragments visible on the surface soil.

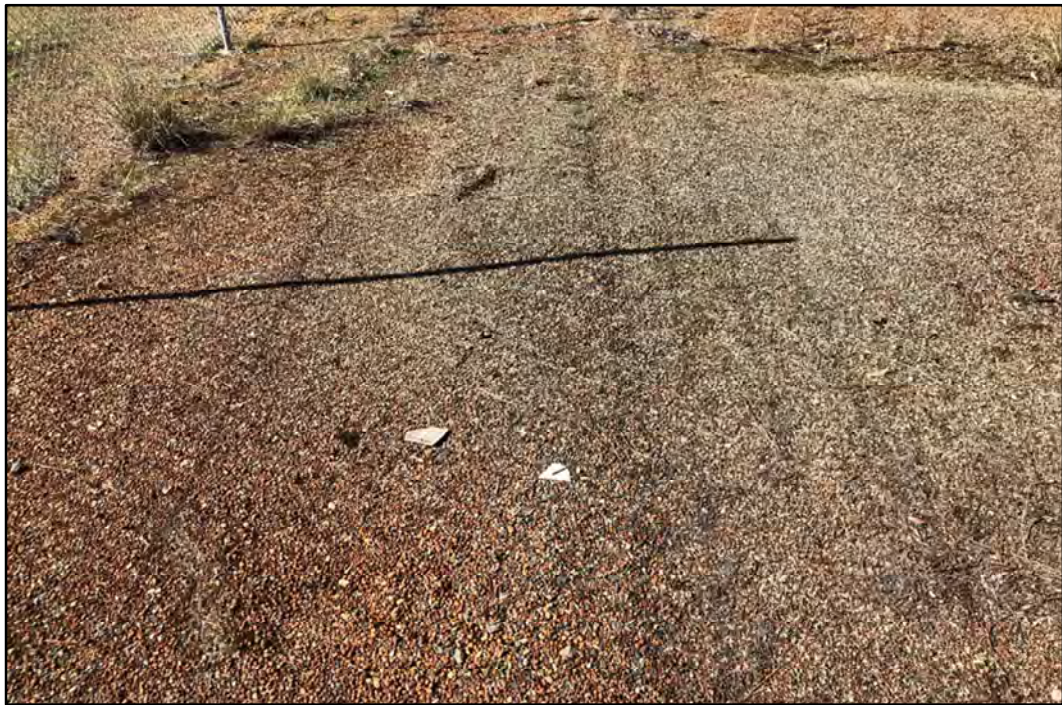
Plate 4: ACM fragments on the surface soil of one of the access tracks to the south of the Roundhouse

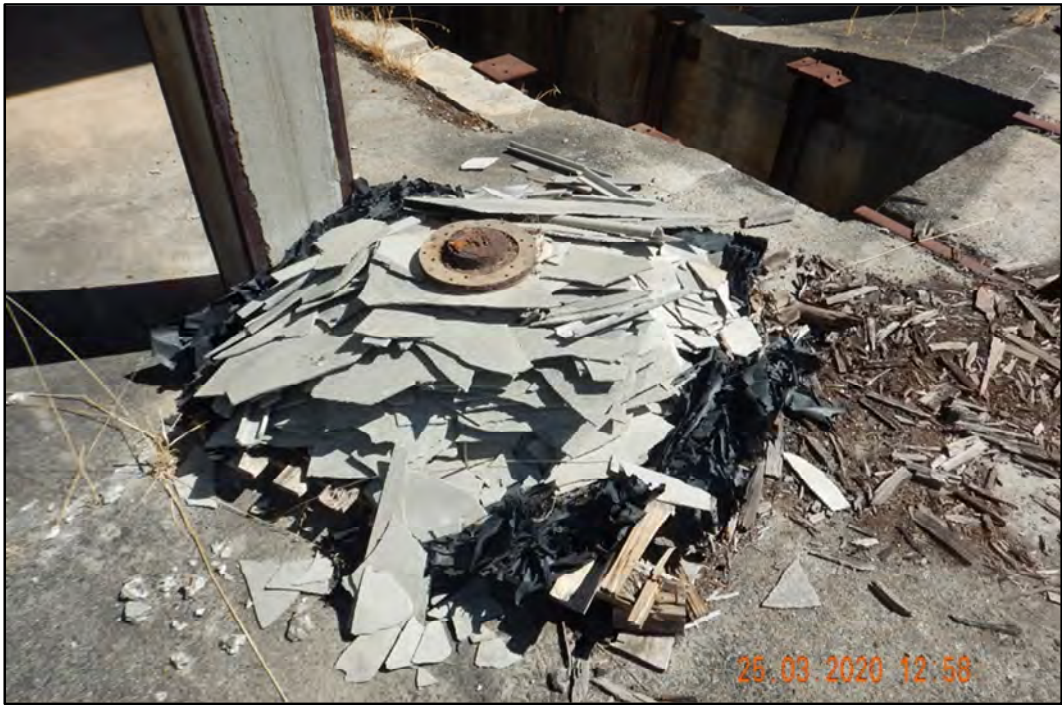
Plate 5: Stockpiled ACM in the Roundhouse.

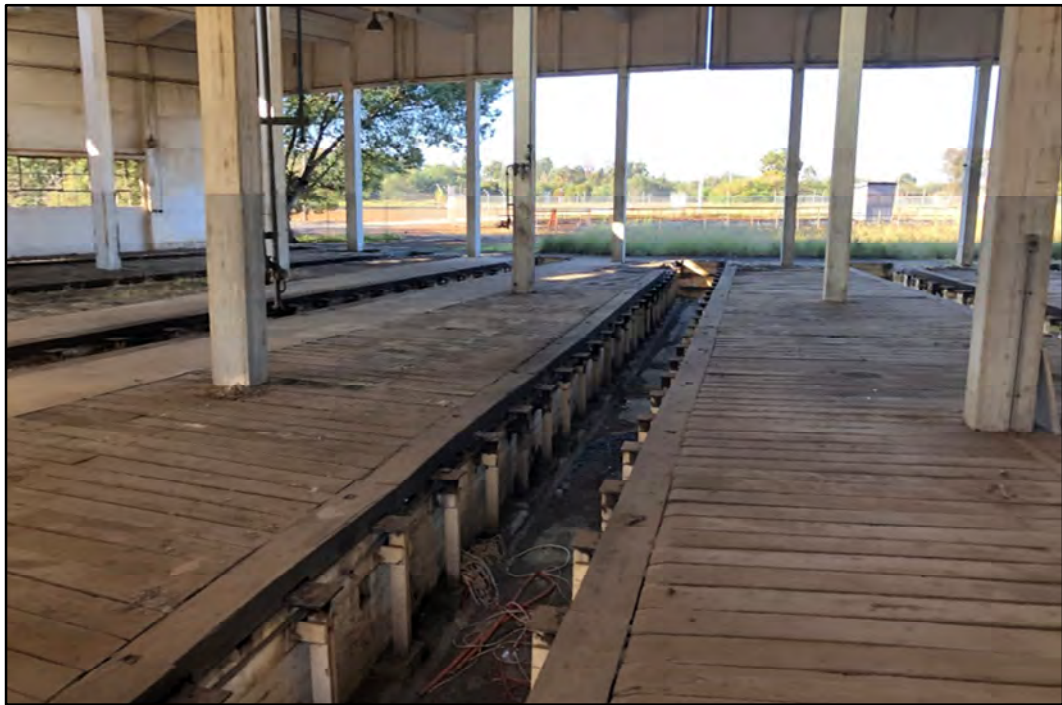
Plate 6: Inside the Roundhouse facing north. Several of the 14 bays are visible. Wiring can be seen at the base of the service pit.

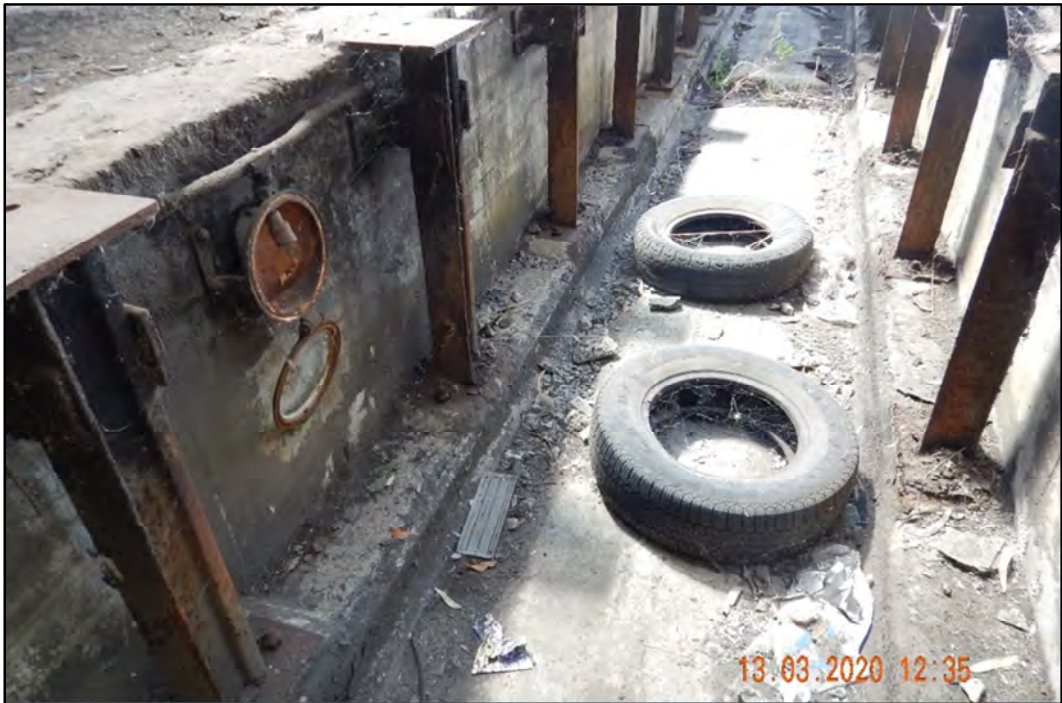
Plate 7: Waste (tyres, plastic, concrete, steel) observed in one of the service pits in the Roundhouse.

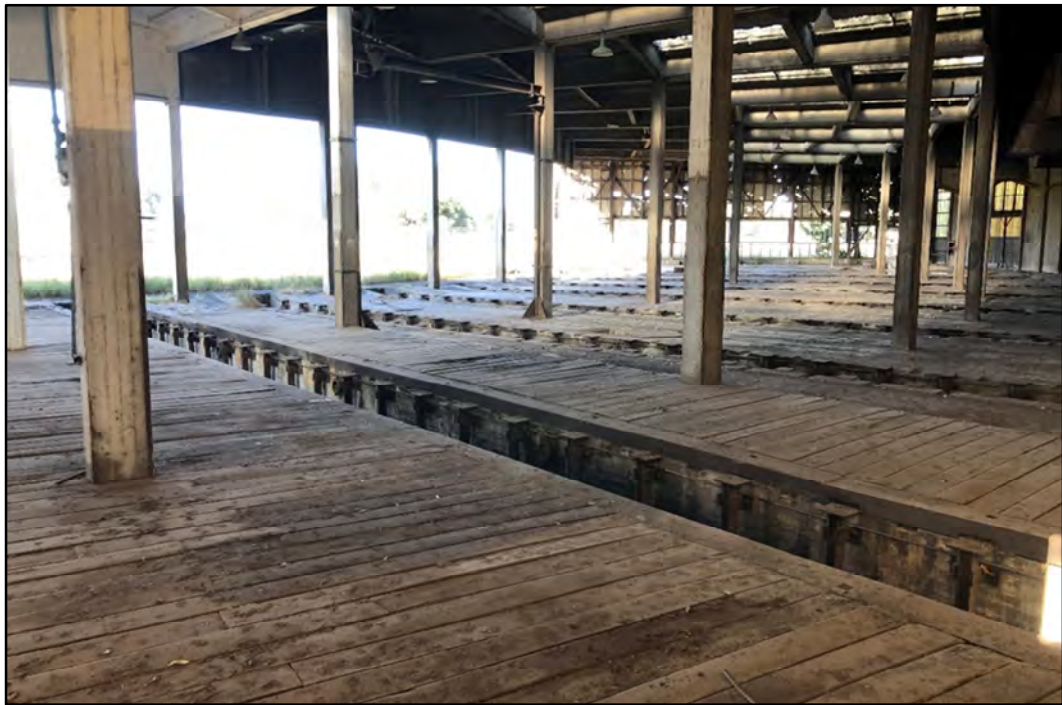
Plate 8: Minor staining on the timber floors within the Roundhouse.

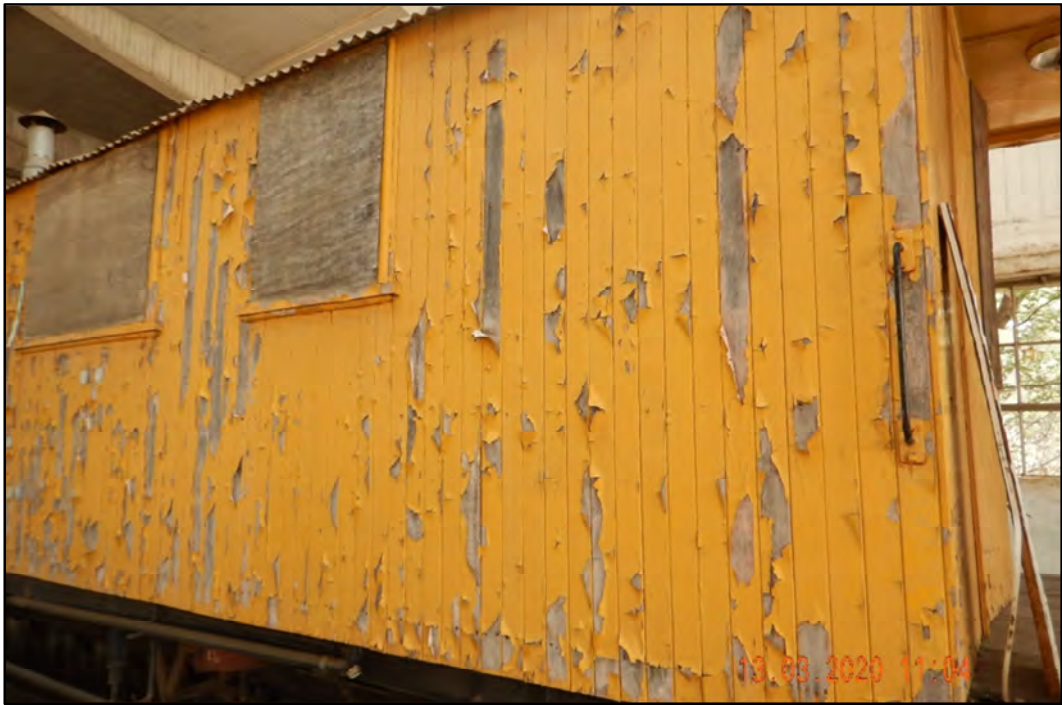
Plate 9: The workmen’s carriage in the Roundhouse, located in the northern bay.

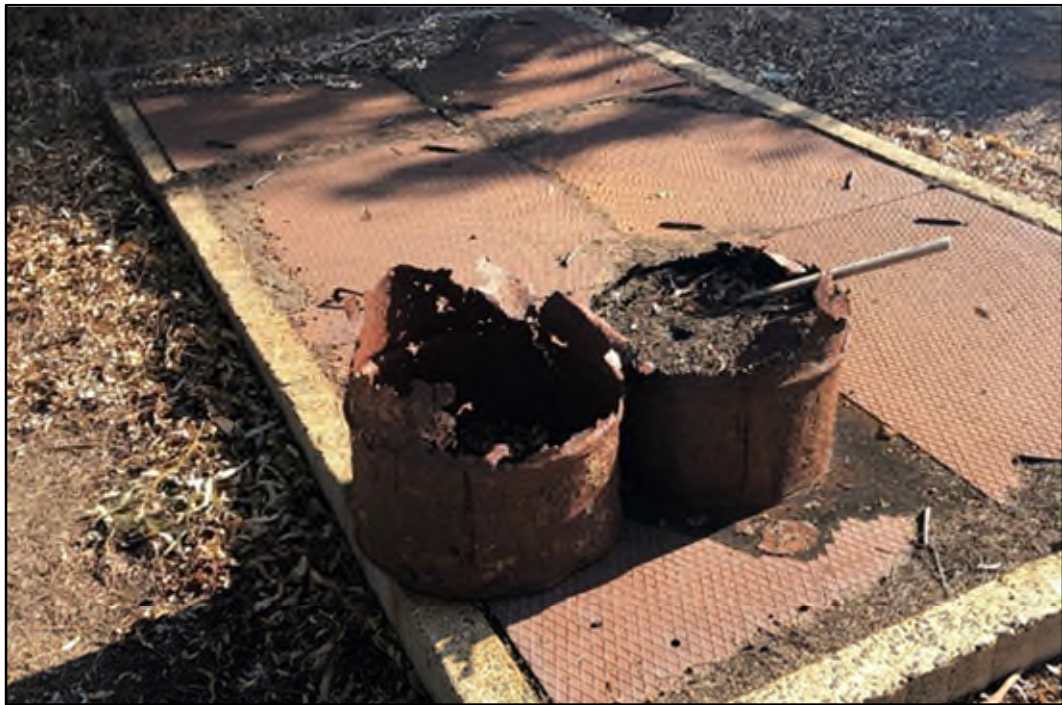
Plate 10: The two half drums on the triple interceptor trap. The drum on the right of the image contains the tar-like product, the other on the left was empty.

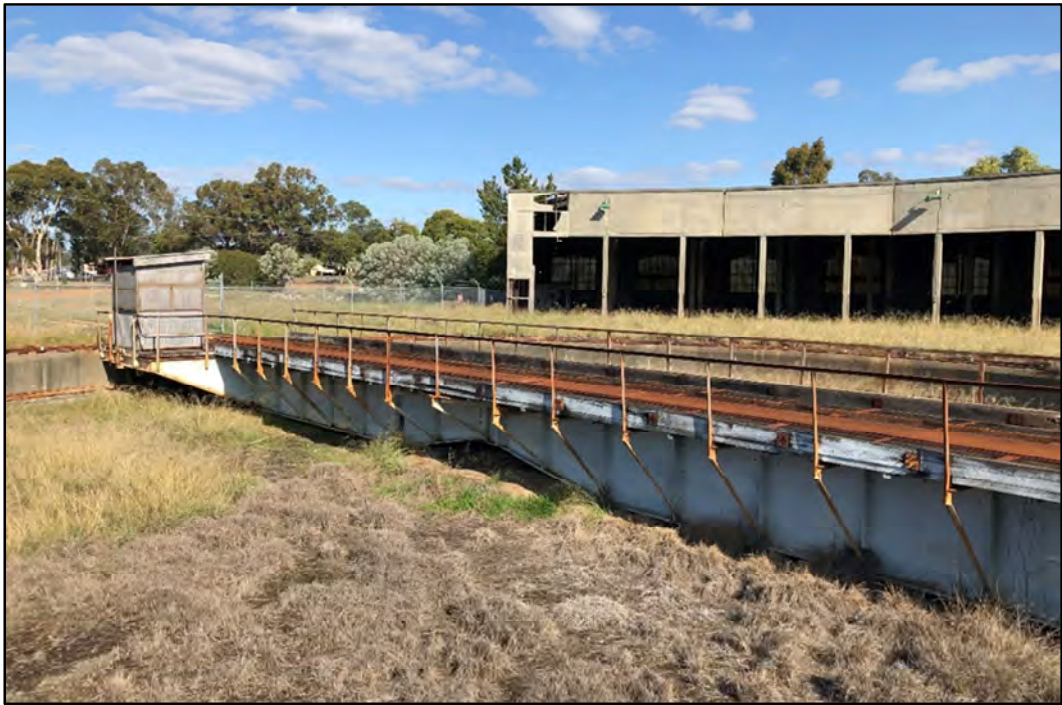
Plate 11: The Turntable, photo facing south.

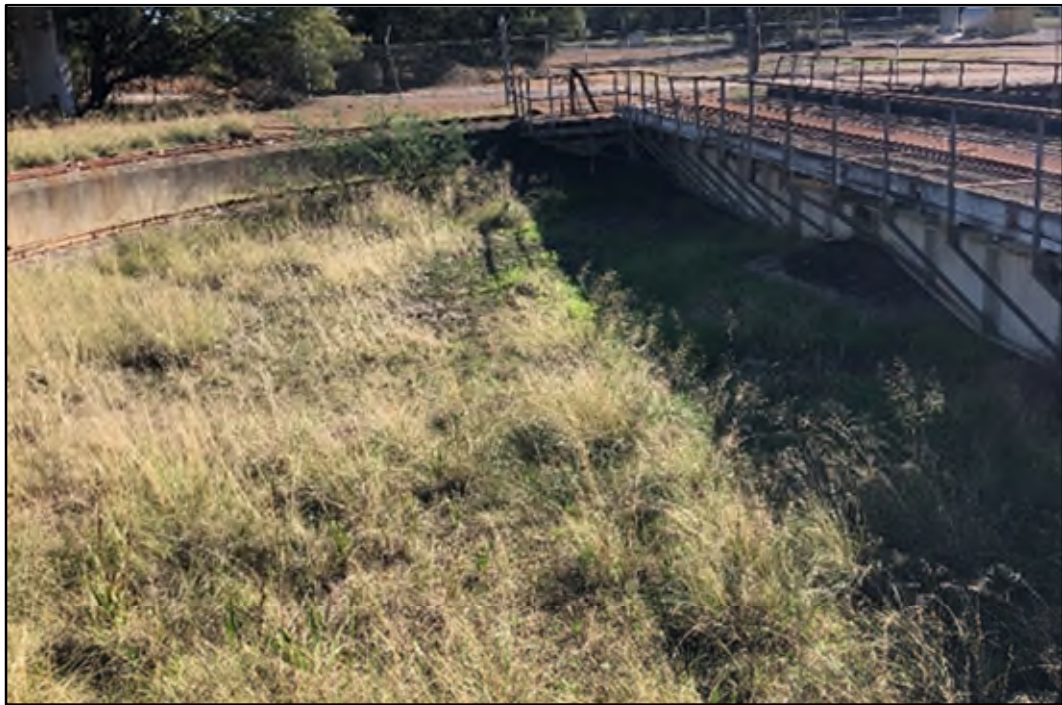
Plate 12: The Turntable, photo facing north.

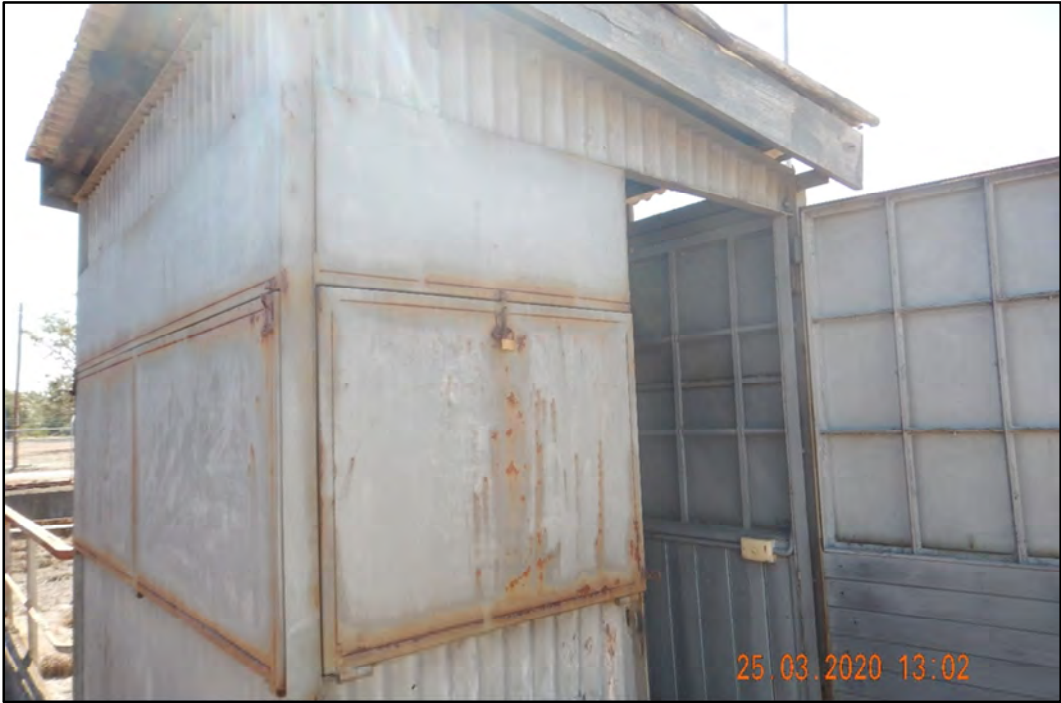
Plate 13: The operators shed on the Turntable.

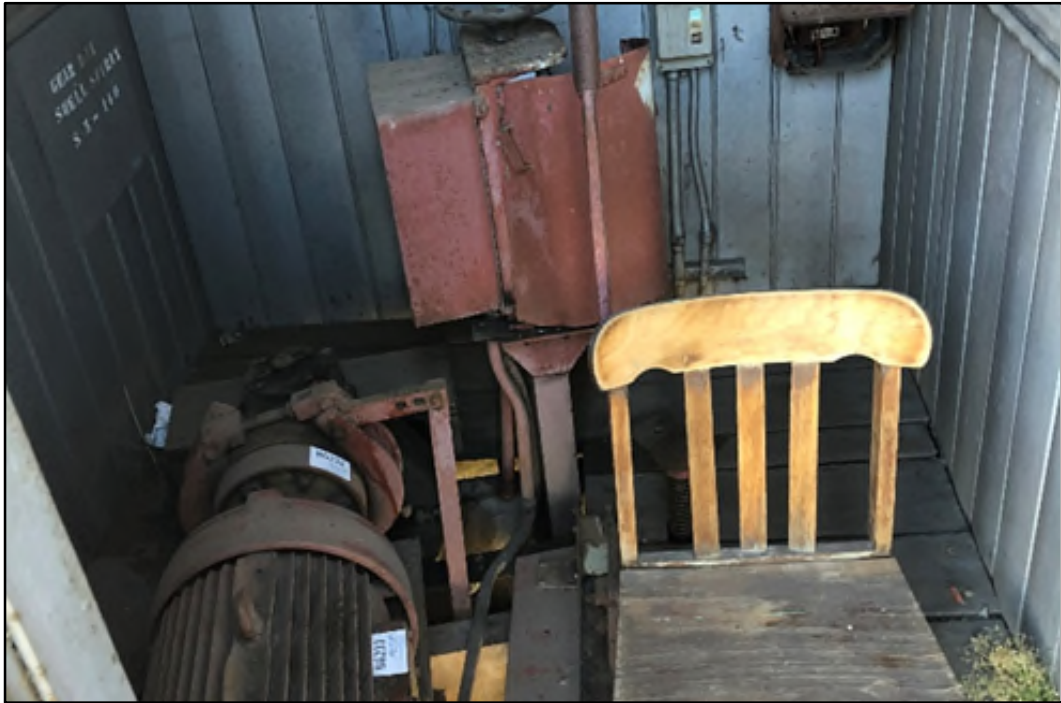
Plate 14: Inside the operators shed on the Turntable.

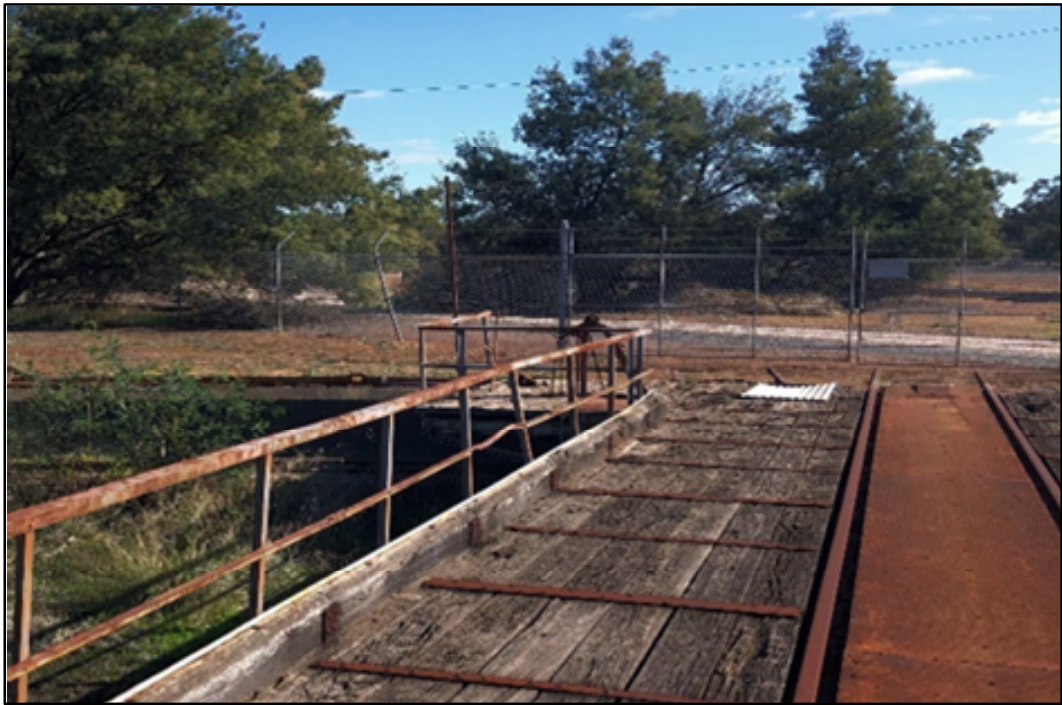
Plate 15: Turntable platform, looking north-west towards the manual operation pulley. The rusted steel and degraded decking are visible.

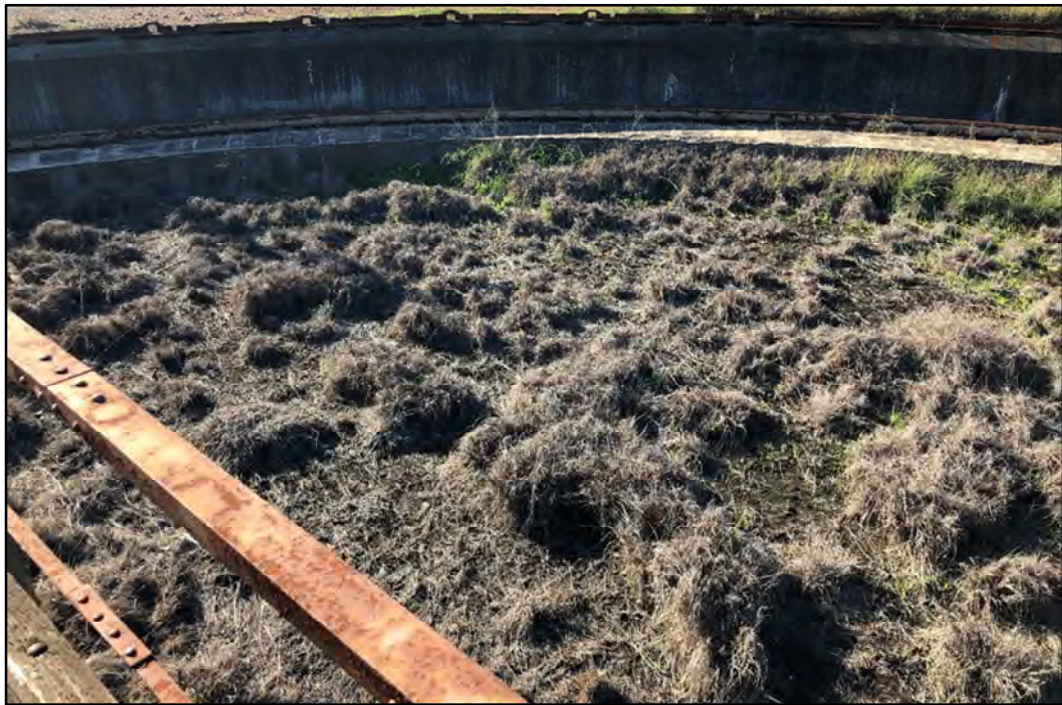
Plate 16: Distressed vegetation observed beneath the Turntable.

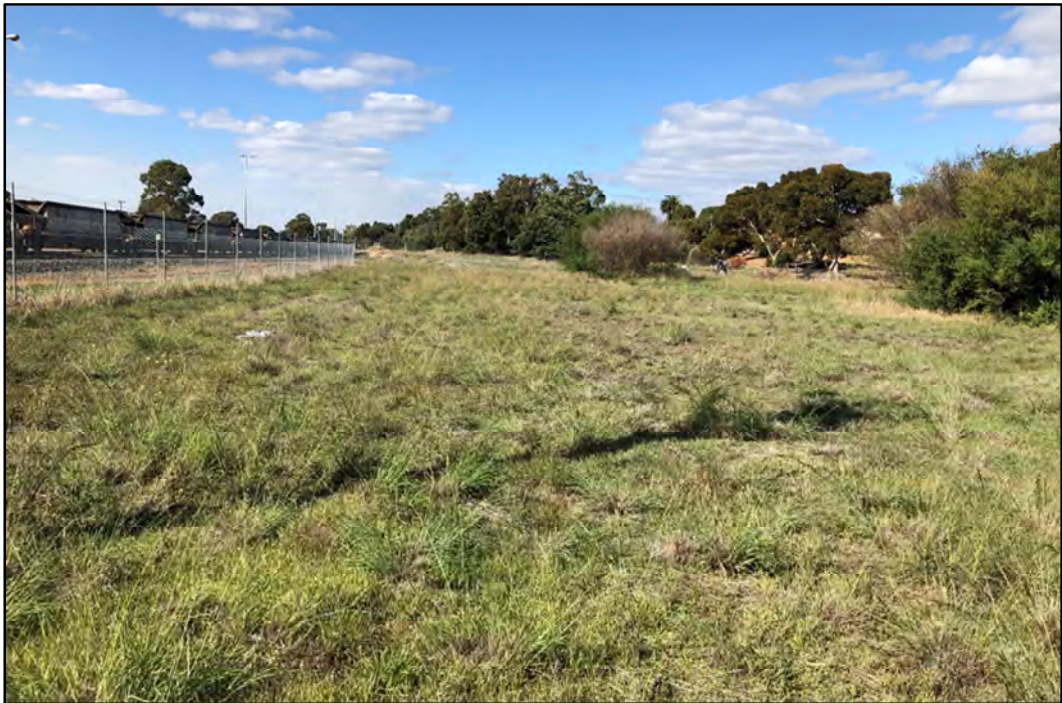
Plate 17: Photo of low-lying vegetation on the eastern portion Lot 561.

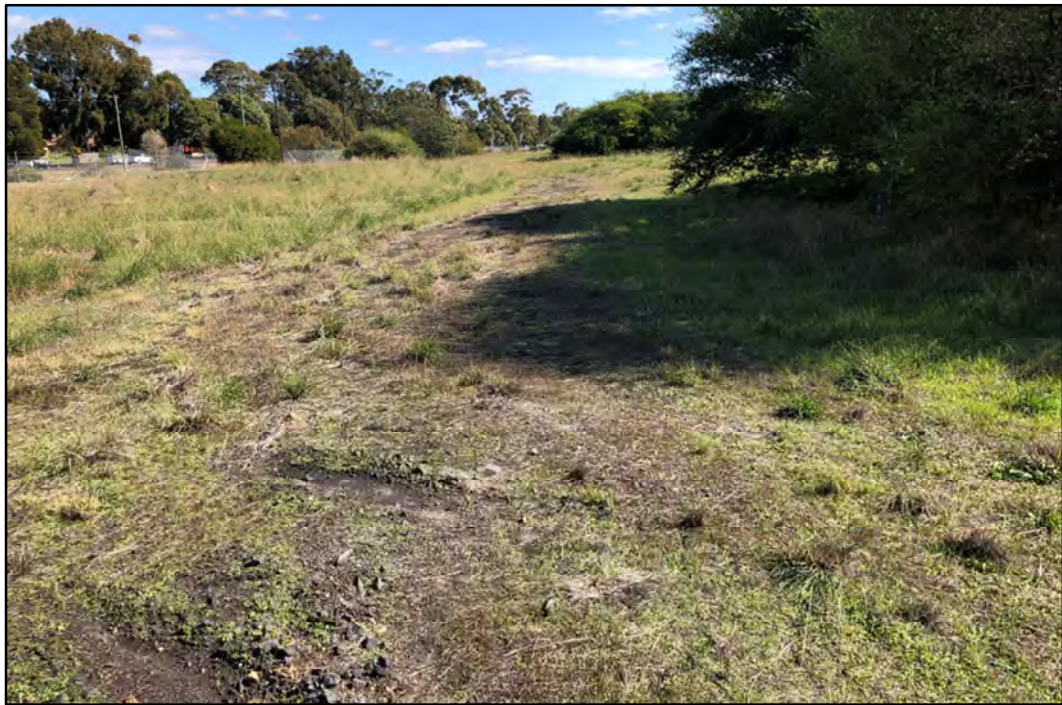
Plate 18: Dark grey sand encountered during the Site inspection.

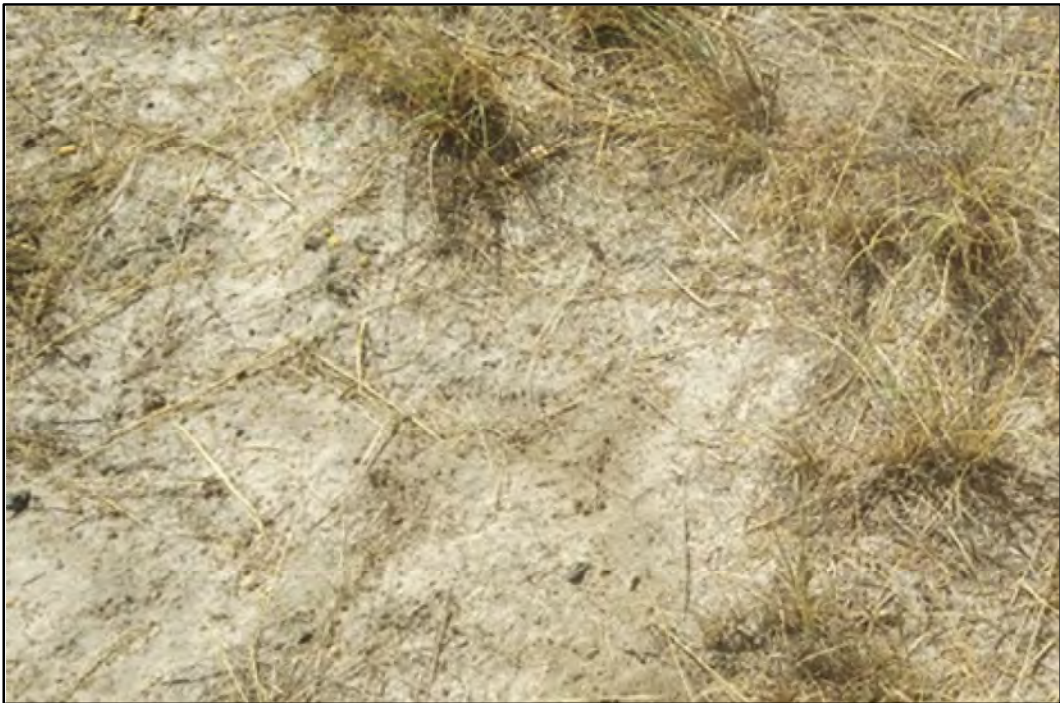
Plate 19: White sand encountered during the Site inspection.

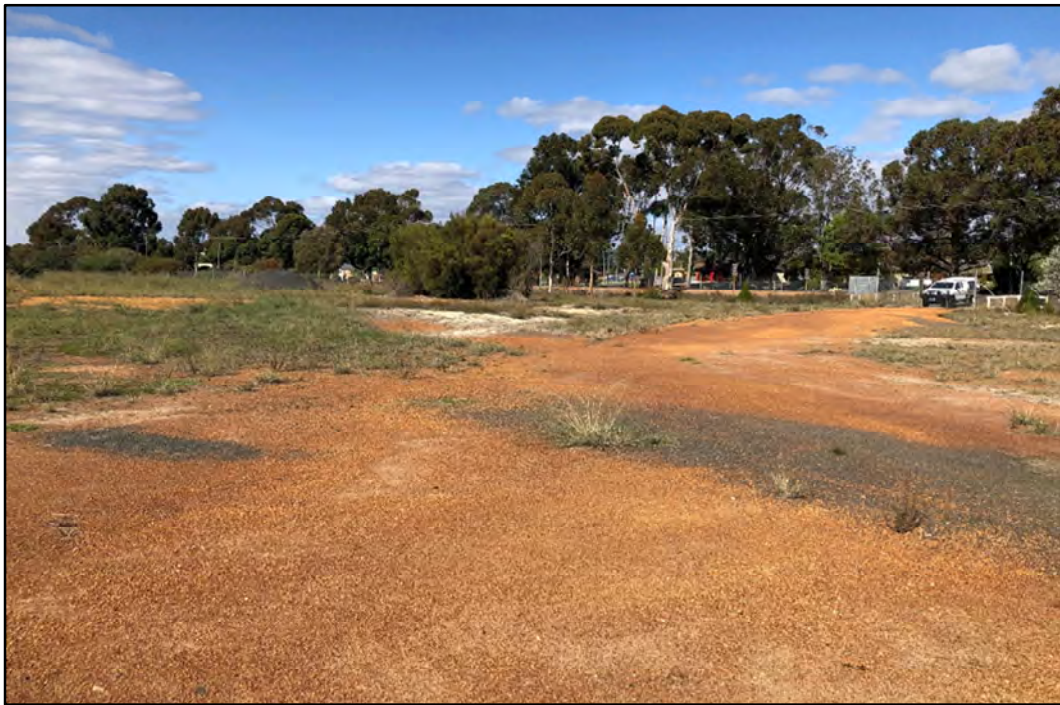
Plate 20: The ironstone laterite observed on the access tracks in Lot 561. Photo facing to the south towards the Site entrance.

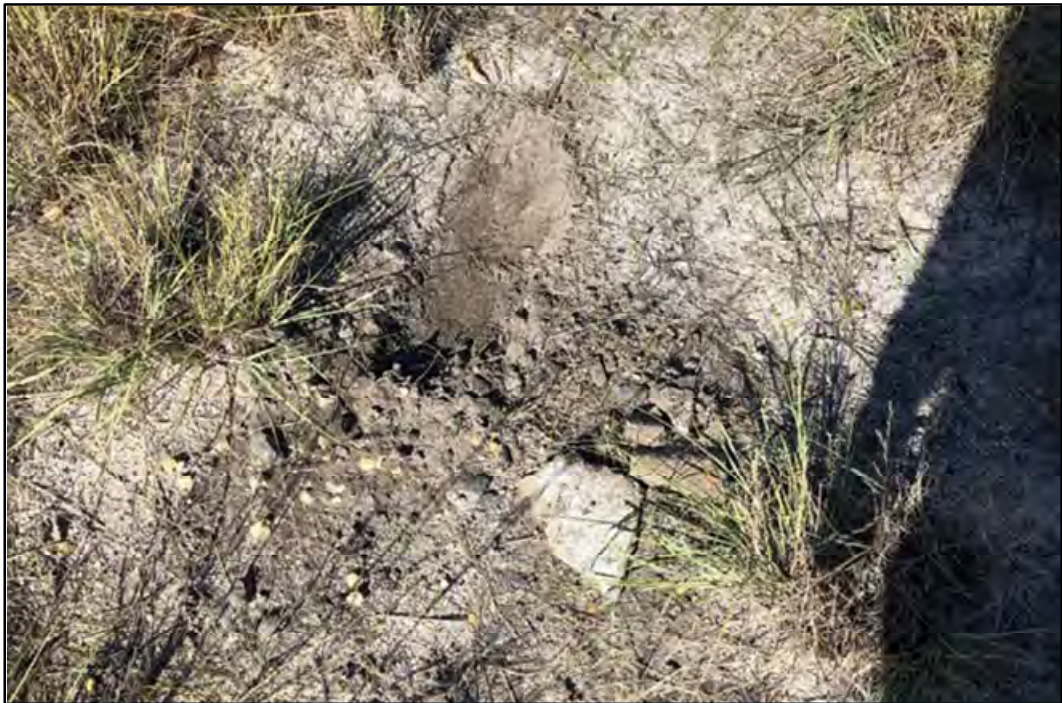
Plate 21: ACM observed in the fill material in Lot 561.

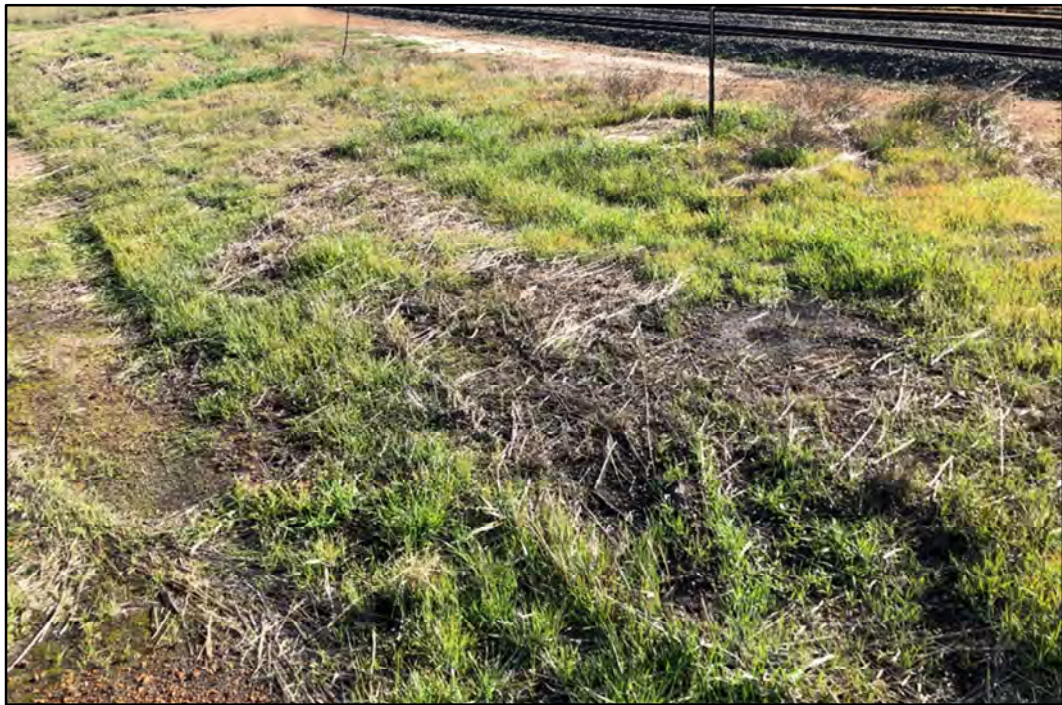
Plate 22: Black ash material observed on the Site surface near the northern boundary.

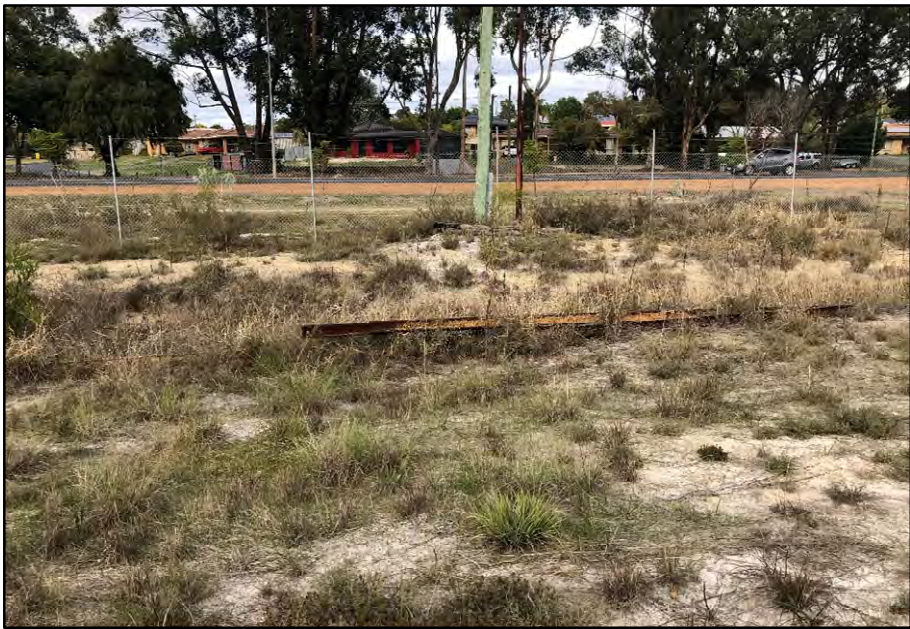
Plate 23: Steel rails that were observed on the soil surface of Lot 561.

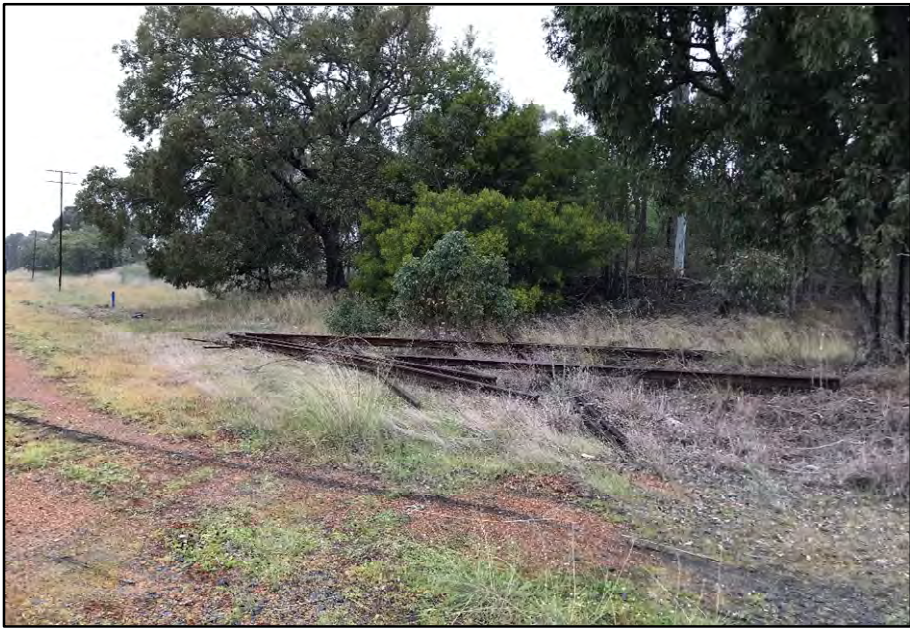
Plate 24: A second location where steel rails that were observed on the soil surface of Lot 561.

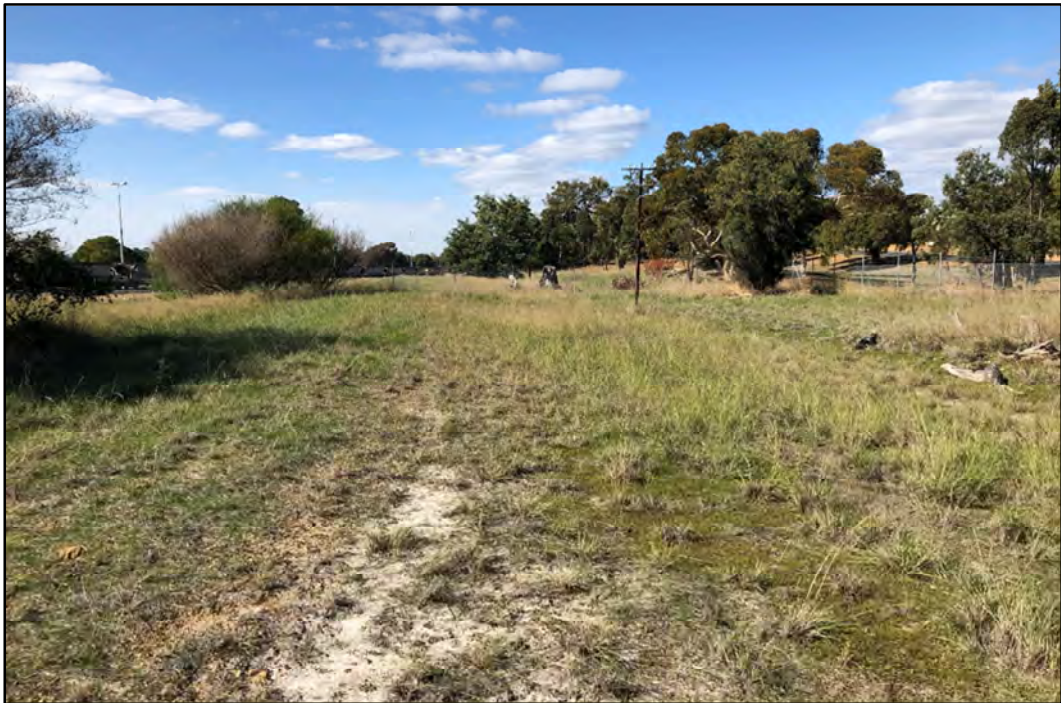
Plate 25: The undulating nature of Lot 561. Image facing to the east.

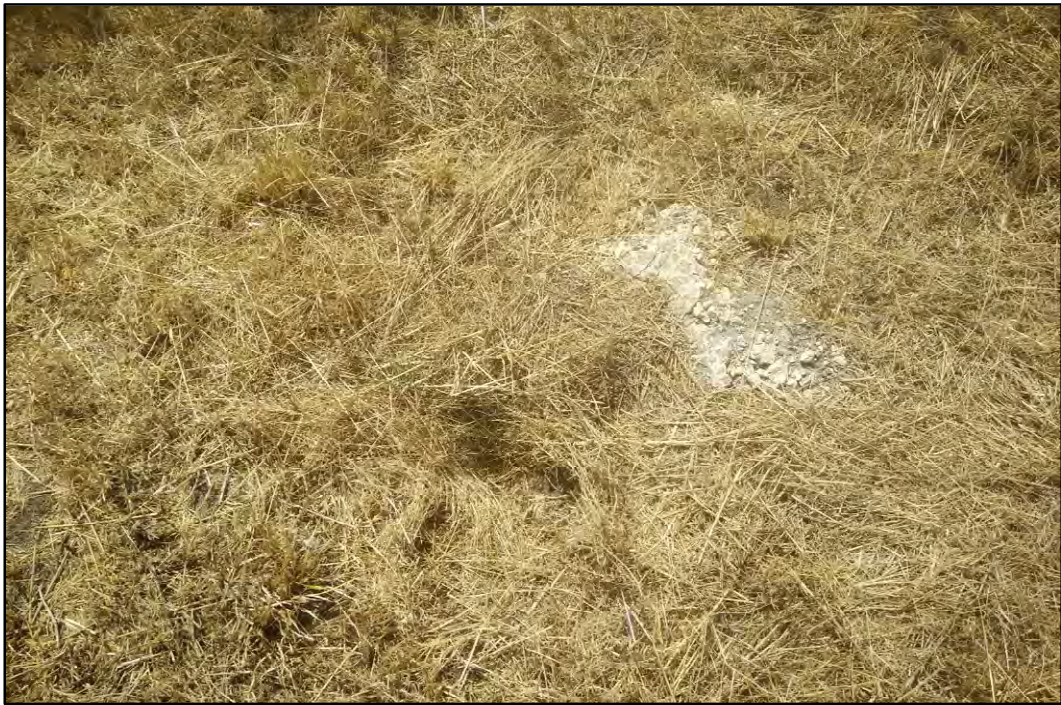
Plate 33: The concrete observed at the location of former groundwater well MB2.

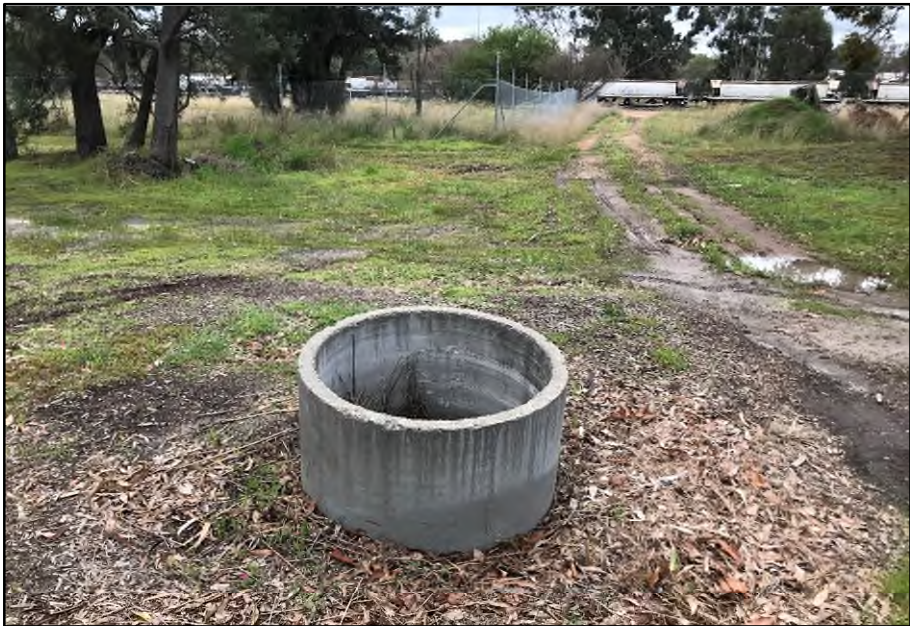
Plate 34: One of the soak wells observed in the eastern portion of Lot 561. The well was observed to sit atop the soil surface .

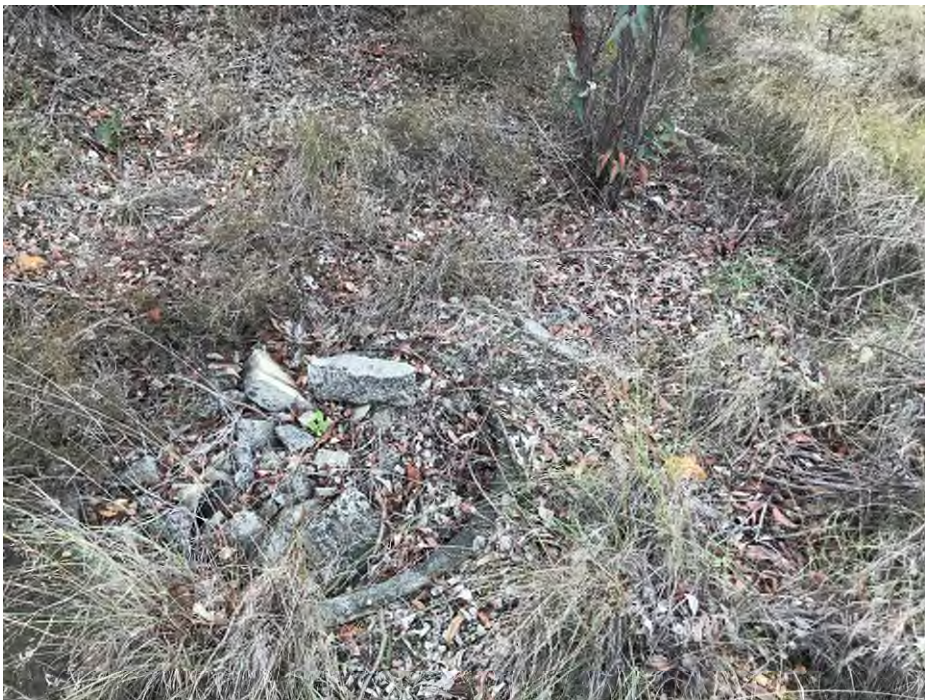
Plate 35: The second unused soak well observed on Lot 561. Fragments of concrete are visible within the soak well.

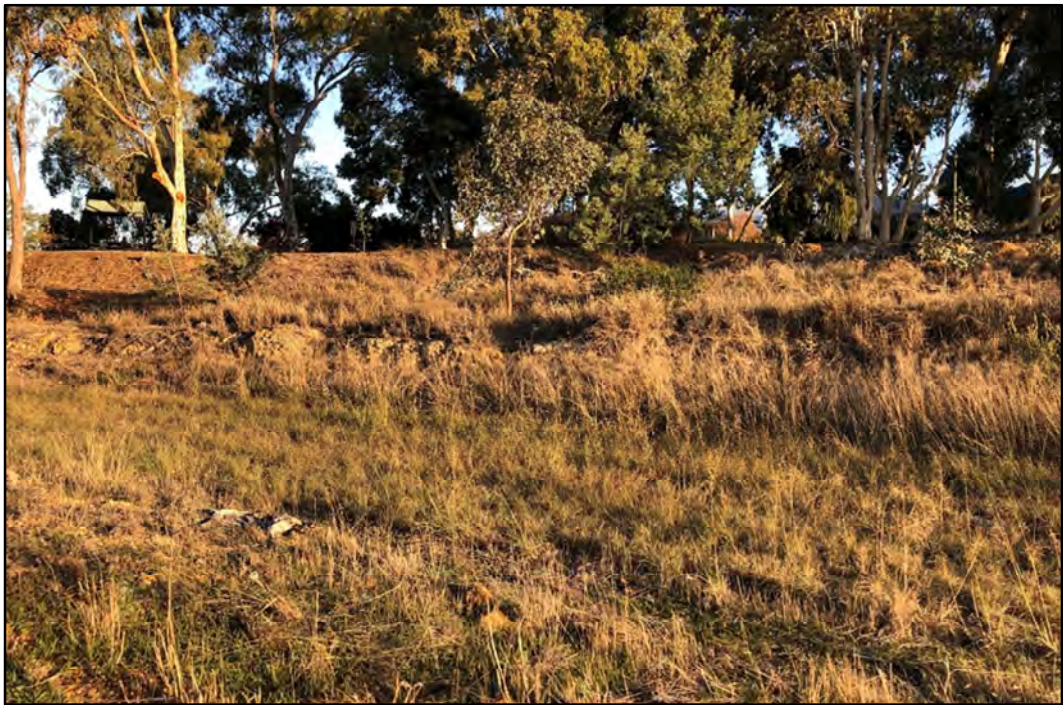
Plate 36: Example of the topography and vegetation on Lot 2860, photo taken facing towards the south-west.

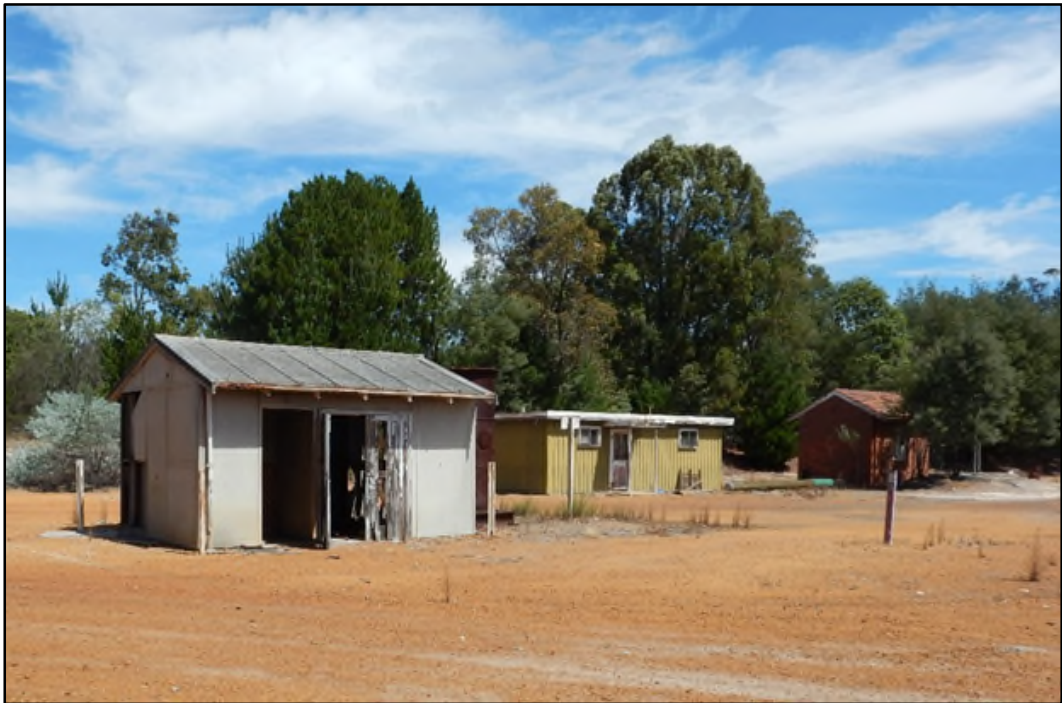
Plate 37: The two buildings (Compressor Shed on the left and unknown building on the right) located on Lot 560, west of the Roundhouse.

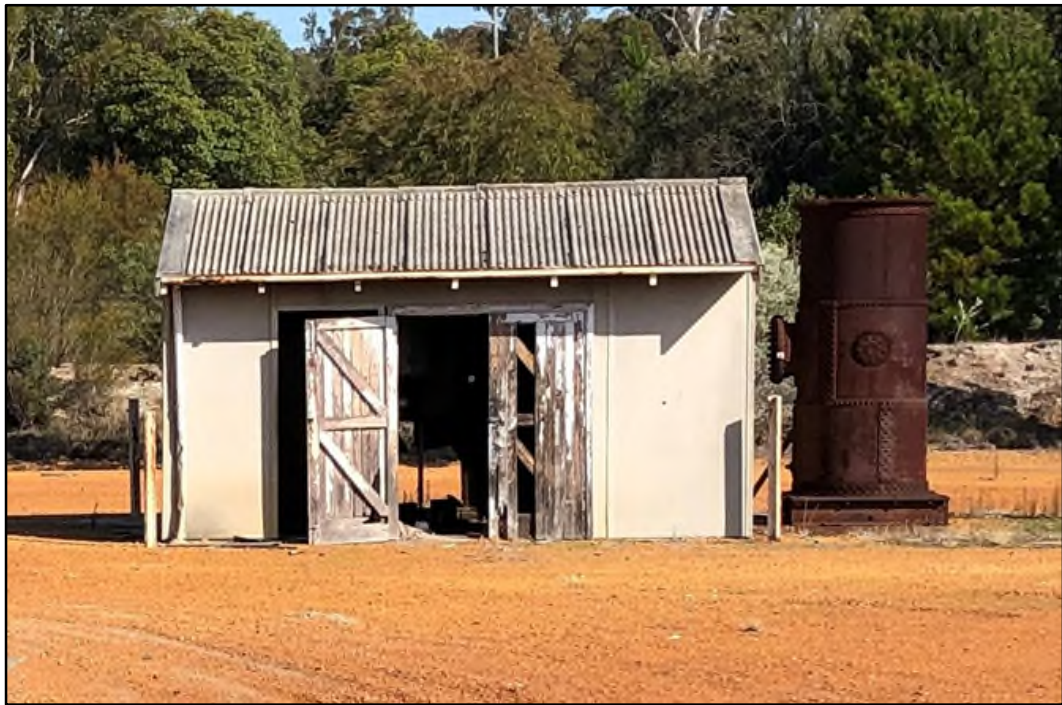
Plate 38: The Compressor Shed. Photo facing south. The compressed air reservoir can be observed to west (right) of the compressor shed.
