APPENDIX 17

Site Inspection Photographs

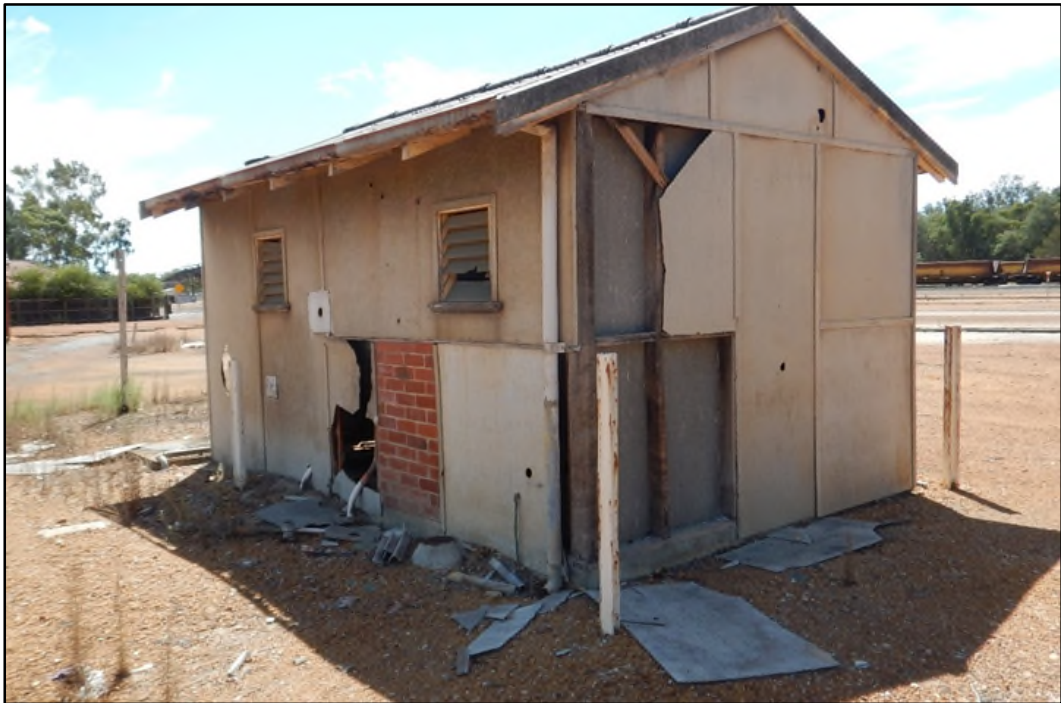
Plate 39: The damaged ACM cladding on the Compressor Shed. ACM fragments can be observed on the soil surface around the Shed.

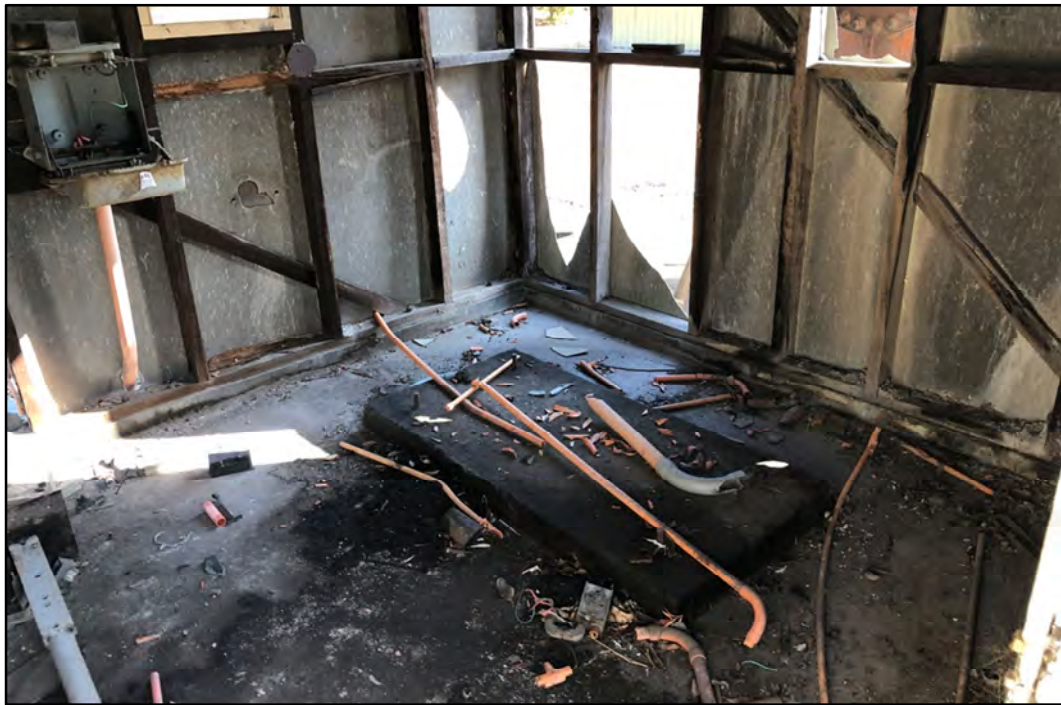
Plate 40: Inside the Compressor Shed. ACM fragments and black discolouration on the walls and concrete floor can be observed.

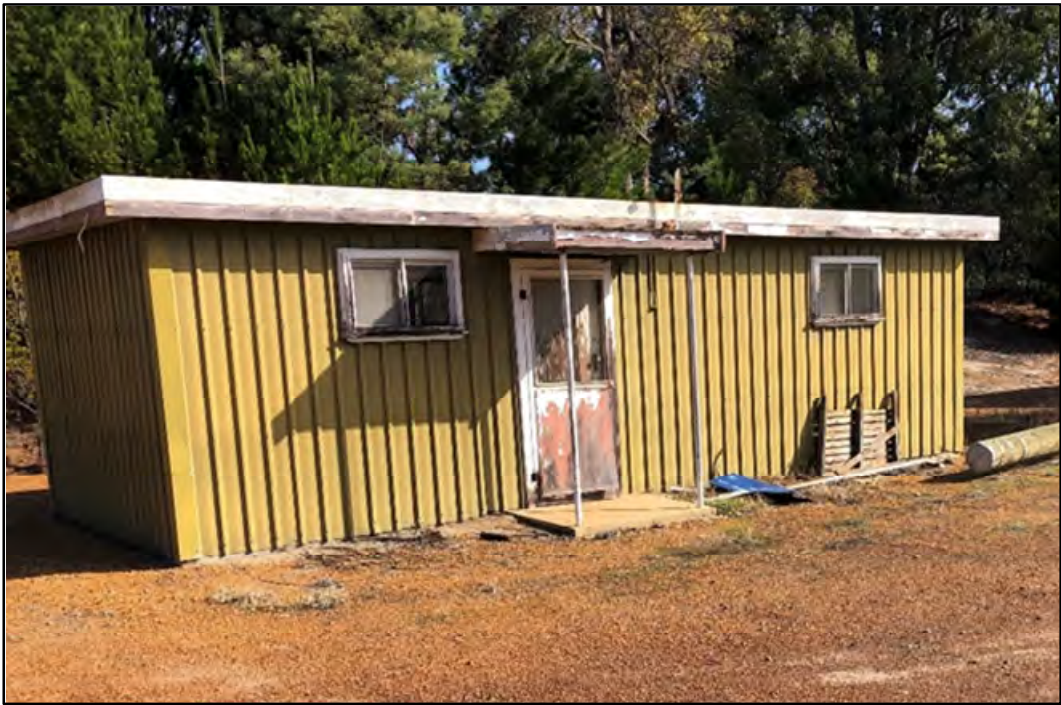
Plate 41: The unknown building present on Lot 560, west of the Compressor Shed.

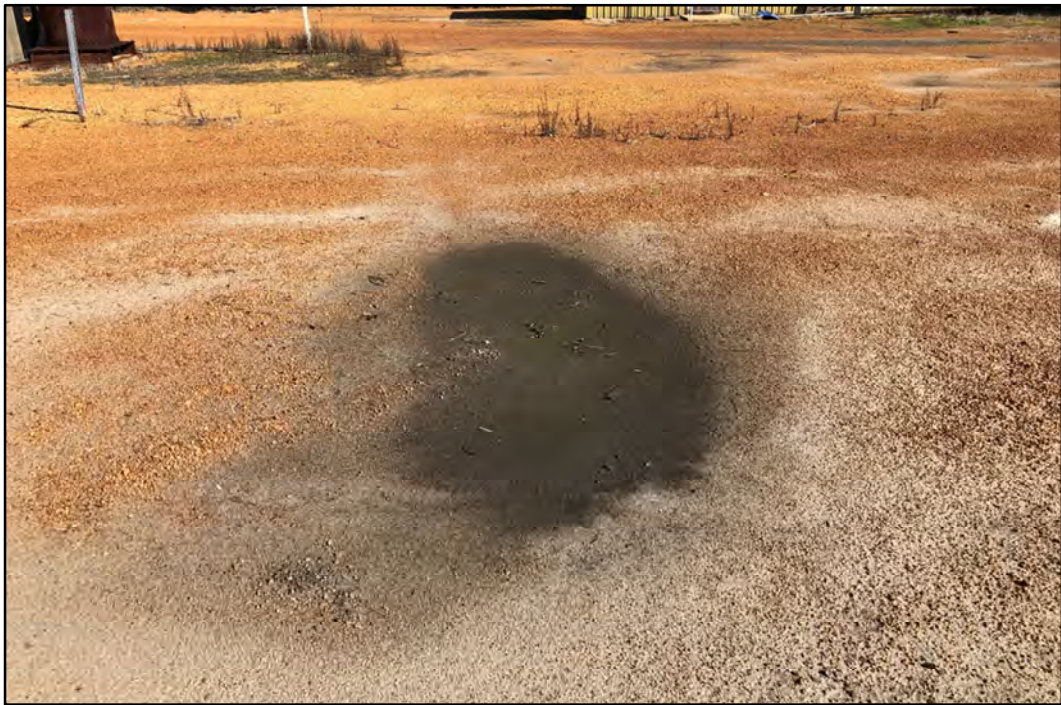
Plate 42: Dark soil observed north of the Compressor Shed on Lot 560.

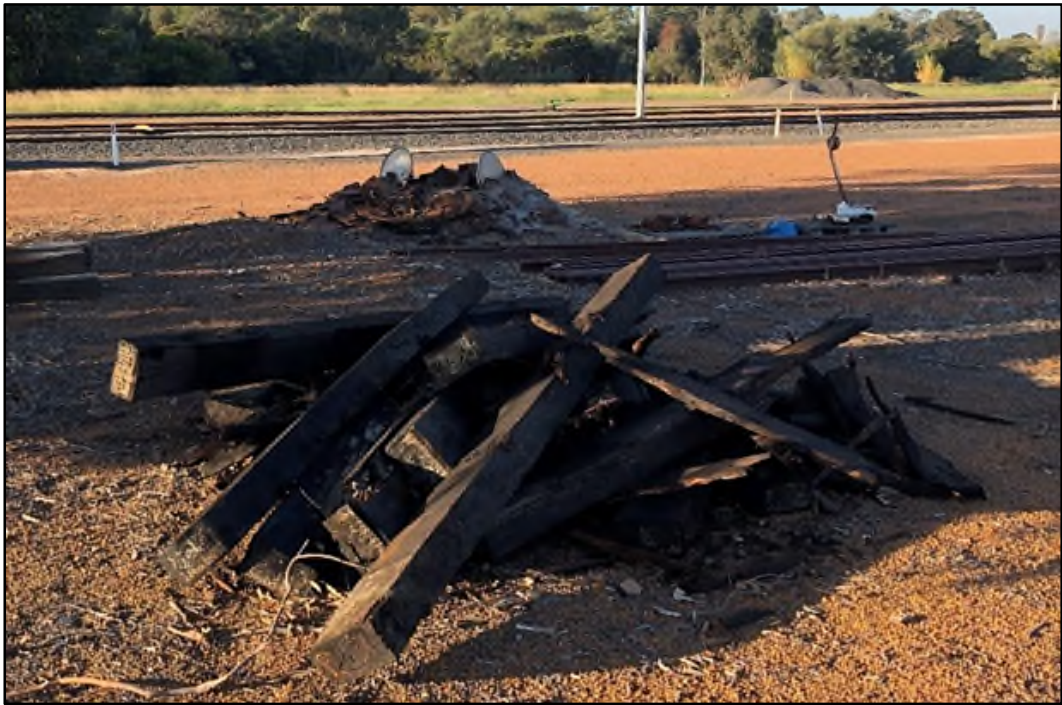
Plate 43: Stored railway waste on Lot 2856. The burned railway sleepers can be observed in the foreground

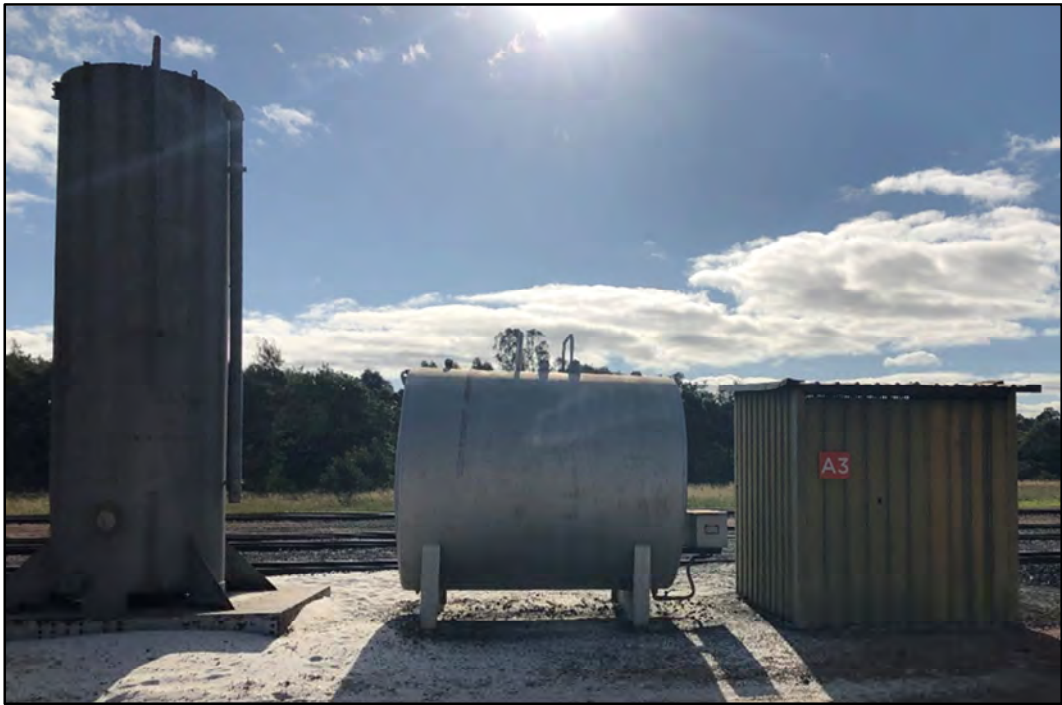
Plate 45: Sand AST to the left, nitrate/chromate AST in the centre and shed to the right. Photo taken looking north, approximately 75 north of the Roundhouse.

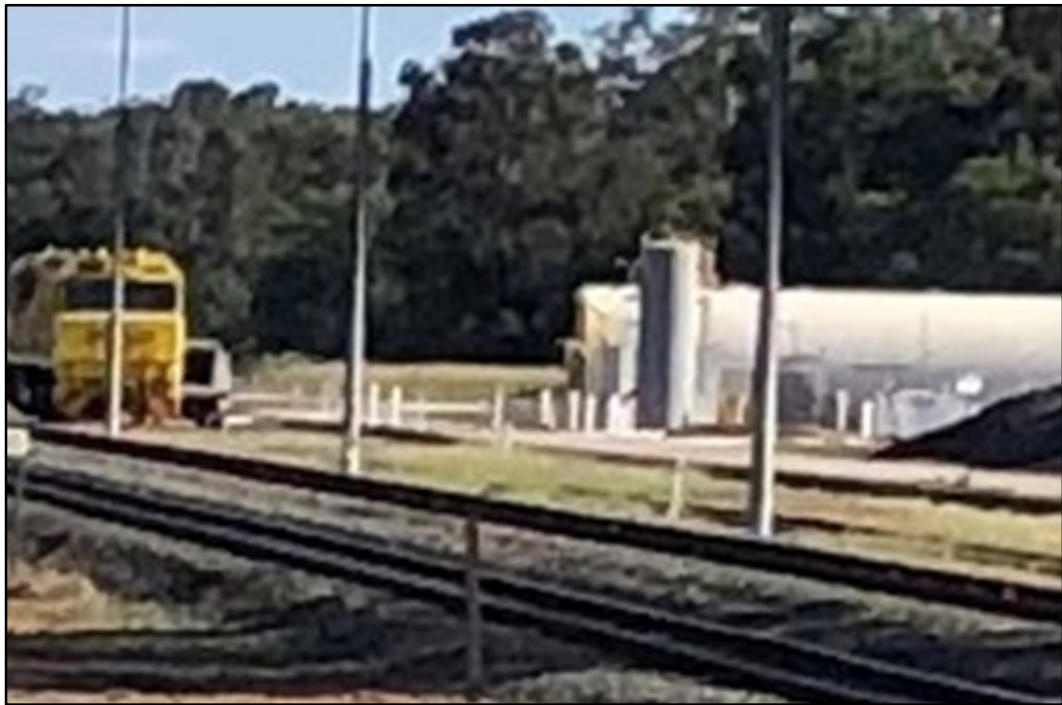
Plate 46: Offsite Aurizon Diesel AST, photo taken looking towards the north-west.

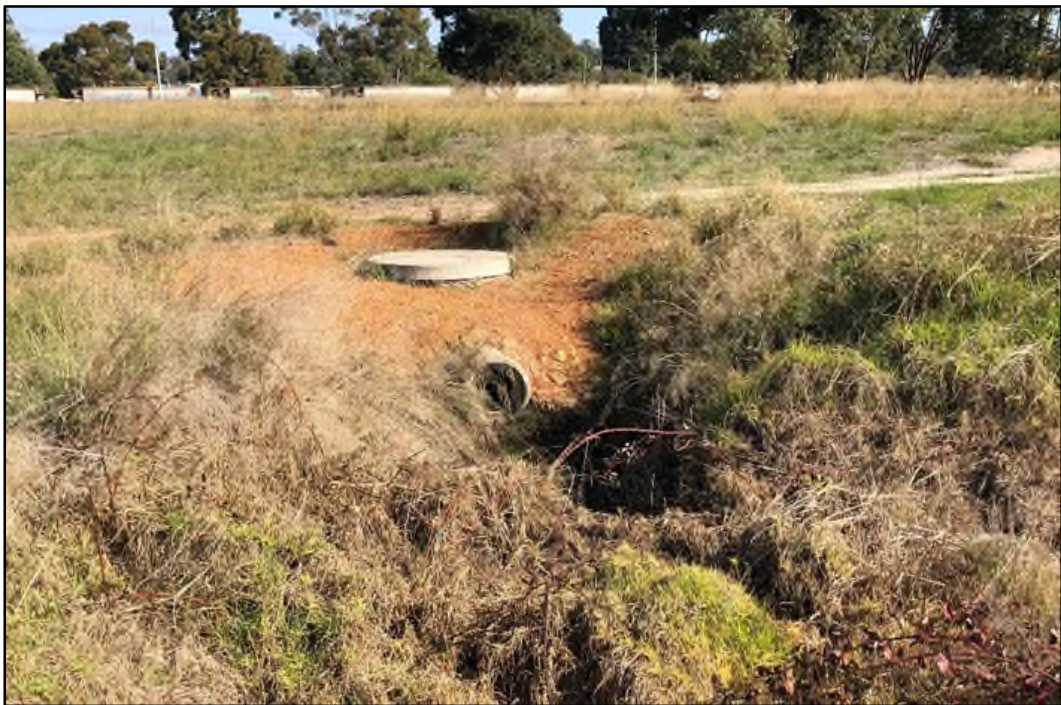
Plate 47: Underground drainage release point at ephemeral creek, located offsite.

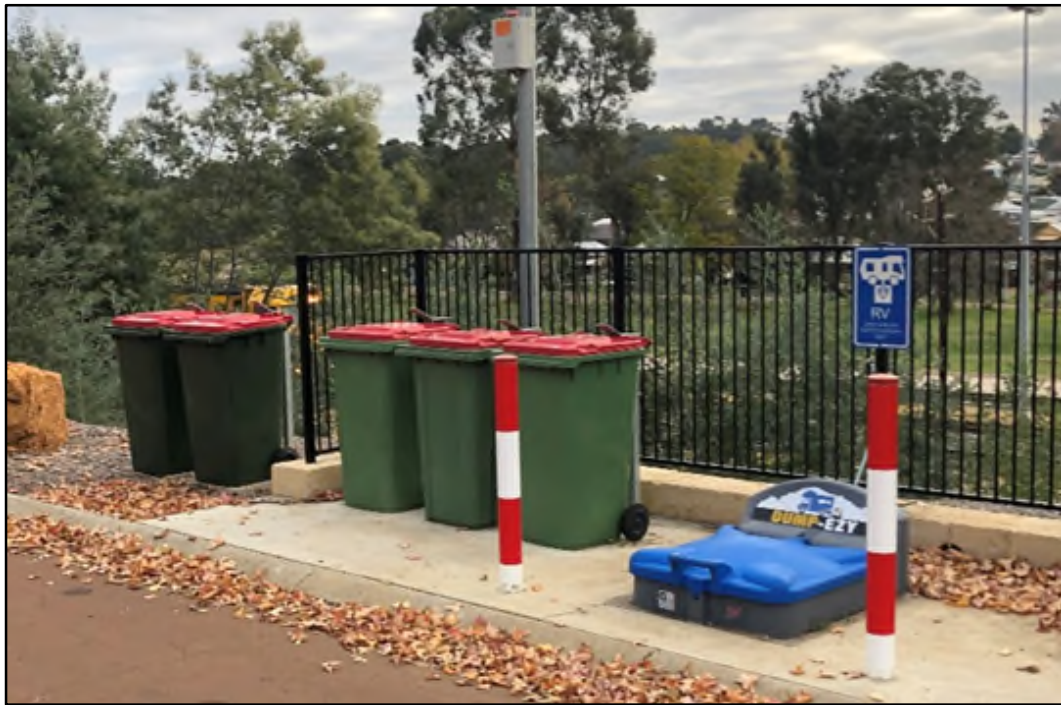
Plate 48: Sewage disposal location, near Collie Information Centre, south of Lot 2860.

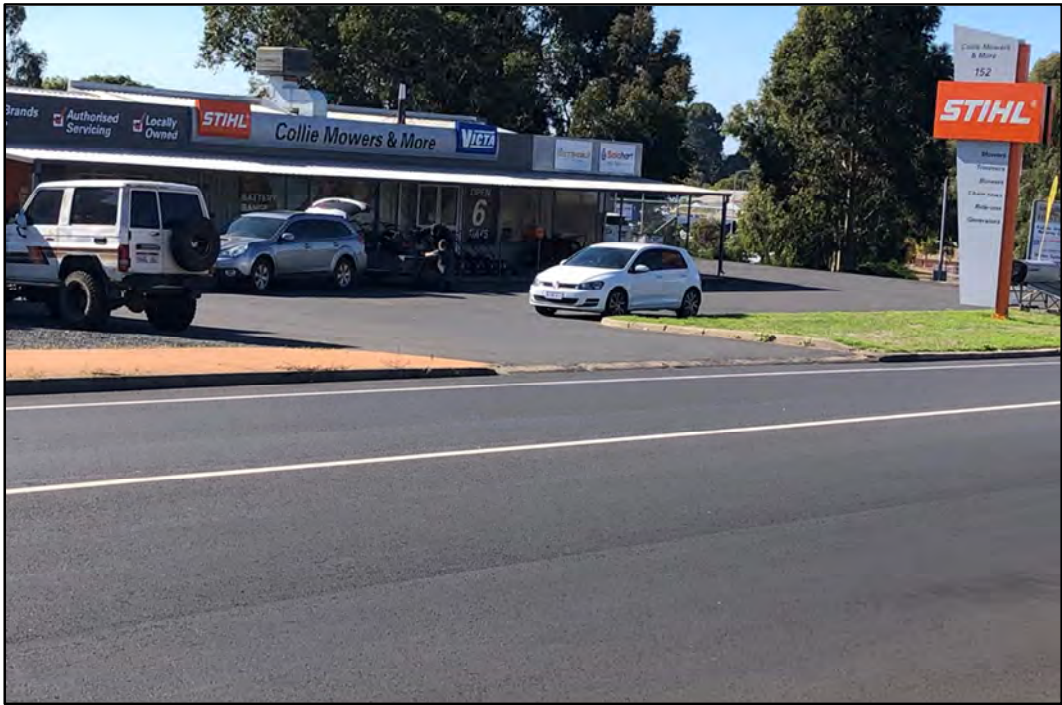
Plate 49: The location of the former Nightowl service station, east of the Site.

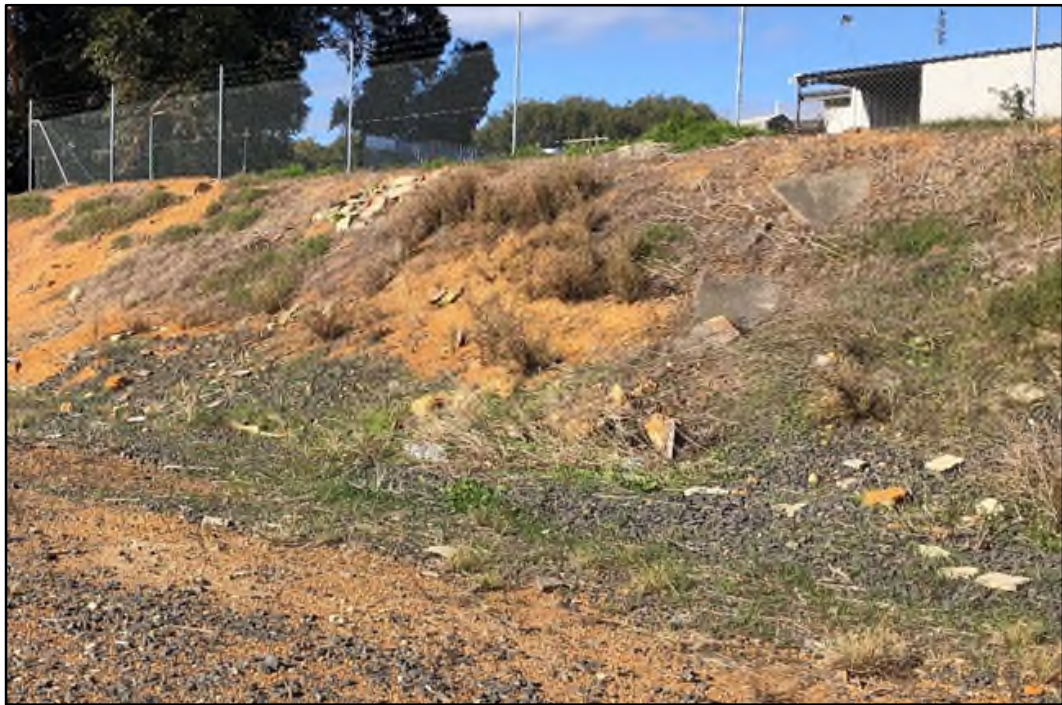
Plate 50: Northern wall embankment with C&D waste observed, offsite.

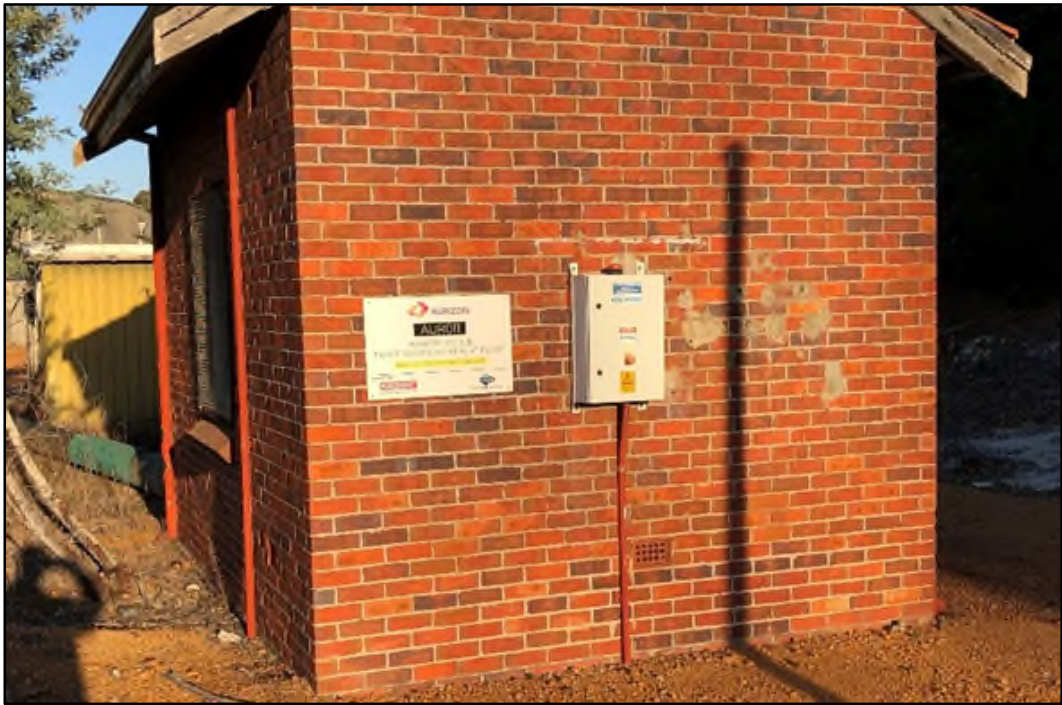
Plate 51: Aurizon Collie Depot Trade Waste Treatment Plant sign on brick building, west of the Site.

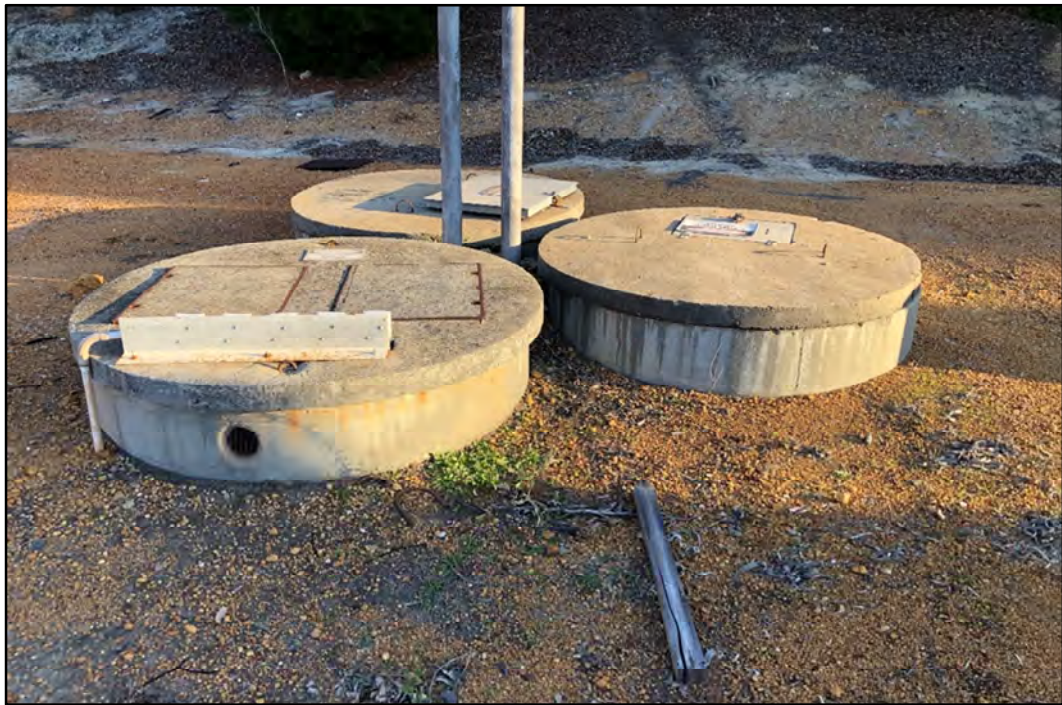
Plate 52: The three concrete lids, understood to be the septic tanks associated with the Aurizon Administration building.
