TIMBER HOUSES IN TOWNSVILLE

The houses at the Heritage Centre illustrate the changes in housing construction over the last 100 years.

NATIONAL TRUST
OF QUEENSLAND
Townsville/NQ Branch

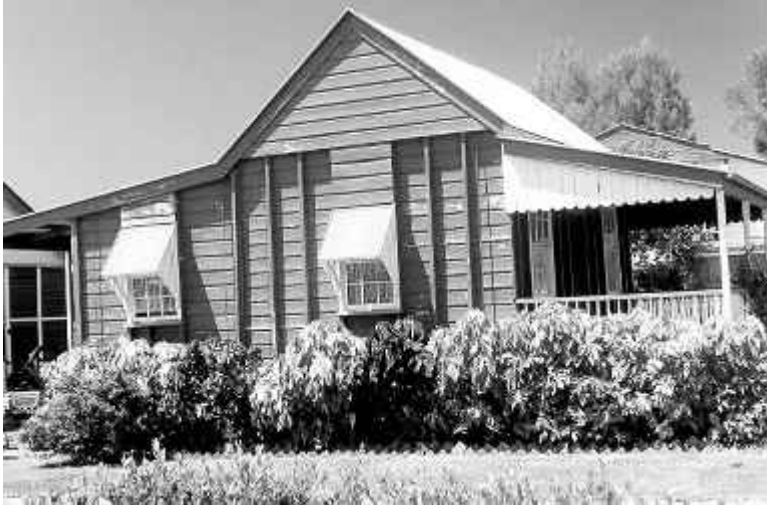
An early example of exposed framing, on the Worker's Dwelling at the National Trust Heritage Centre

'Exposed framing' describes the building technique where the framing of the house, with horizontal bottom plates and top plates joined by vertical studs, was exposed on the outside. The frame was sheathed with wide horizontal boards on the inside.

'Currajong' and the Worker's Dwelling both illustrate this building technique.

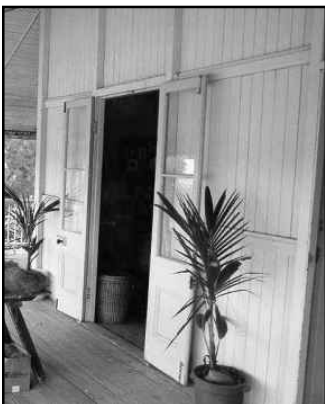
Style of exposed framing showing belt rails and internal VJ boards, introduced

Whereas the space between the stud framing on earlier houses was narrow, the studs were now placed further apart and held firm with top and bottom plates and horizontal belt rails. The sheeting, though still internal, was of narrower boards, called VJs, placed vertically. The Farmhouse illustrates this building technique.

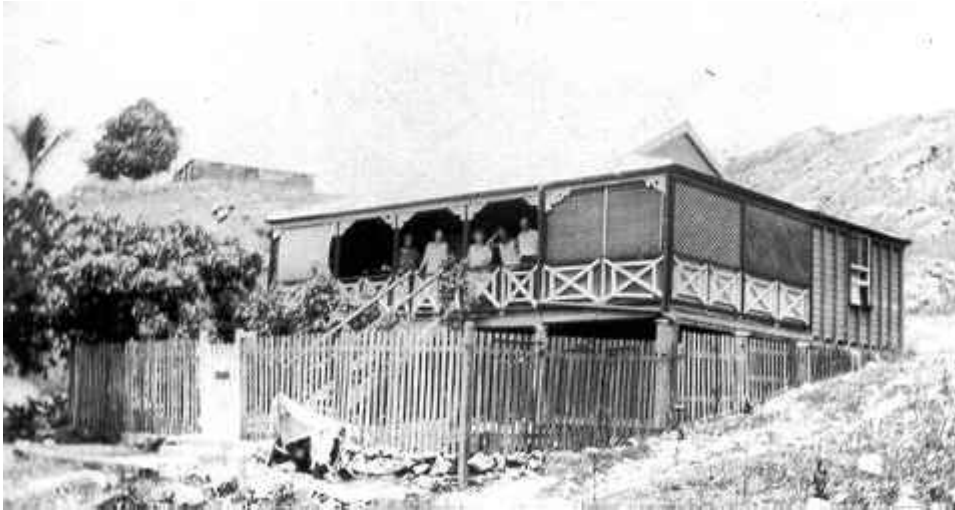
An early example of a high-blocked house, about 1890

Until 1900 most timber houses were on low blocks or piers, of brick or timber. From the 1890s houses raised on high piers, usually of timber, became increasingly common.

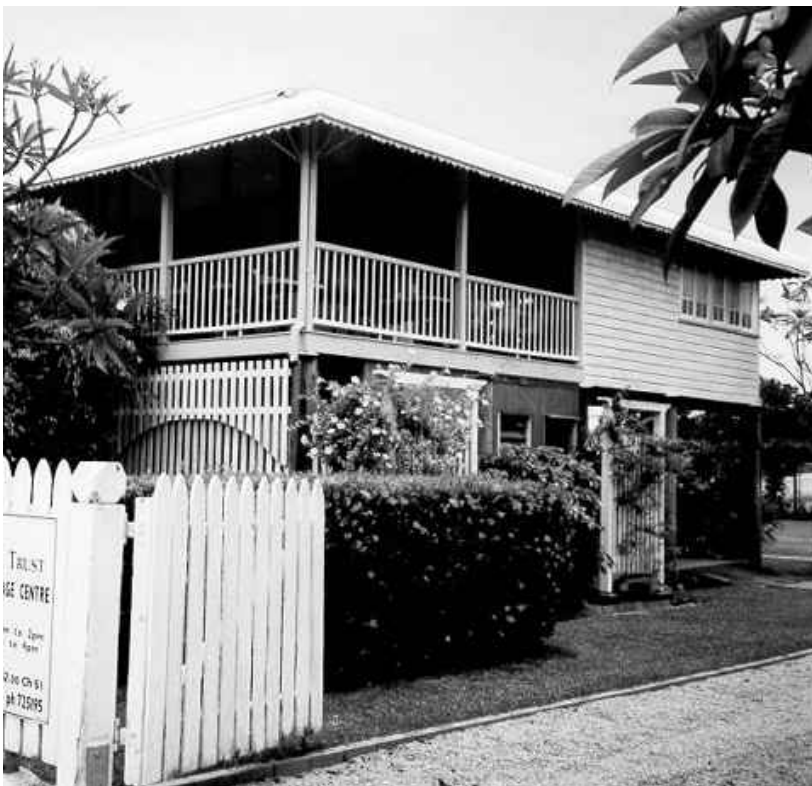
The Farmhouse at the Heritage Centre, showing chamfer boards on the rear walls

By the 1930s, and perhaps even as early as the 1920s, exposed framing went out of use. Chamfer boards or weatherboards were placed horizontally on the outside of the frame, and VJs were used to line the

Chamfer board: Wall cladding using horizontal lengths of timber with a shallow groove giving a smooth finish but again providing a weatherproof surface.

inside walls, so that houses were double sheeted.

This form of construction can be seen on the rear of the Farmhouse, which was enclosed in the 1940s.

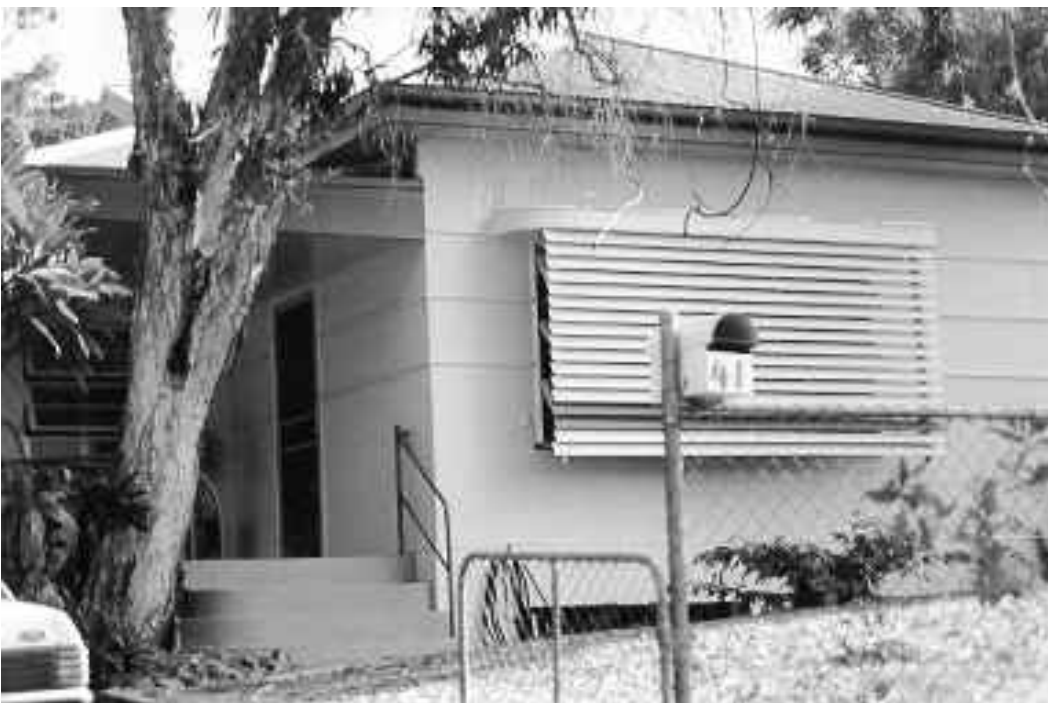
One of the earliest houses in Townsville to be sheeted externally with Fibrolite

By the 1930s a building board called Fibrolite® (fibrous-cement sheeting) revolutionised house building. It came in large sheets, so that builders could cover walls very quickly. From then on one finds houses either sheeted externally and internally with Fibrolite, or sheeted externally with Fibrolite and with VJs on the inside walls.
