CONSERVATION AND RESTORATION OF BUILDINGS

conservation of roofs

Australian Council of National Trusts

By Clive Lucas O.B.E., B.Arch., F.R.A.I.A.

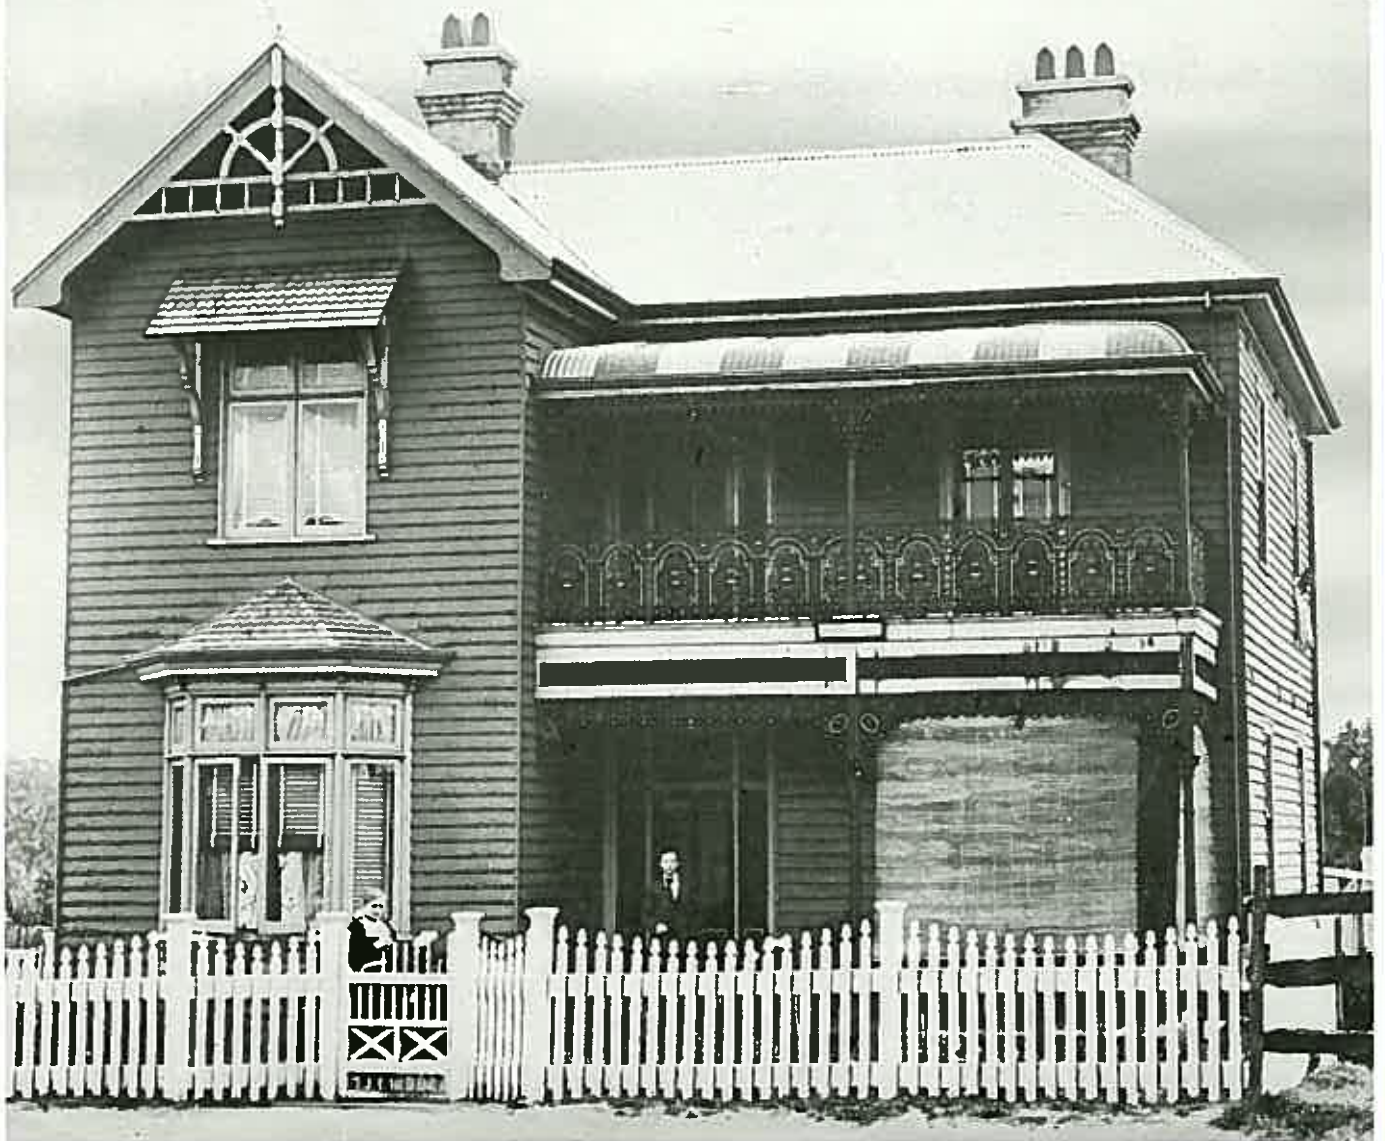
COVER

This early twentieth century photograph shows many of the traditional roofing details found in Australian buildings:

Chimney pots are slate, roof is corrugated iron, gutter is ogee pattern, gable is finished with mouldings and turnery, bay window and sun hood is shingled incorporating shaped shingles, verandah roof is bull nosed and striped, downpipes are circular.

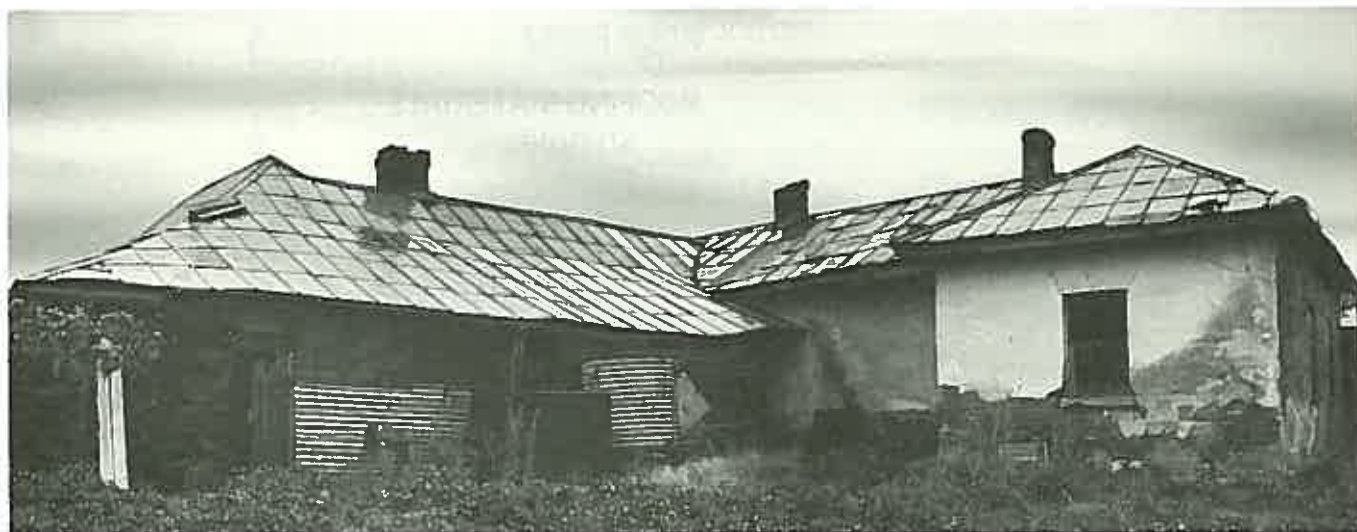
An English iron tile roof before restoration. Although in an advanced state of decay all the detail was there for exact restoration.
(Cooma Cottage, Yass, N.S.W. Photo: John Morris)

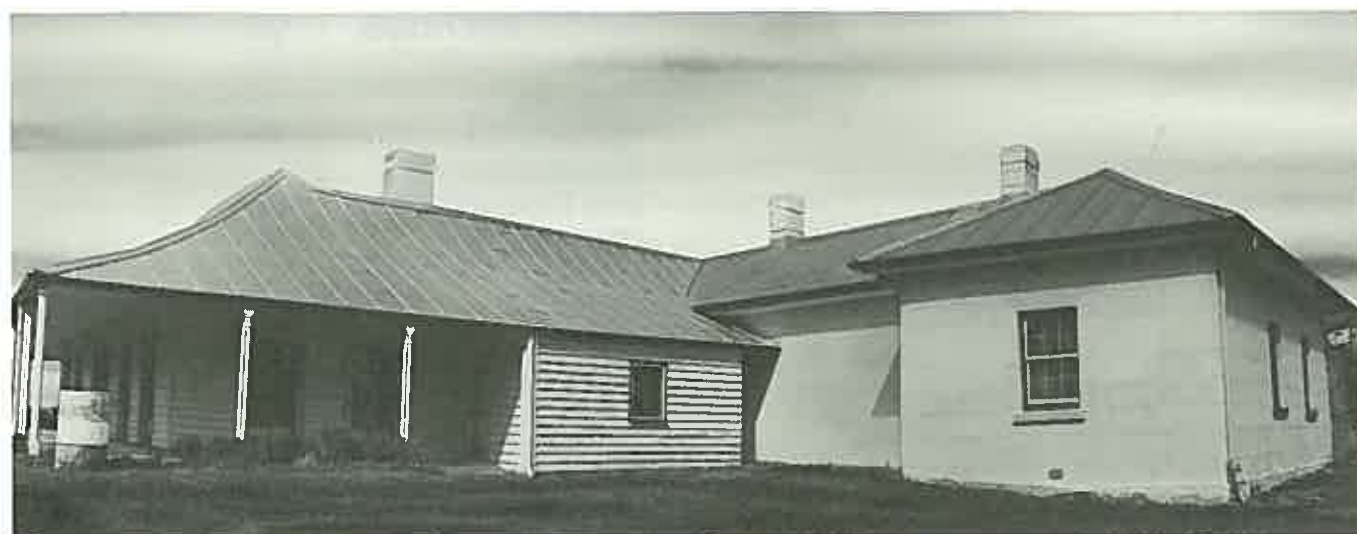
The iron tiles have been reproduced and the half round gutters reinstated.
(Restoration Architect: Clive Lucas)

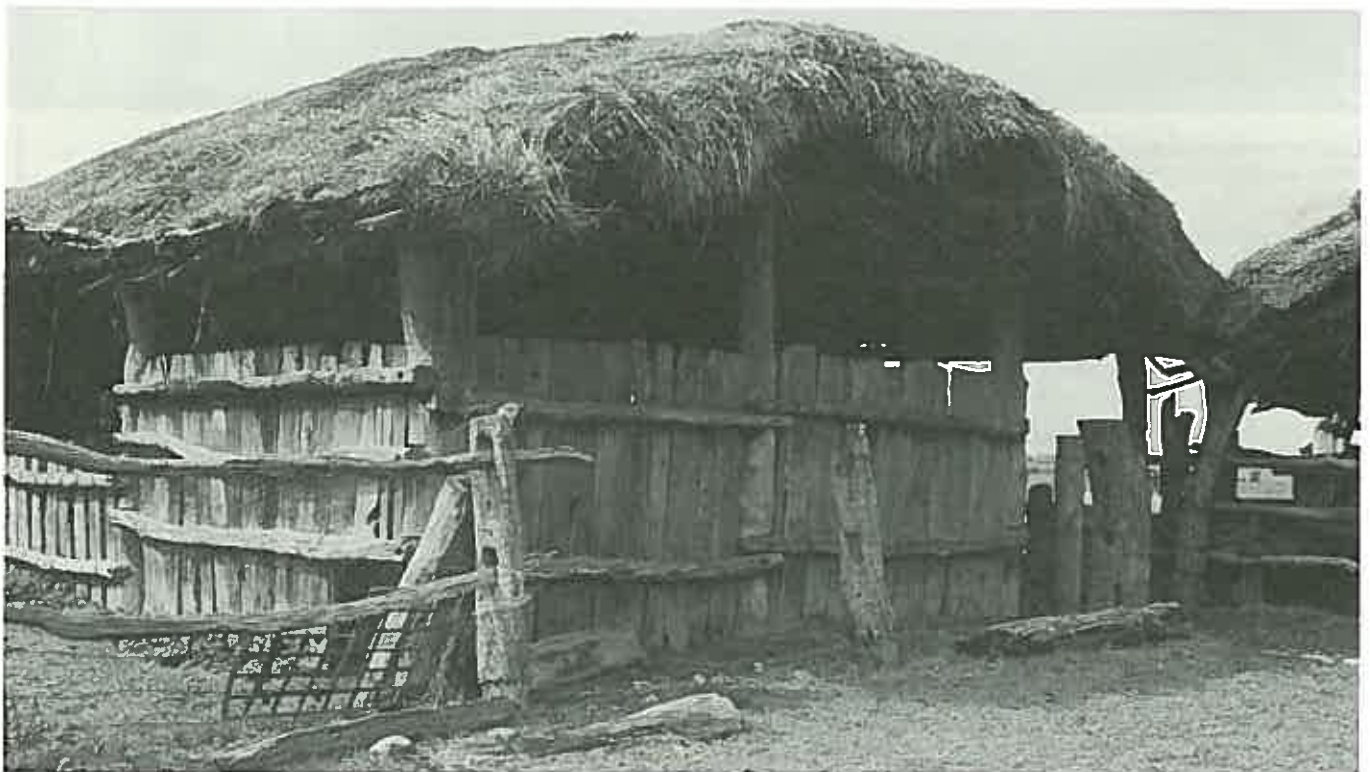
One of the earliest outstation establishments north of Adelaide. The bush pole structure is covered in straw held in place by wire netting which could be later.
(Barn, Stone Hut, S.A. Photo: Stephen Gilbert)

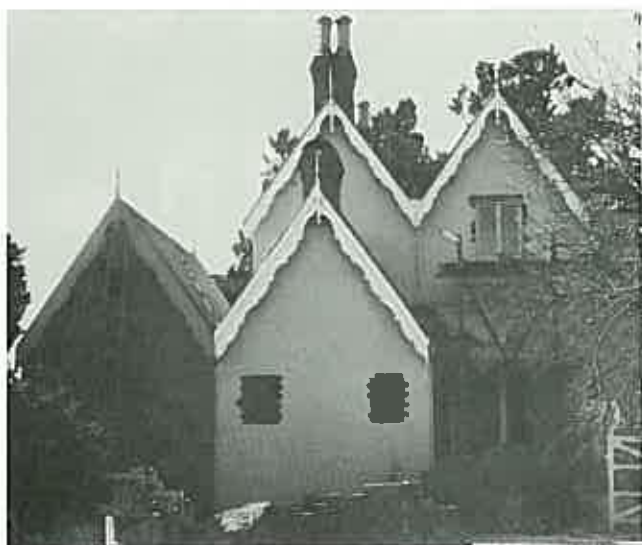
The importance of roof form when making additions and alternation to a building.

The enclosed diagrams show best how to sympathetically add to traditional Australian roof forms.

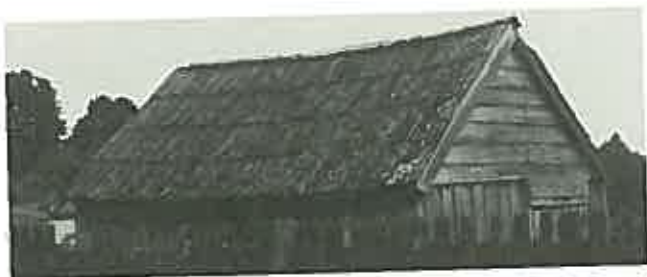
Split shingles are found in various widths and lengths. Long shingles on a Tasmanian outbuilding.
(Shed, Grigg Street, Deloraine, Tasmania)

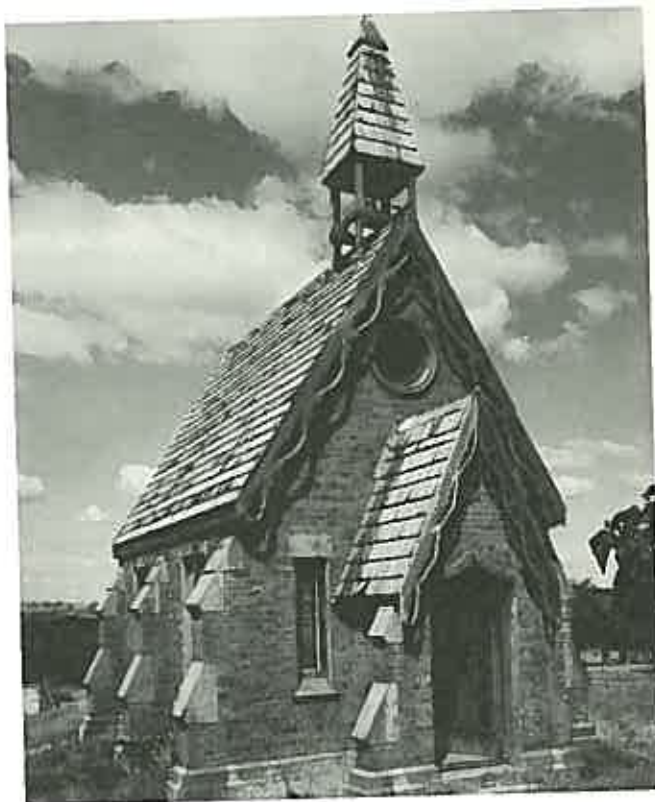
Split shingles newly restored to this picturesque building with elaborate fretted barge boards.
(Chapel at Brickendon, Longford, Tasmania. Photo: Wesley Stacey)

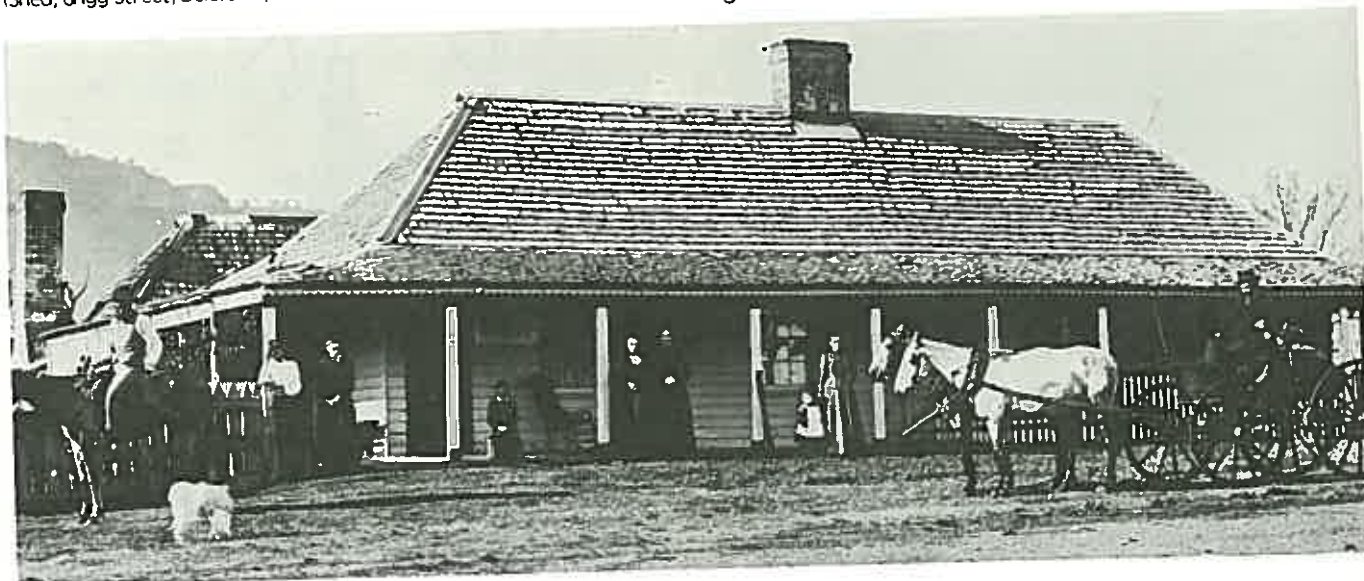
A shingle roof with iron ridging.
(Kangaroo Valley Hotel, near Nowra, N.S.W. Photo in possession of D.C. Woodhill)

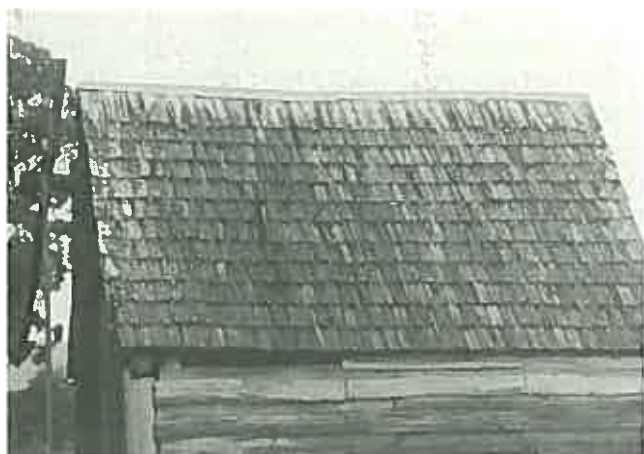
The more normal sized shingle.
(Outbuilding, St Mary's, Tasmania)

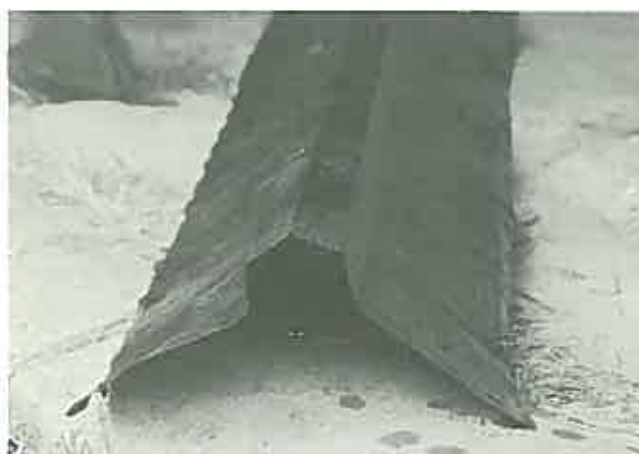
One of the earliest ridging forms used in Australia, made in England
by A. Moorewood & Co. (Elizabeth Farm, Parramatta, N.S.W.)

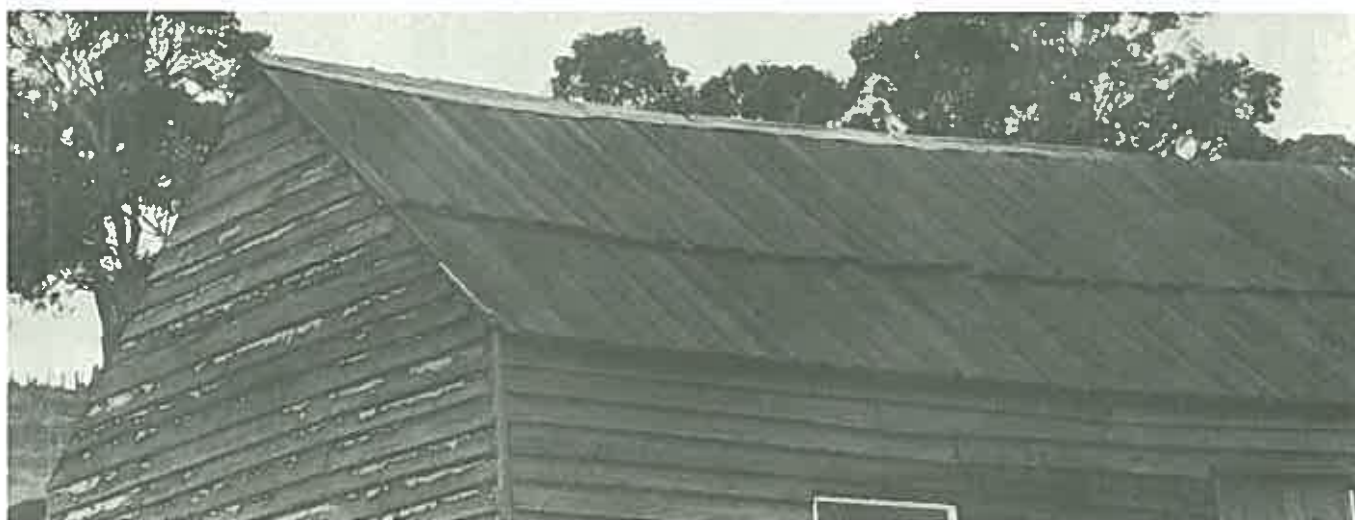
Timber roofing was also composed from sawn palings particularly for outbuildings.
(Shed, Marlborough Street, Portville, Tasmania)

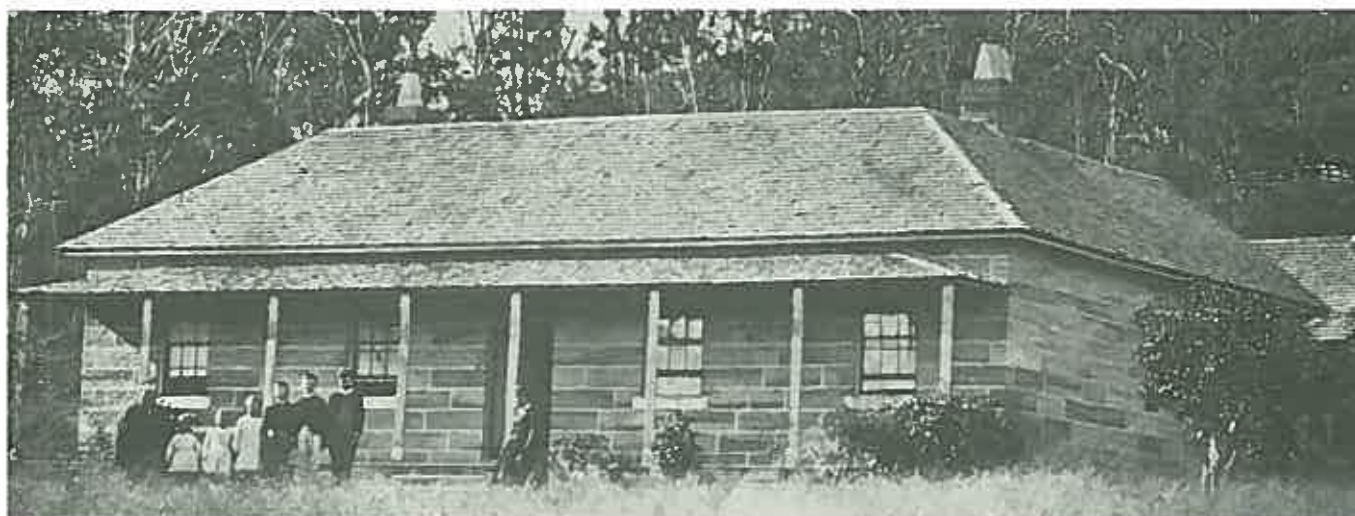
An 1850's shingle roof with woven hips.
(Buxton Cottage at Glenmore, near Camden N.S.W. Photo in possession of Miss Grace Moore)

Hips were sometimes of lead, dressed over a wooden roll, or sometimes the shingles were woven at these junctions. Timber saddle boards were used from the beginning and iron ridging was used during the second half of the 19th century but, whatever happens, preserve or restore the traditional detail found in your building. There may also be cases where shaped shingles were used to form a pattern in the roof covering. If this is the case, and it is very rare, great care should be taken to preserve the pattern.

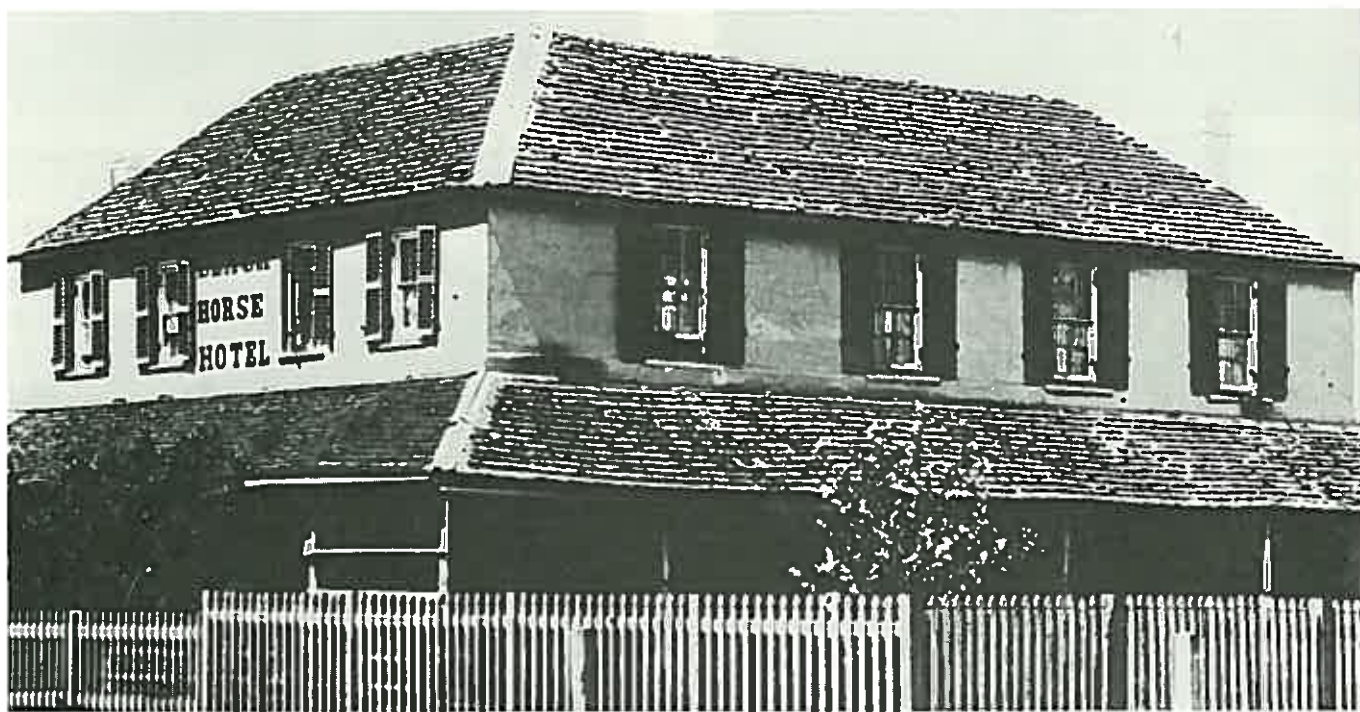
Nineteenth century photograph of Black Horse Inn, Richmond, N.S.W. with shingled roof and iron ridging.
(Photo in possession of Hawkesbury Agricultural College)

The enclosed photographs of the Black Horse Inn at Richmond, N.S.W. show how its character changed with the substitution of iron roofing. However, while

investigation of the building no doubt will reveal some evidence for the shingle roof, not all its details will be known and it would most probably be best to preserve and restore the iron roof.

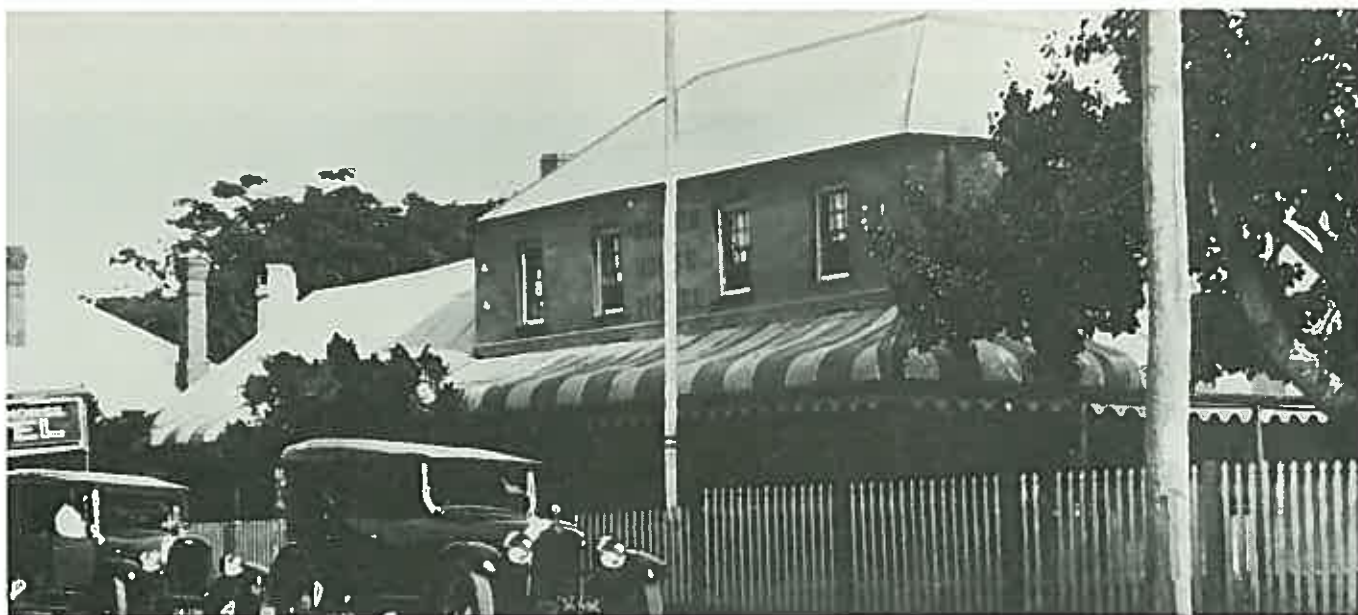
1920s photograph of the Black Horse Inn shows how it had changed with an iron roof and bullnosed roofing to the encircling verandah.
(Photo in possession of J. C. Woodhill)

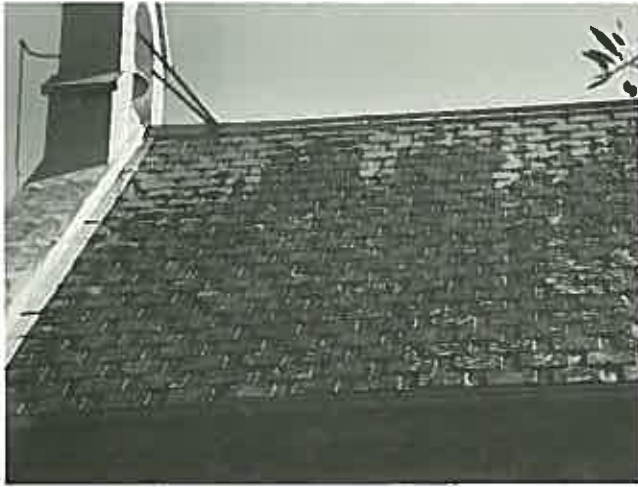
An unusual slating pattern on this 1860's church which should be maintained.
(Holy Trinity, Lyndoch, S.A.)

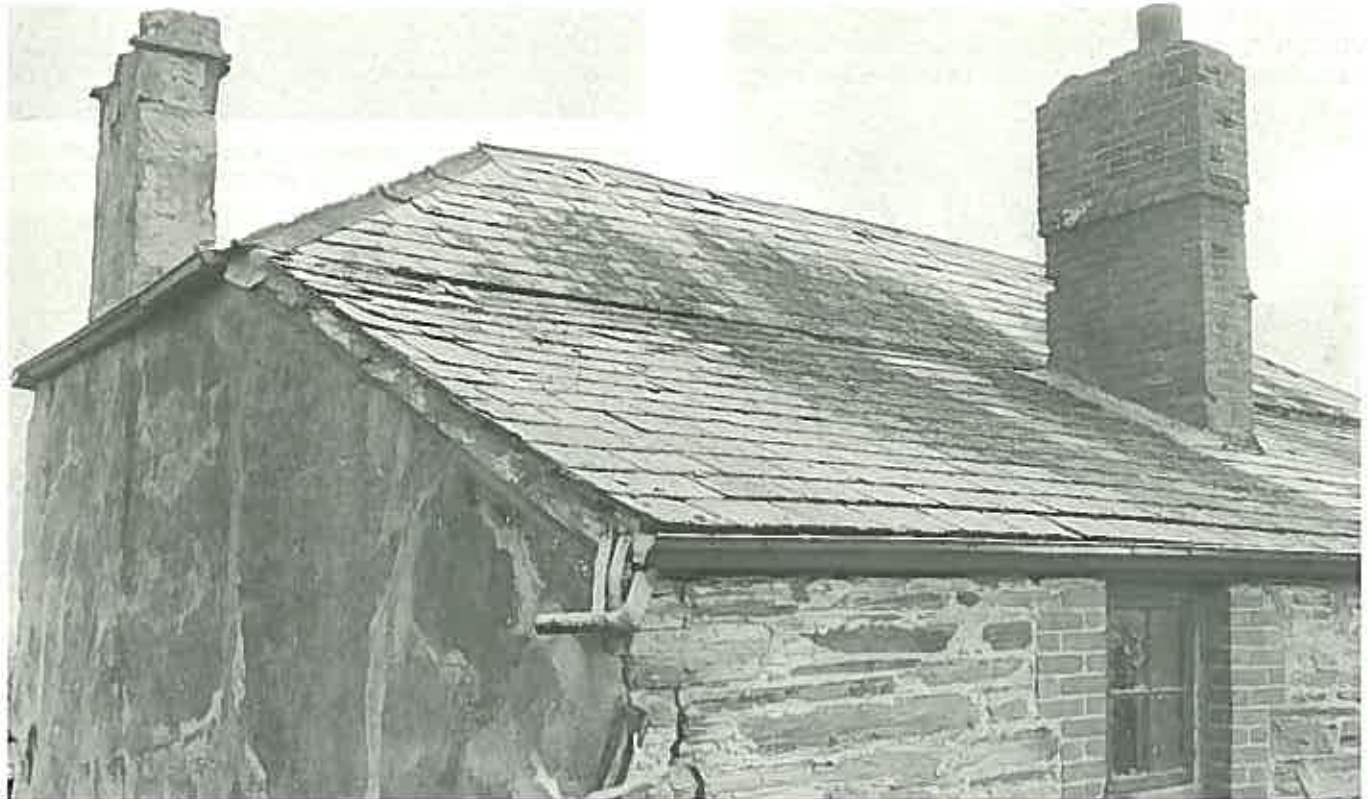
In this dilapidated example can be seen the end of the roof, the overlap of the slates and the ends of the battens. The slates were quarried within a mile of this house at Delabo Quarries, opened in 1840.
(House, George Street, Willunga, S.A. Photo: Stephen Gilbert)

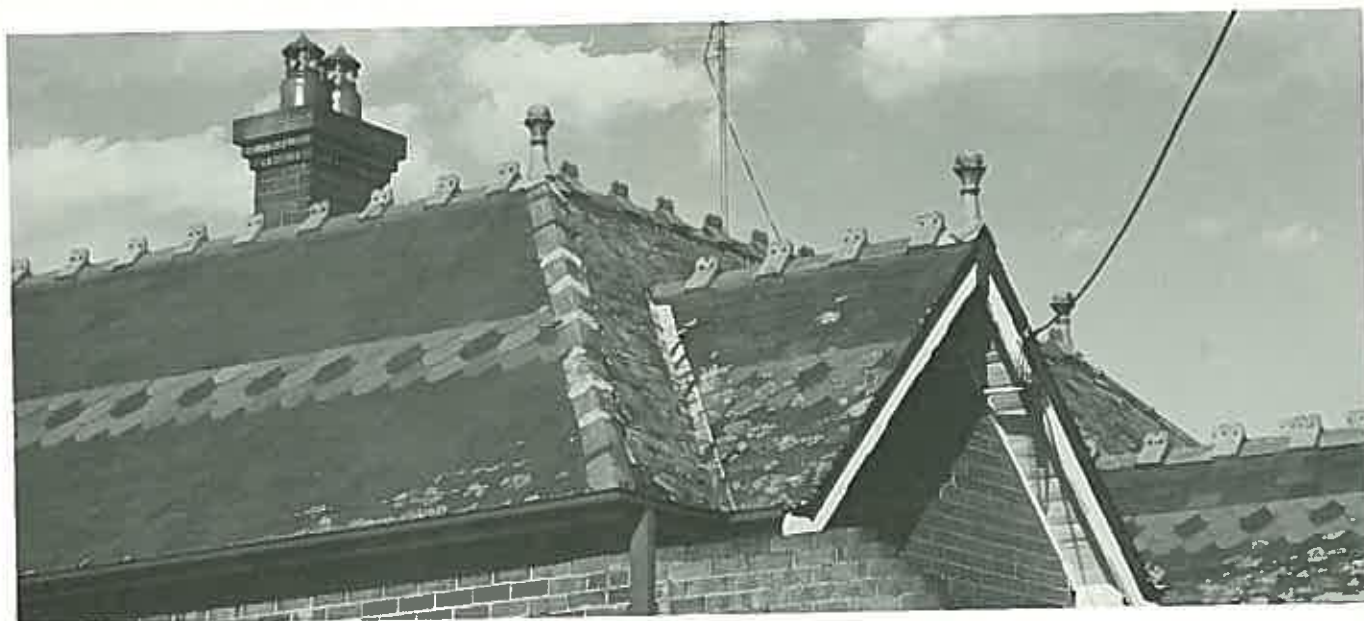
Roofs with patterned slates of different hues and shapes were popular at the end of the 19th century
(Cottage, Lithgow Street, Goulburn, N.S.W.)

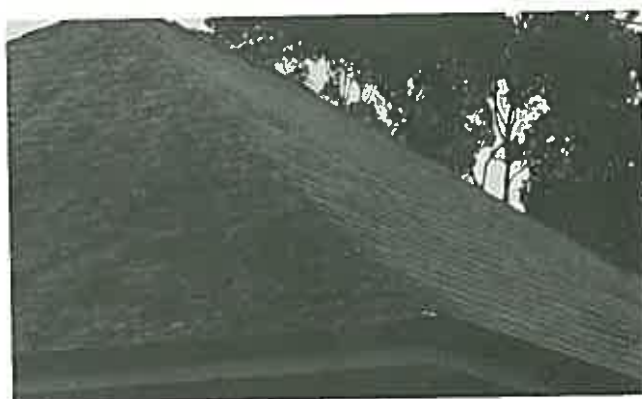
During the Edwardian period slate roofs with secretly flashed mitred hips were made. (Cottage, Fox Valley Road, Wahroonga, Sydney)

So far as ridging is concerned it is fair to say that lead with wings dressed over a timber roll was the main detail, but galvanised iron was also used, particularly in hot dry areas from an early date. There are also examples with cast iron cresting. Since about 1900 hips were sometimes secretly flashed with lead soakers, and the slates mitred at the hip. Also about this time terra cotta ridging was used with slate. The ridge was often elaborate and there were terra cotta finials like those associated with Marseilles tile roofs.

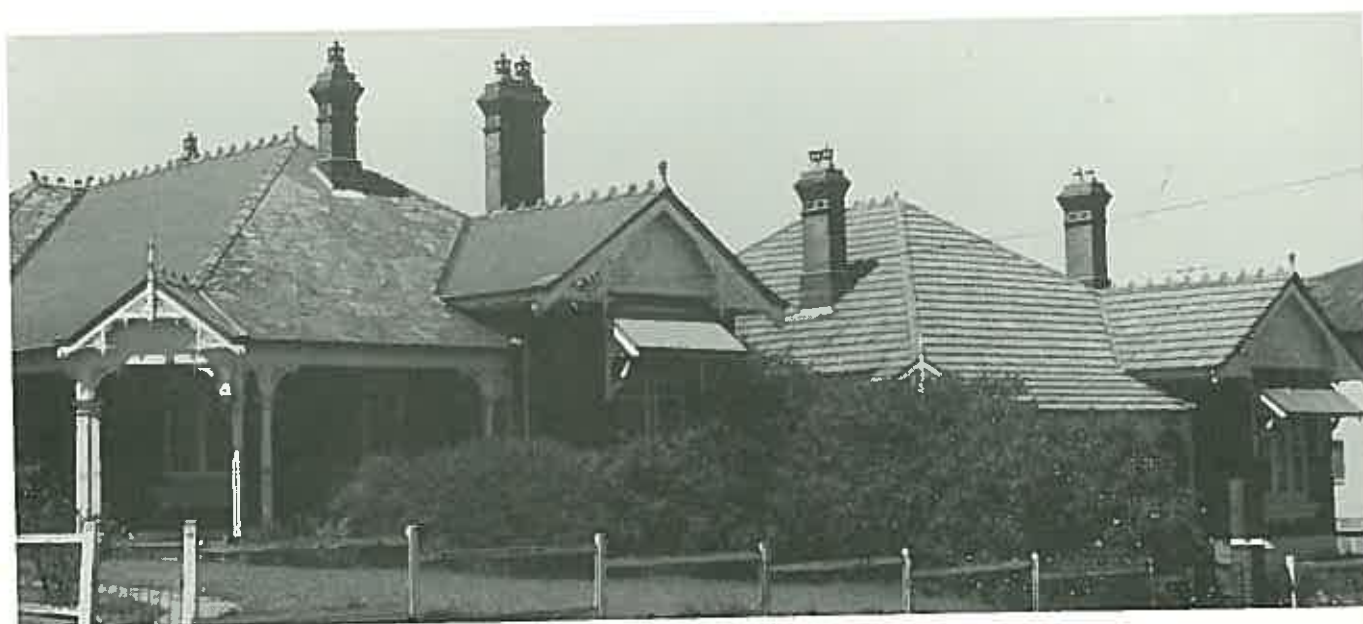
At the beginning of this century Marseilles patterned tiles were as popular as slate. In these contemporary houses one owner chose the slate with terra cotta ridging while the other, a roof completely of new clay tiles. (Houses, 471-743 Liverpool Road, Croydon, Sydney)

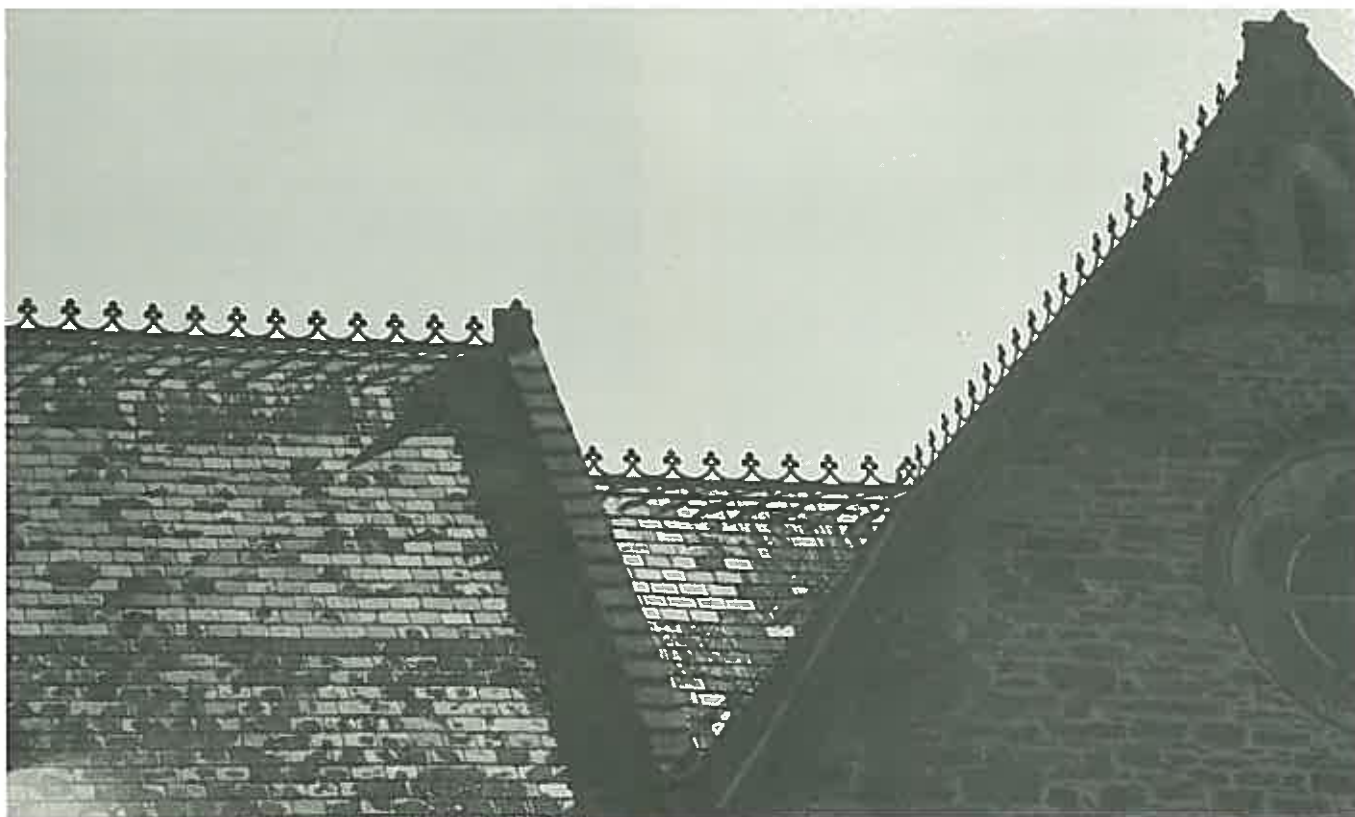
Slate roofs were sometimes enriched with cast iron cresting along the ridge.
(St. George's Church, Gawler, South Australia)

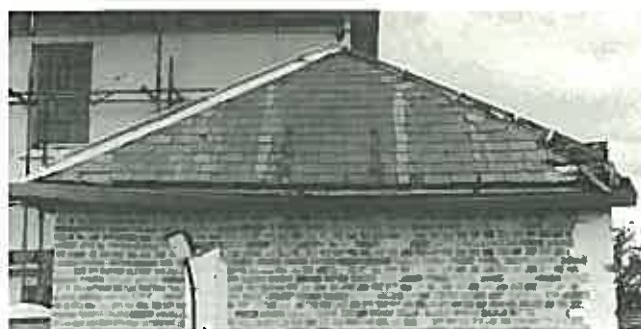
For most of the nineteenth century the traditional ridging was lead over a timber roll. In this derelict example enough detail survives for accurate restoration.
(Willandra House, Ryde, Sydney. Photo: Ian Stapleton)

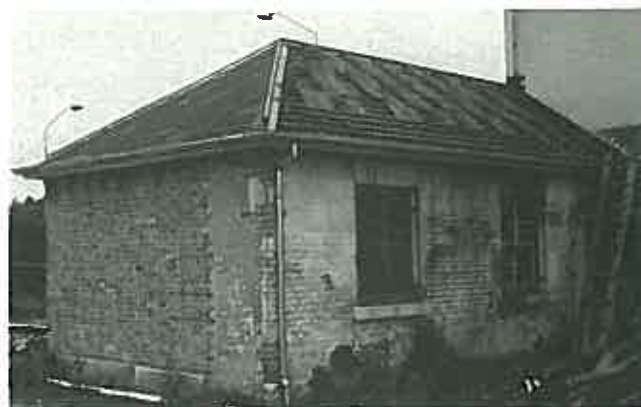
Slates and the traditional lead ridging being restored.
(Restoration Architects, Fisher Lucas)

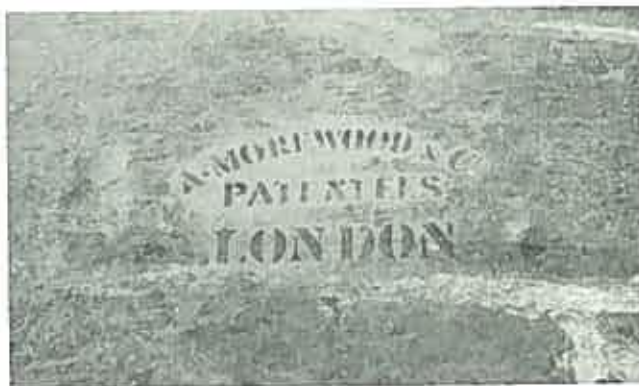
The trade label of A. Morewood & Co. patentees, London, found on the underside of the earliest iron tiles.
(Kleusendorffes Inn, Tahmoor, N.S.W.)

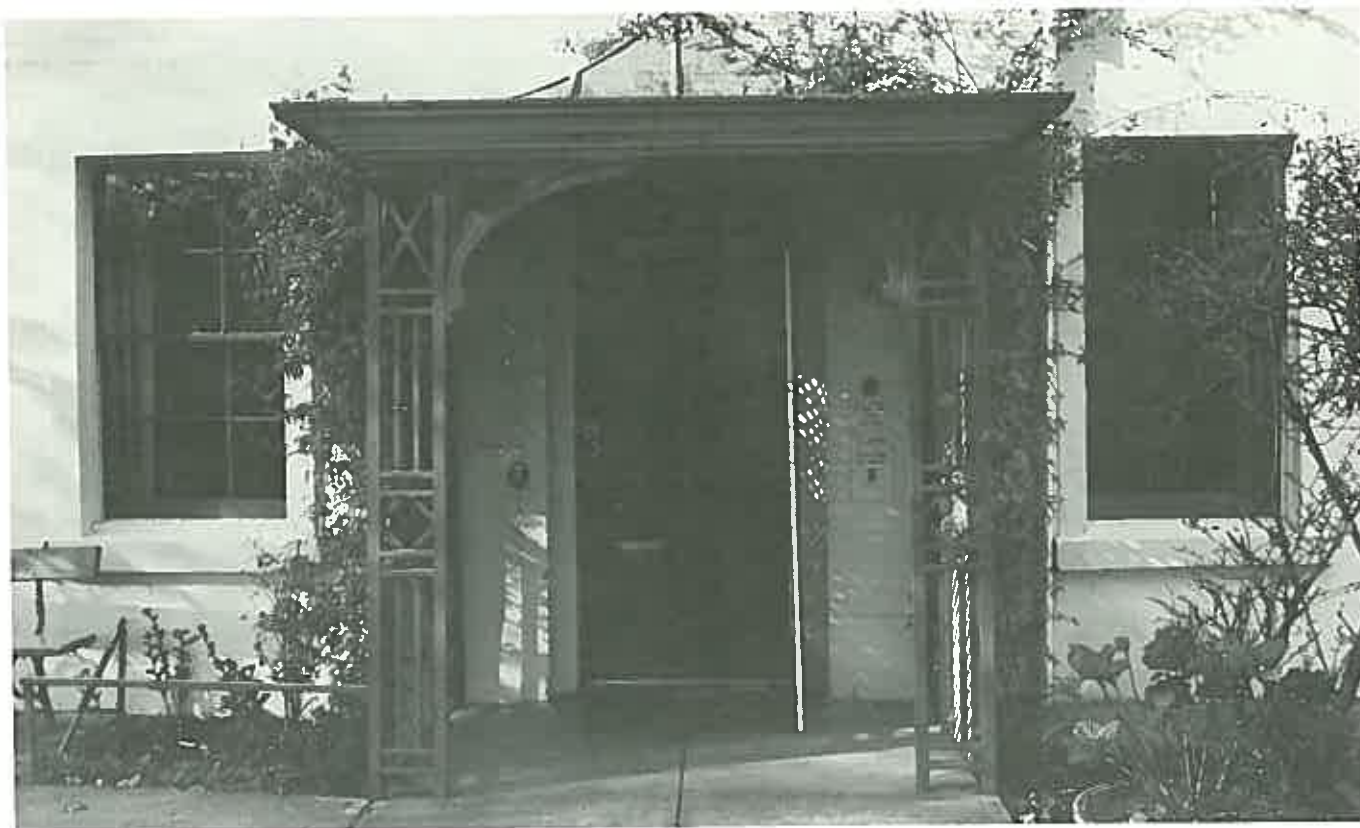
Early metal roofs were often zinc. In Sydney this material was being advertised for verandah roofs during the 1830's
(Hawthornden, 142 Davey Street, Hobart)

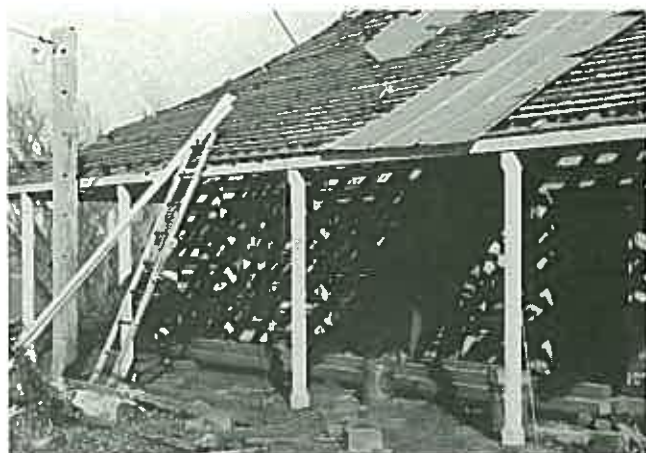
Iron tile roofing being restored. The battens of the original shingle roof survive and have been used to support the metal.
(Cooma Cottage, Yass, N.S.W. Restoration Architect: Clive Lucas)

Often these metal tile roofs were fitted over shingle roofs, or sometimes the shingles were stripped and the battens left to support the metal roof.

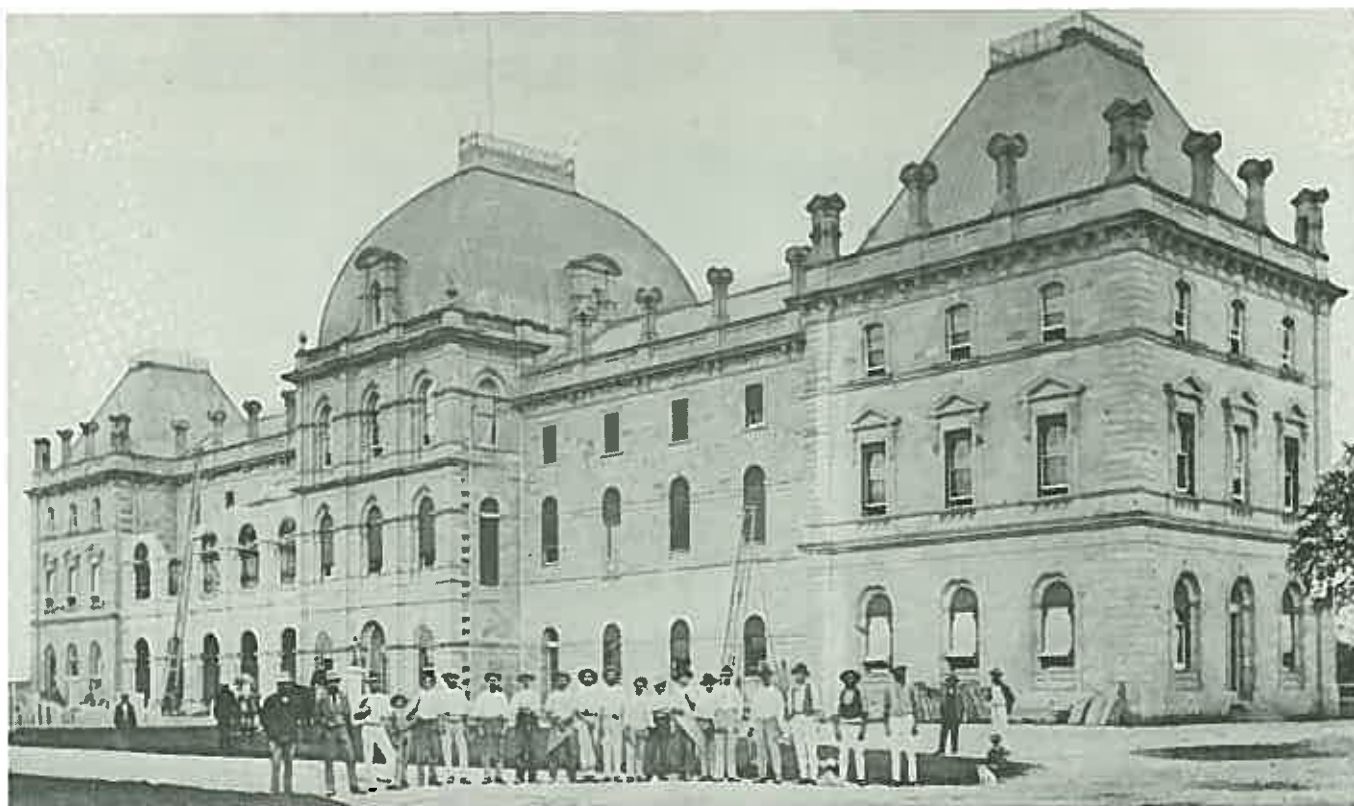
Rolled zinc roofs were popular particularly for public buildings in the warmer parts of the country.
(Photo c. 1880, Parliament House, Brisbane in possession of John Oxley Library)

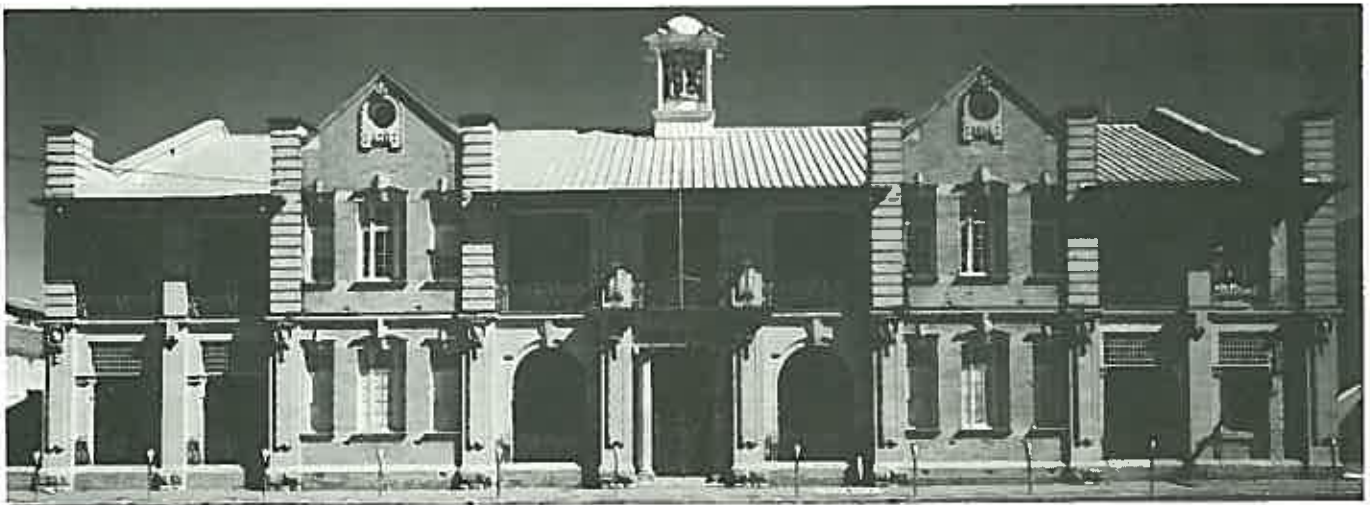
The traditional rolled zinc form continued to be popular in Queensland until well into this century; here it is carried out in galvanised iron. (Technical College, Rockhampton, 1914. Photo: Richard Stringer)

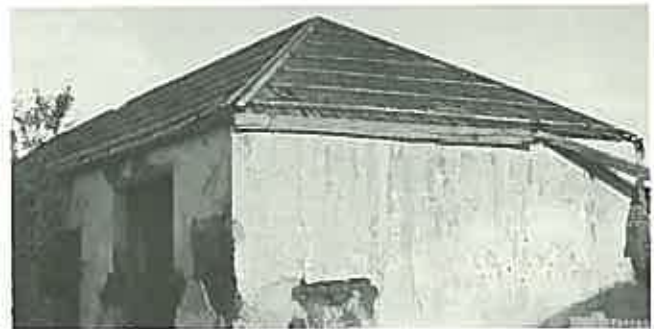
When shingled roofs failed they were often battened and sheeted with corrugated iron. (Cottage now demolished, Cleveland, Tasmania)

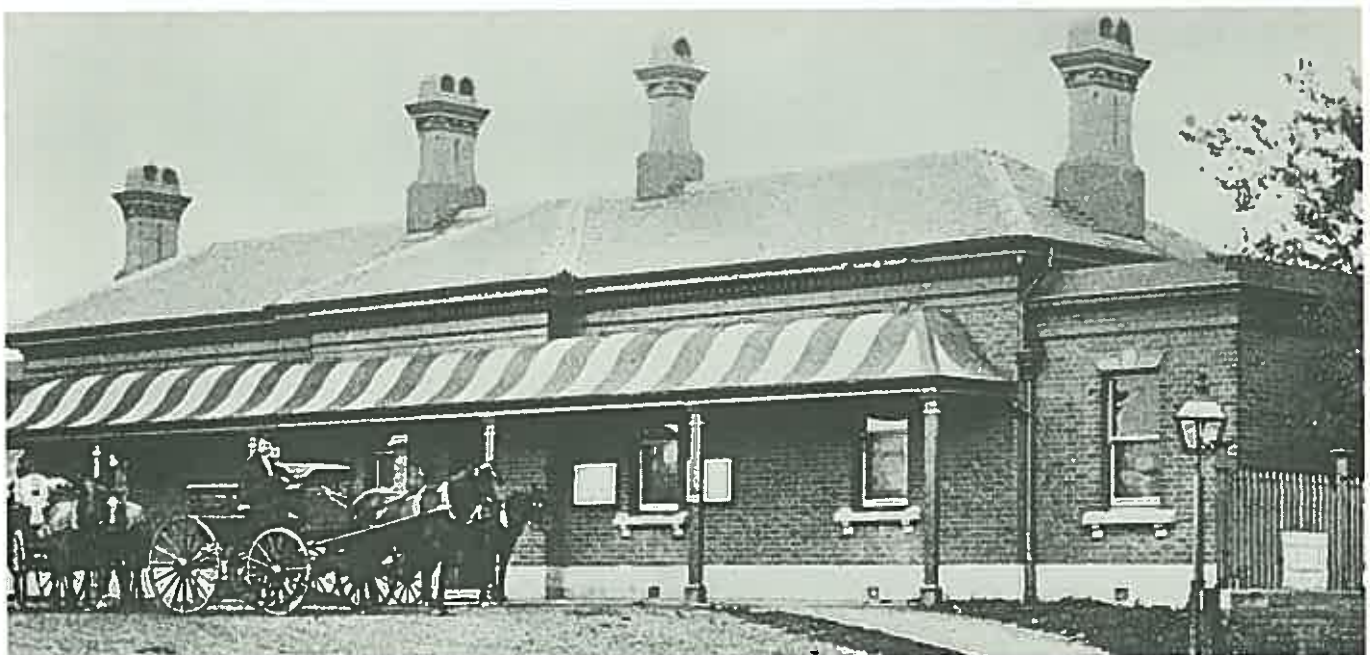
The curved verandah roof is here enlivened by the popular 19th century use of painting in stripes. (Railway Station, Richmond, N.S.W. Photo in possession of D.C. Woodhill)

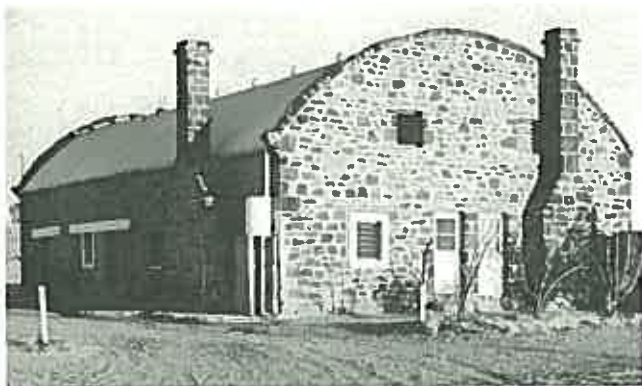
A semicircular roof has been made of rivetted curved sheets obviating the necessity for timber framing in a region where timber was scarce and transport difficult.
(Station Store, Murnpeowie, South Australia. Photo: Stephen Gilbert)

iron fixed over them. This has meant that many shingle roofs have survived underneath, where they serve as thermal insulation. Iron also had the advantage that it would be curved, and it was much used for verandahs and covered ways, which needed as a result only a light timber supporting structure. Like other metal roofs it was sometimes used for verandahs and skillions, while the main roof was covered with split shingles.

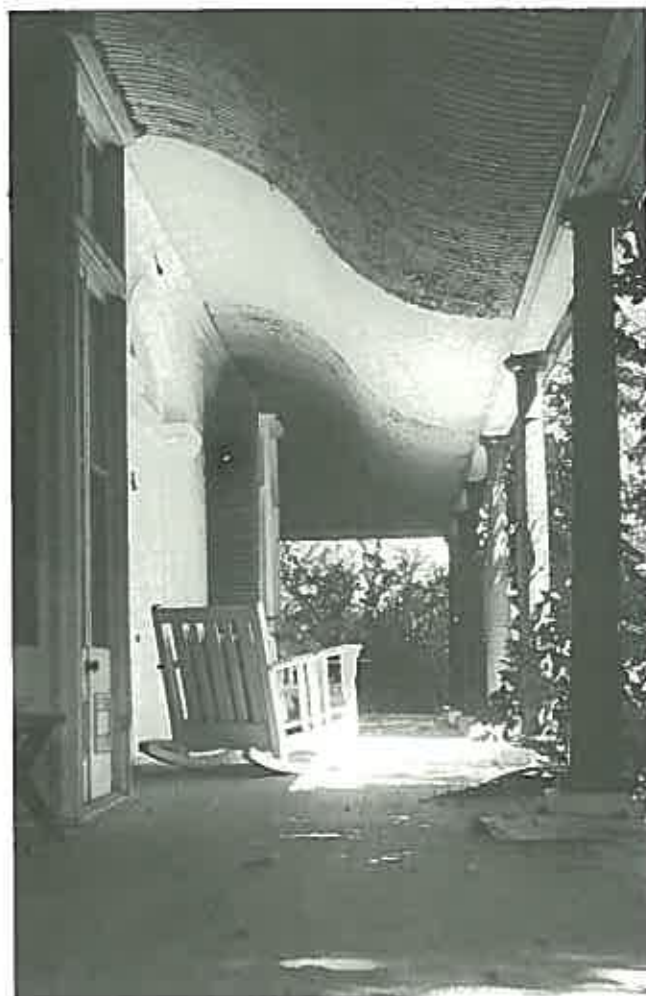
When iron was curved it needed little support as shown in this verandah.
(Hartwell House, Kiama, N.S.W.)

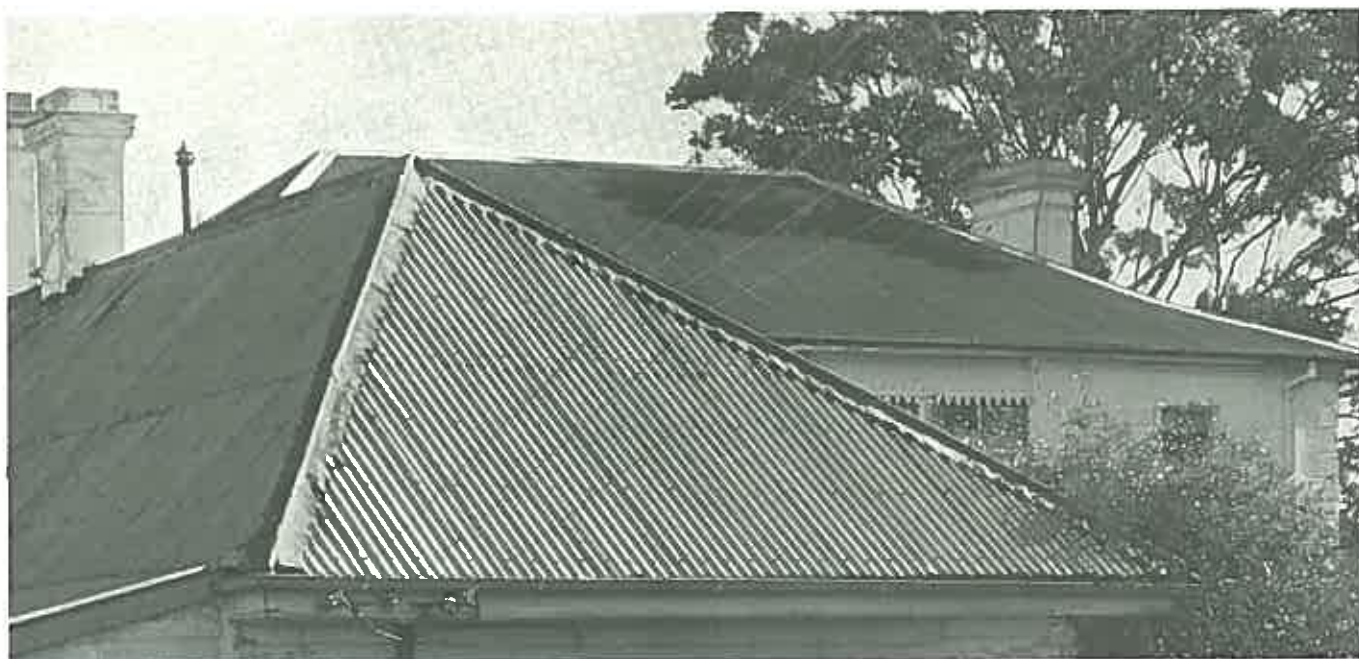
The traditional lead covered ridge roll used with corrugated iron.
(Glenlee, Menangle Park, N.S.W. Restoration Architects: Fisher Lucas)
