CONSERVATION AND RESTORATION OF BUILDINGS

conservation of roofs

Australian Council of National Trusts

By Clive Lucas O.B.E., B.Arch., F.R.A.I.A.

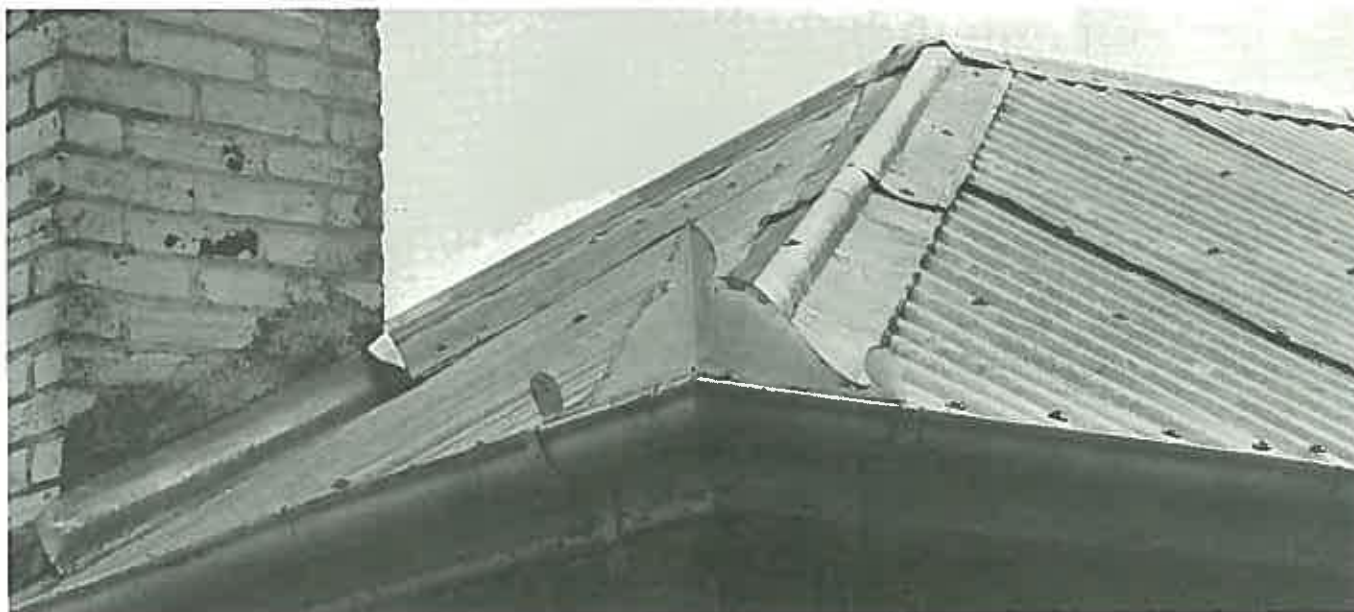
The usual iron ridging found, here with a shaped acroterion at the corners of the half round gutter. The roof is fixed by screws through lead washers.
(Cottage, Ayers Street, Burra, S.A.)

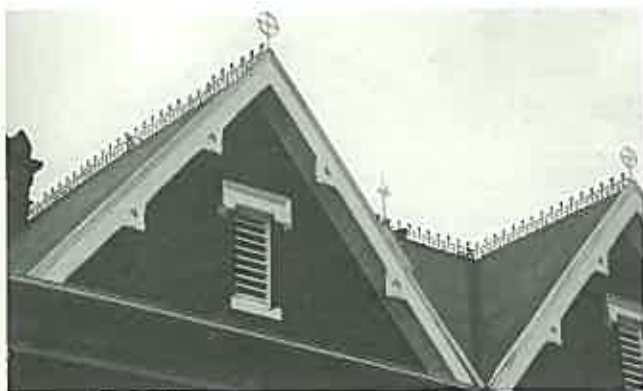
Cast iron cresting on this Edwardian iron roof.
(The Presbytery, Forbes, N.S.W.)

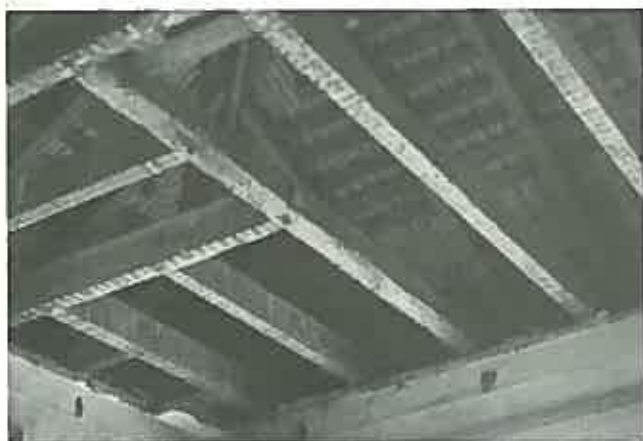
Sometimes shingles were stripped before the iron was fixed. Here shingle battens survive from the earlier roofing.
(Glenalvon, Campbelltown, N.S.W. Restoration Architects: Fisher Lucas)

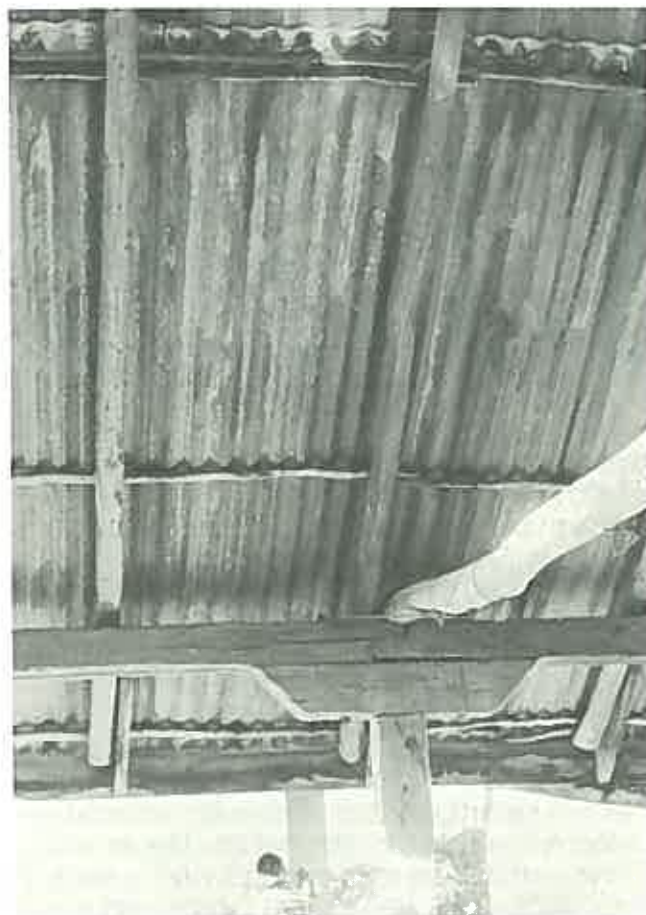
An early corrugated iron roof supported on bush pole rafters and battens. This detail would need to be carefully considered.
(Chateau Tahbilk, Tahbilk, Victoria)

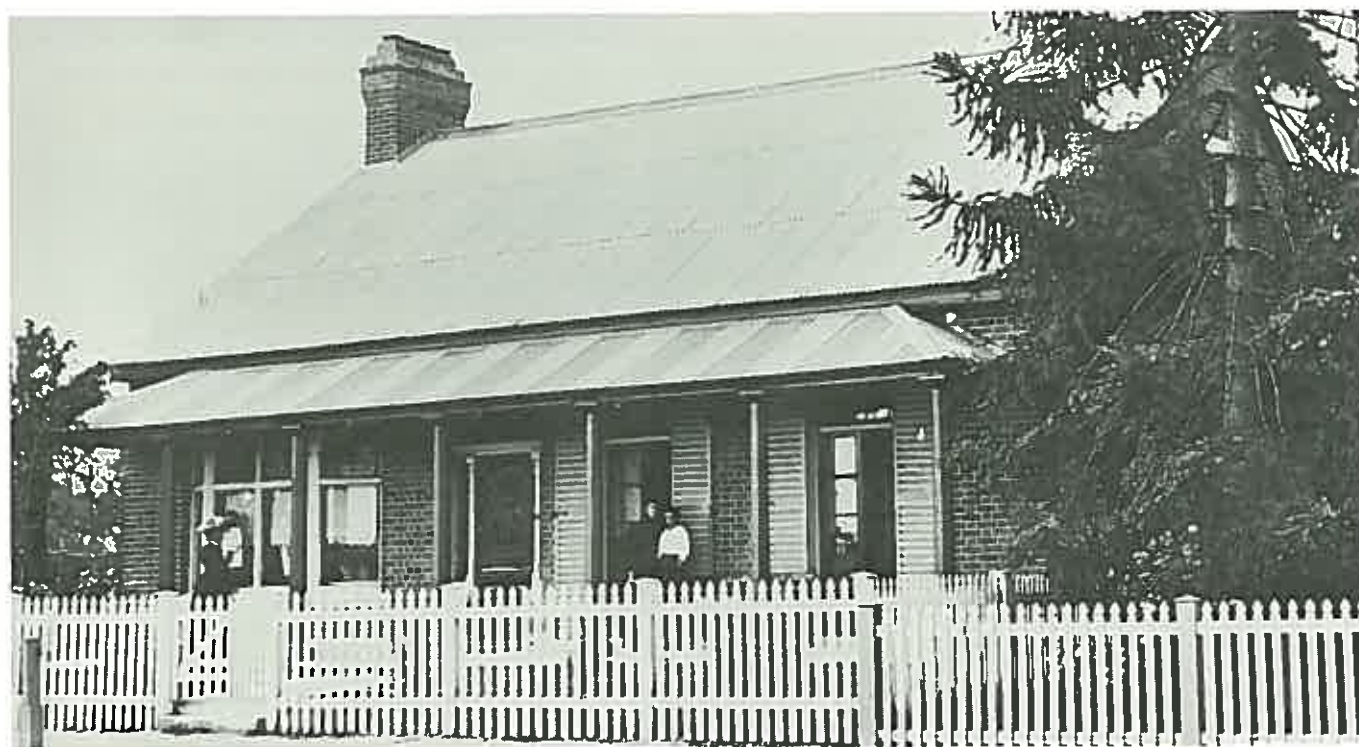
Shorter sheets used in the 19th century gave roofs a special scale and character which should be considered.
(Eltham, 317 Windsor Street, Richmond, N.S.W. Photo in possession of D.C. Woodhill)

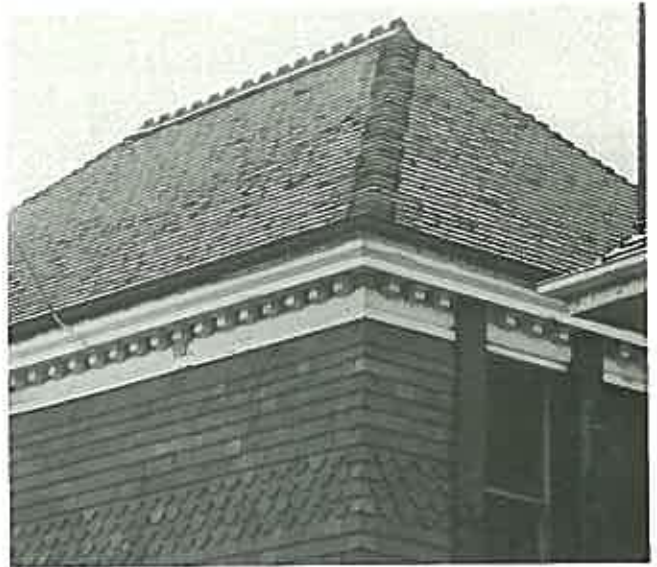
Flat terra cotta tiles were popular for roofs and also walls of Queen Anne style houses. Here there are matching hip and corner tiles, cresting and shaped tiles, all of which were made in England by Burton & Sons of Staffordshire in 1887.
(Caerleon, 15 Girahgulla Road, Bellevue Hill, Sydney)

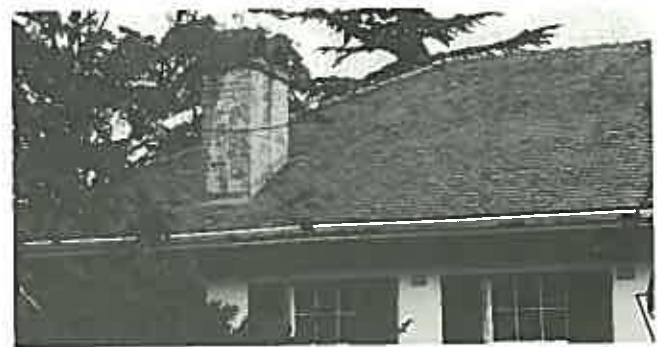
Flat tiles continued in use into this century here with half round terra cotta tile ridging.
(Purulia built in 1916 and 16 Fox Valley Road, Wahroonga, Sydney)

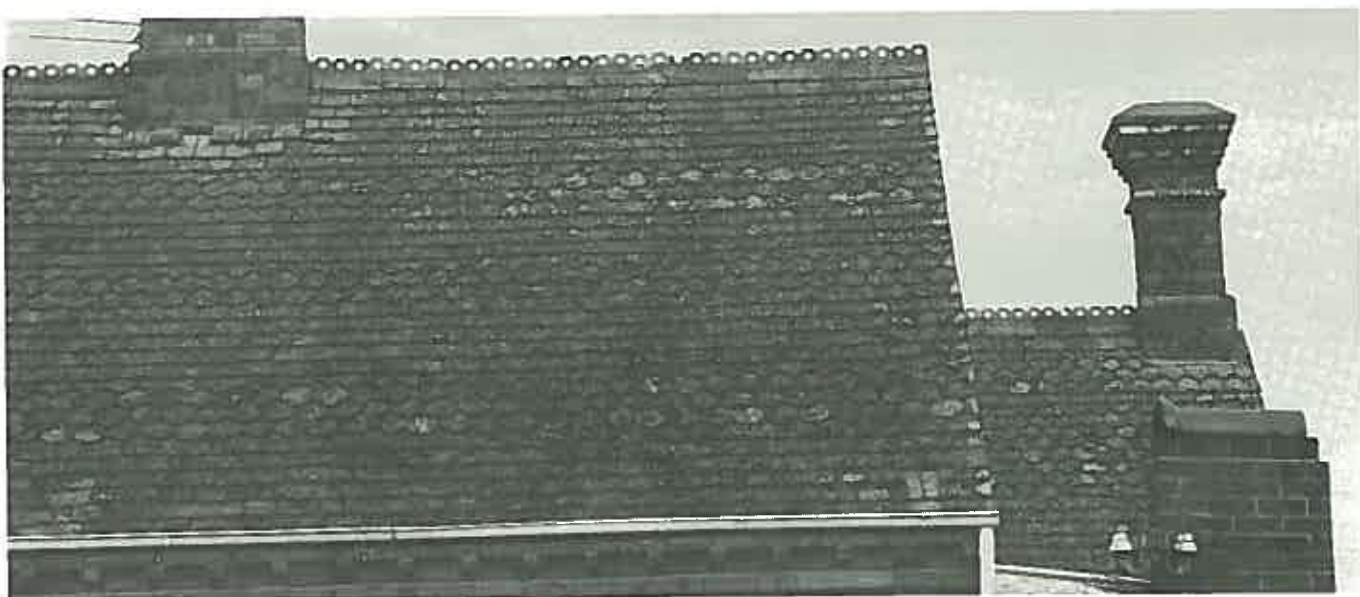
An elaborate use of flat terra cotta tiles in the 1890's
(House at Gulsor's Brickworks, Goulburn, N.S.W.)

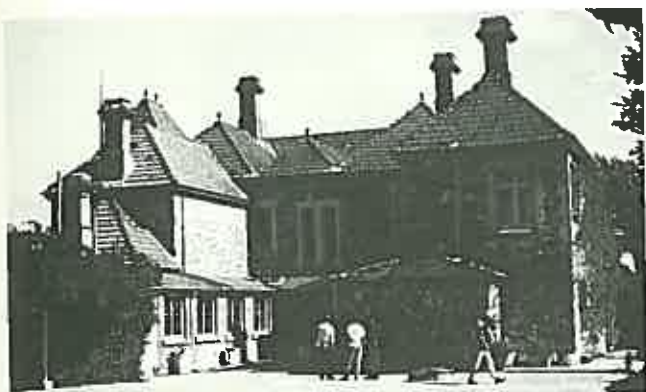
This house built in the 1870's originally had a roof of shingles but after a fire in the early 1890's it was resheeted with the newly available French Marseilles patterned tiles.
(Currendooley, Bungendore, N.S.W.)

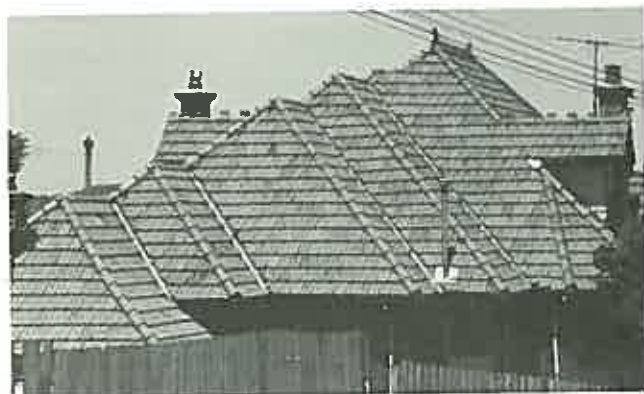
Marseilles tiles with ridging and finials are essential to the character of many Edwardian houses throughout Australia. Some of these tiles carry the mark of Guichard Carvin & Cie of Marseilles.
(Lucellen, 72 Kurraba Road, Neutral Bay, Sydney)

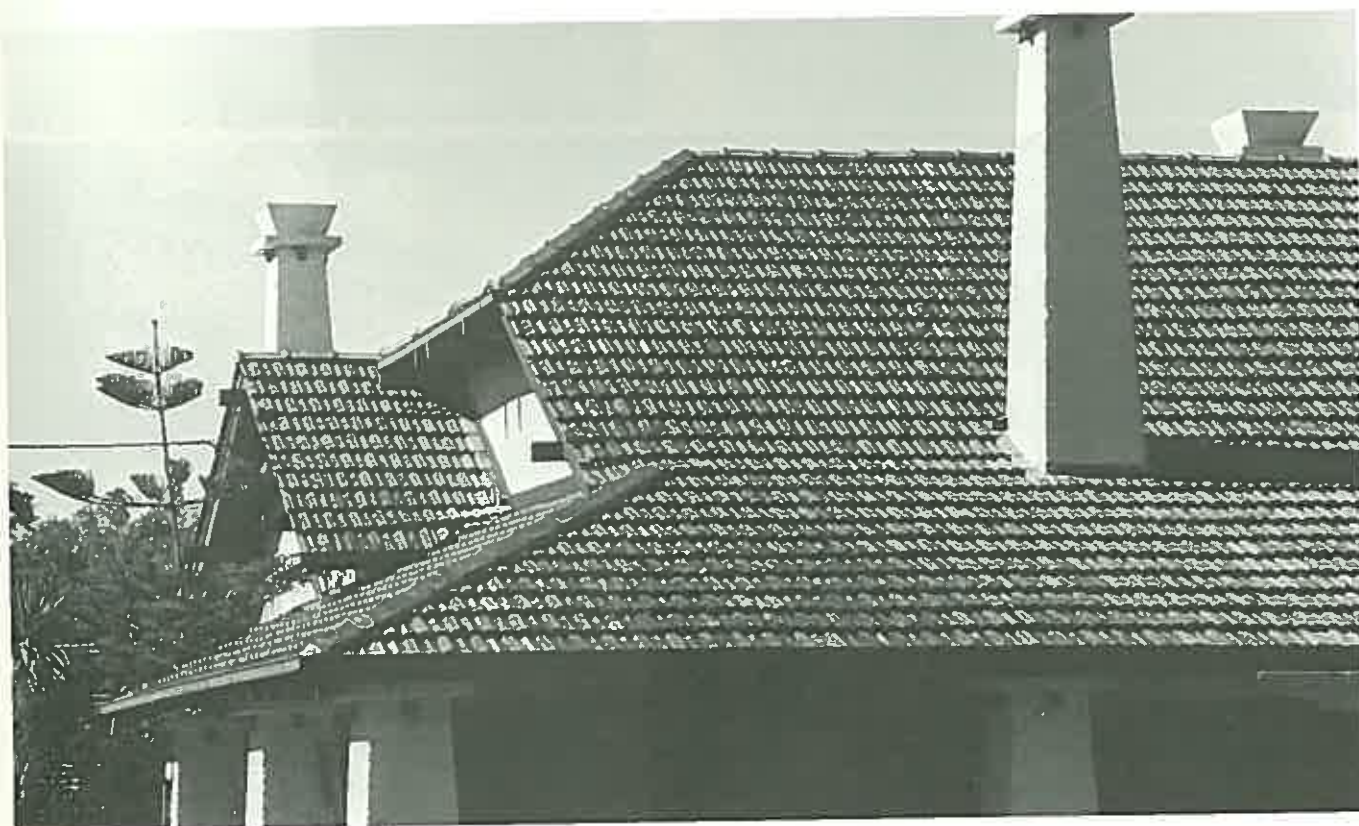
Marseilles tiles are important to the character of the spreading roofs of what is generally termed the Californian bungalow style.
(House, 17 Murray Street, Tanunda, S.A.)

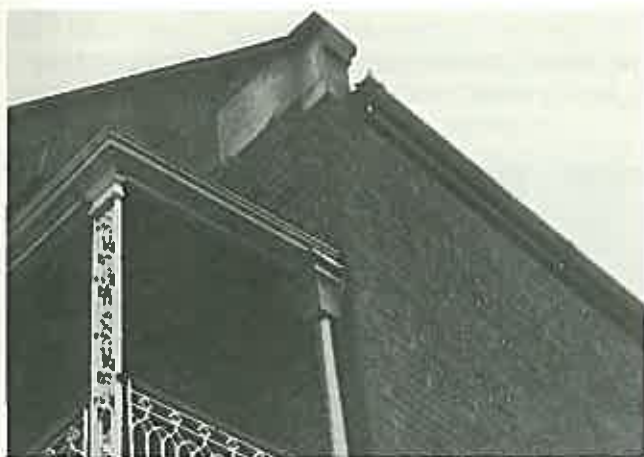
Half round cast iron gutters on the main roof, ogee galvanised gutter on the balcony.

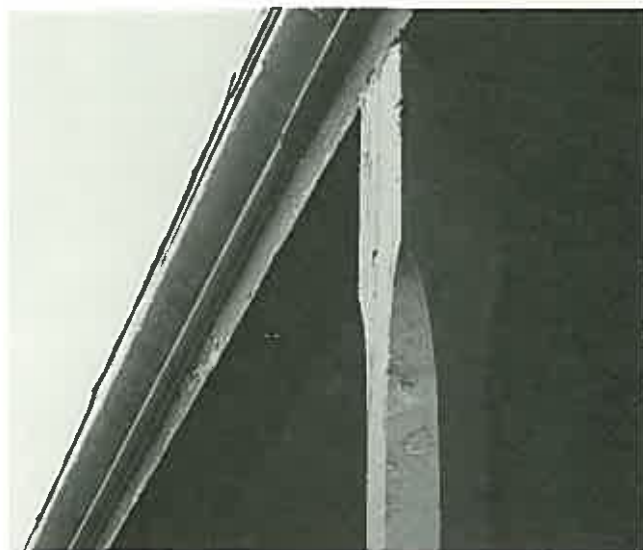
1842 gutter made by hollowing out the trunk of a tree. Mouldings have been added to give a classical profile.

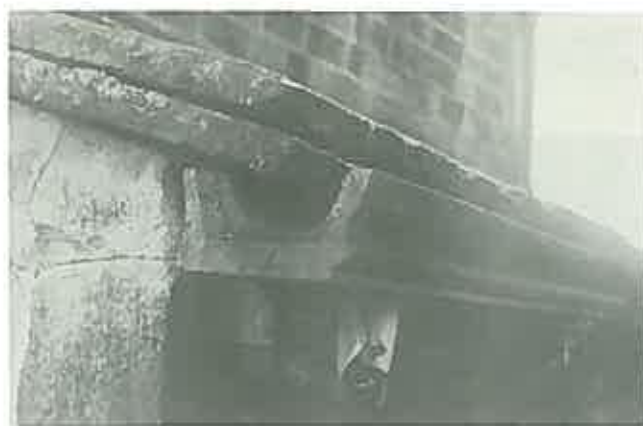
Gutters run in solid timber were used in England.

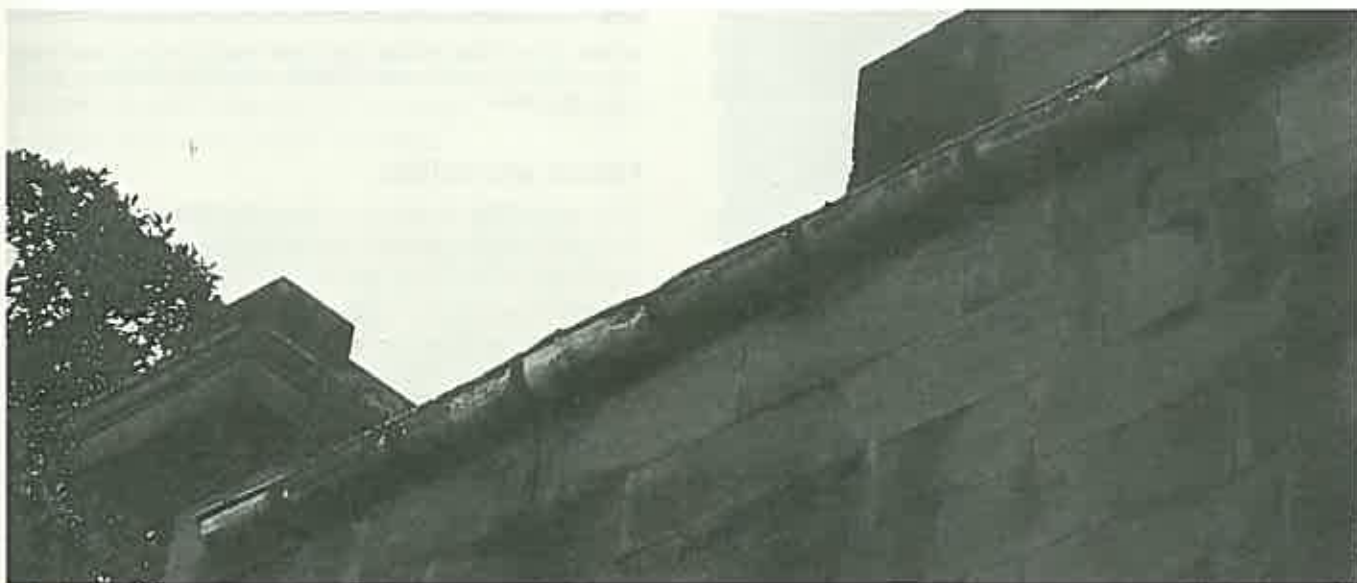
An unusual survival, a half round lead gutter on iron brackets.

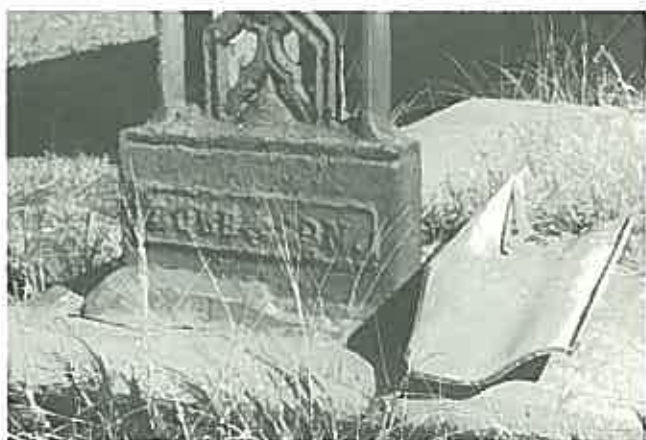
Cast iron patterned gutter probably of English manufacture and dating from first half of nineteenth century.
(Elizabeth Farm, Parramatta, N S W)

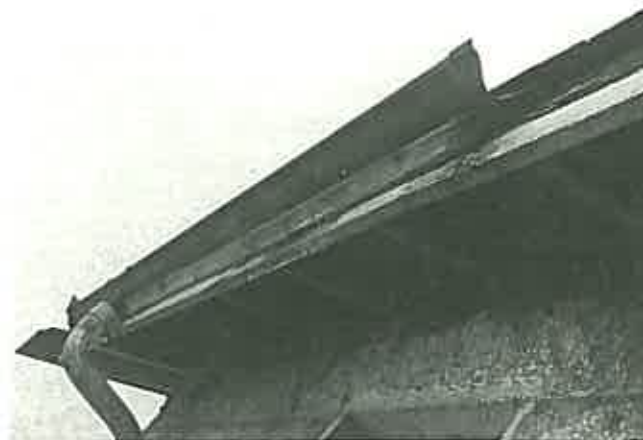
Cast iron ogee gutter with downpipe dating from last quarter of 19th century.
(Cell block, Beechworth, Victoria)

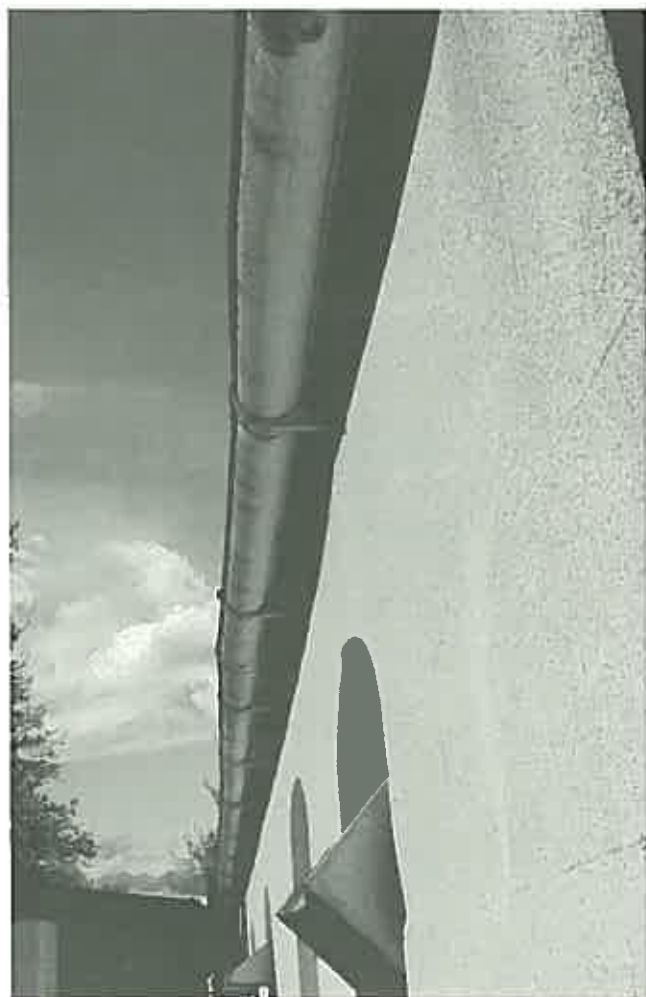
Half round galvanised gutter fixed without fascia by driving brackets directly into masonry
(Vine Lodge, Exeter, N S W)

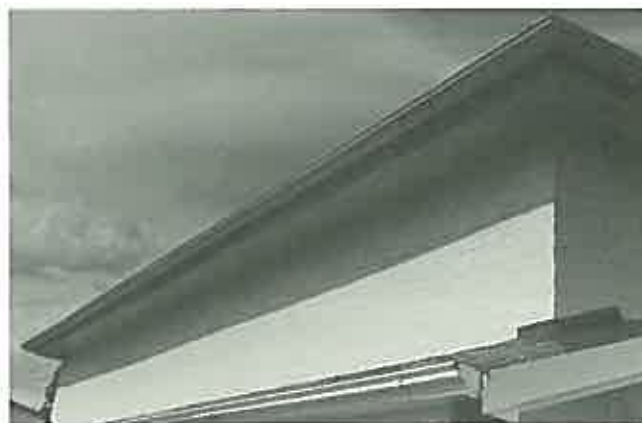
Before gutters were fitted roofs often had a generous overhang. Here ogee guttering has been fitted on extended brackets to solve this detail.
(Strathmore, Nile, Tasmania)

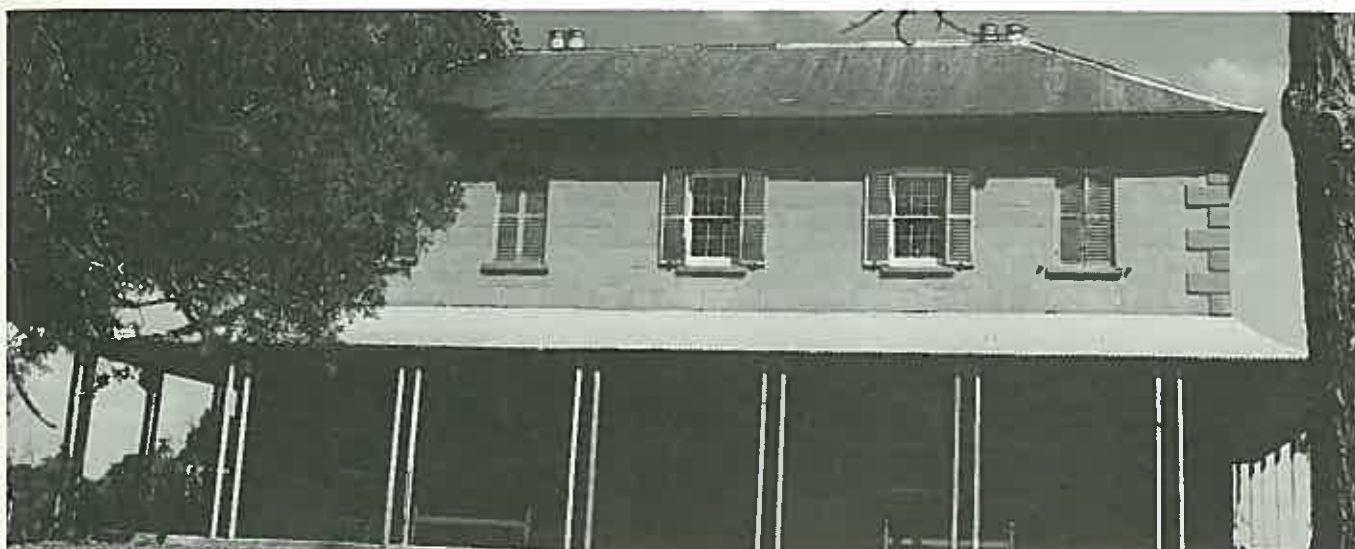
Many early Australian houses had no eaves gutters. In this example, although slates replace the original shingles, the eaves detail survives.
(Rouse Hill House, near Windsor, N.S.W.)

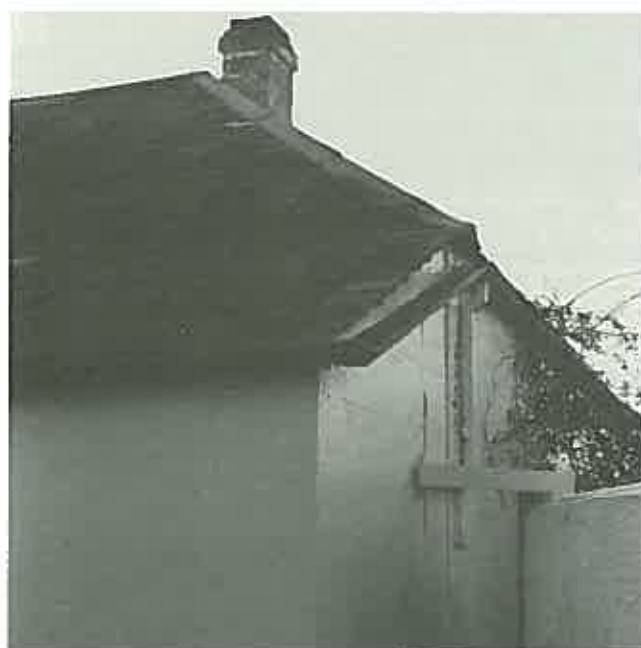
A half round gutter fixed without fascia and adjusted to suit the falls of the roofs is a surviving 19th century detail.
(Horsley, Dapto, N.S.W.)

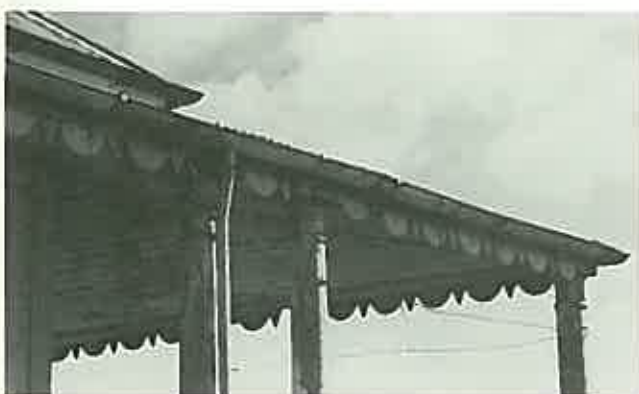
Half round galvanised guttering bracketed off a valanced veranda plate.
(Throsby Park, Moss Vale, N.S.W.)

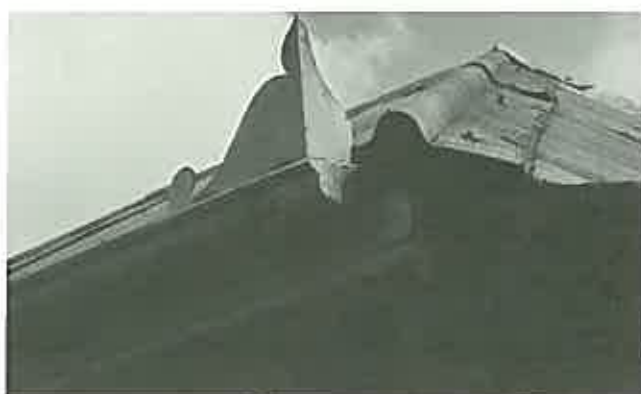
Acroterion fixed at the end of a half round gutter. Intact detail like this is very important.
(Cottage, Ayers Street, Burra, S.A.)

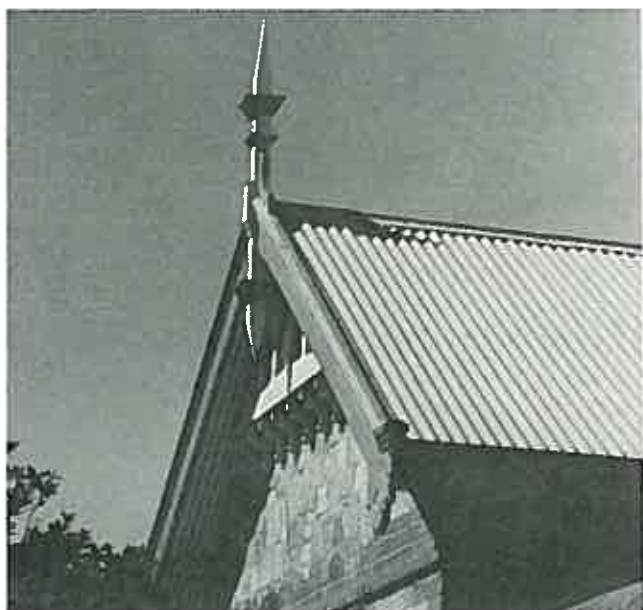
A square finial built up with applied mouldings. Such mouldings have often fallen away. Surviving fragments should be carefully noted and restored.
(House, 10 Adelaide Road, Gawler, S.A.)

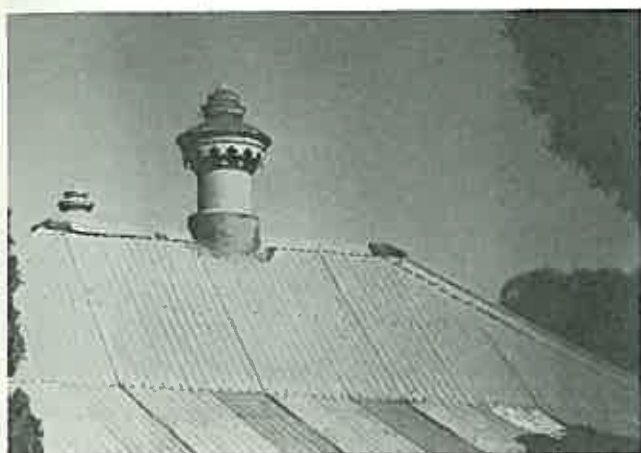
Made by plumbers ventilators are special features with individual details.
(Cottage, Charters Towers, Queensland)

A feature of roofs in the hotter parts of the country are the ridge roof ventilators which are a high point in the art of the plumber. Where these exist they should be carefully repaired or if necessary exactly reproduced.

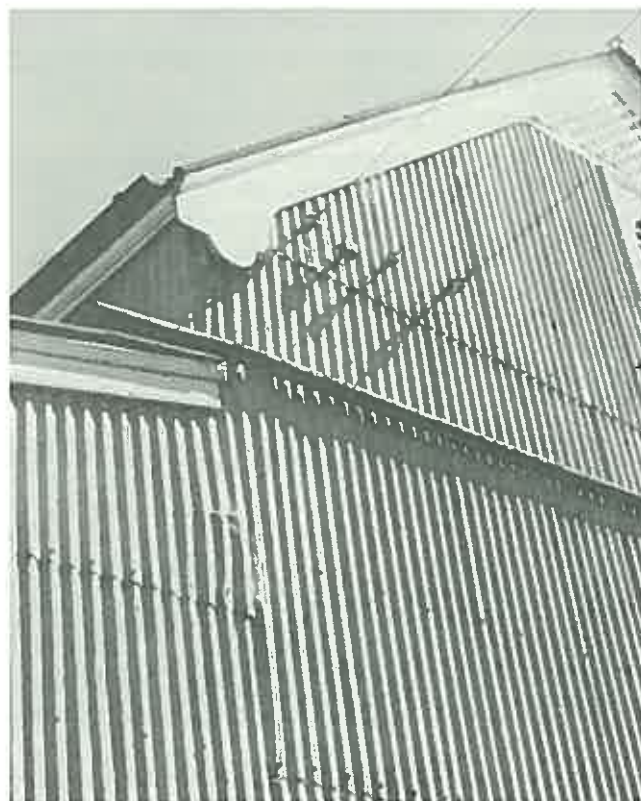
Even on farm buildings, Edwardian detail was elaborate. Here an iron barge roll and timber ovolo cap the top of the stop chamfered barge board. (Woolshed, Beggan Beggan, Harden, N.S.W.)

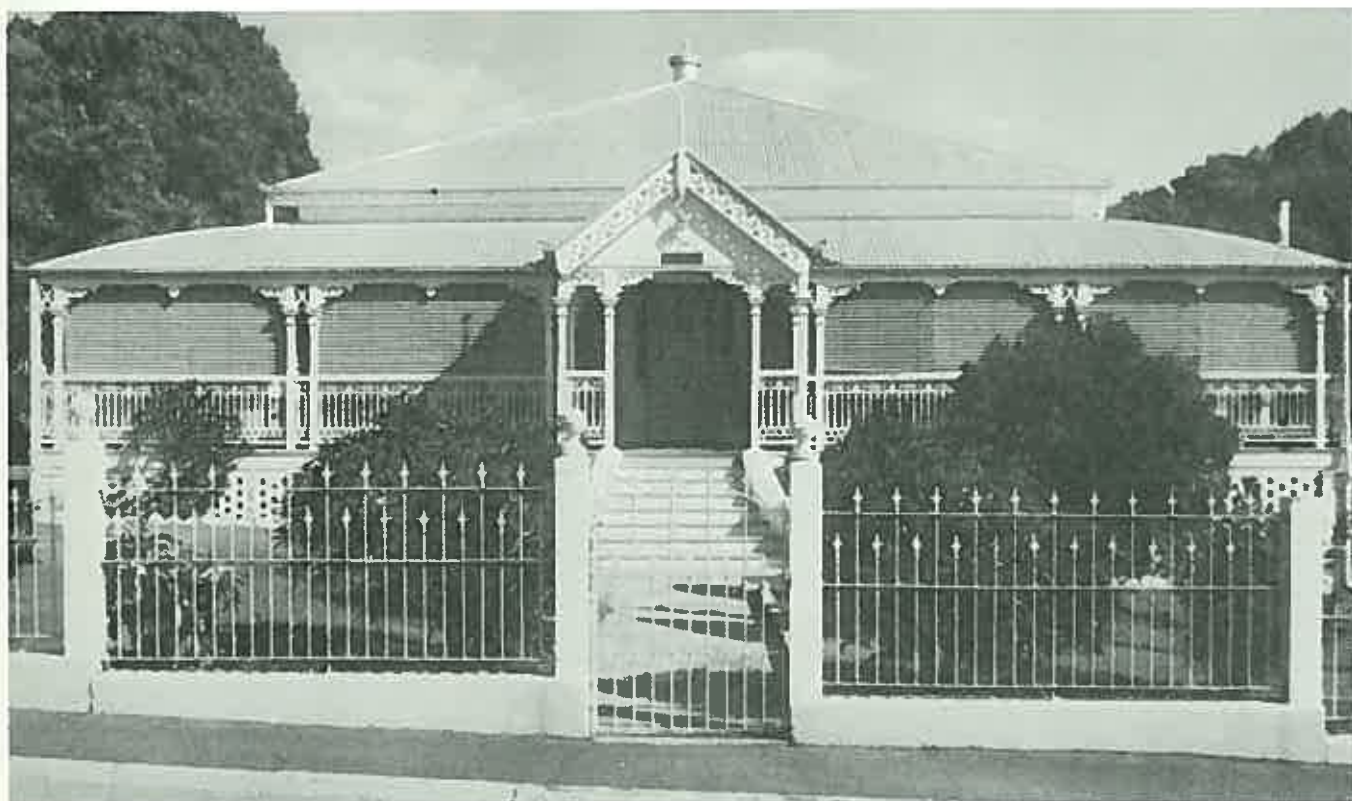
The roofs of northern houses are invariably capped with ventilators.
(House, Townsville, Queensland)

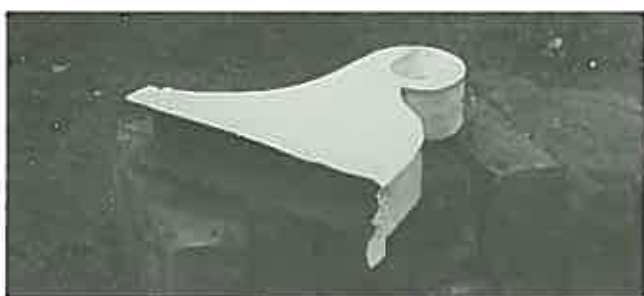
With the introduction of terra cotta tiles iron roofs were often painted tile red and plumbers made up finials to simulate terra cotta details.
(Excelsior, Bathurst, N.S.W.)

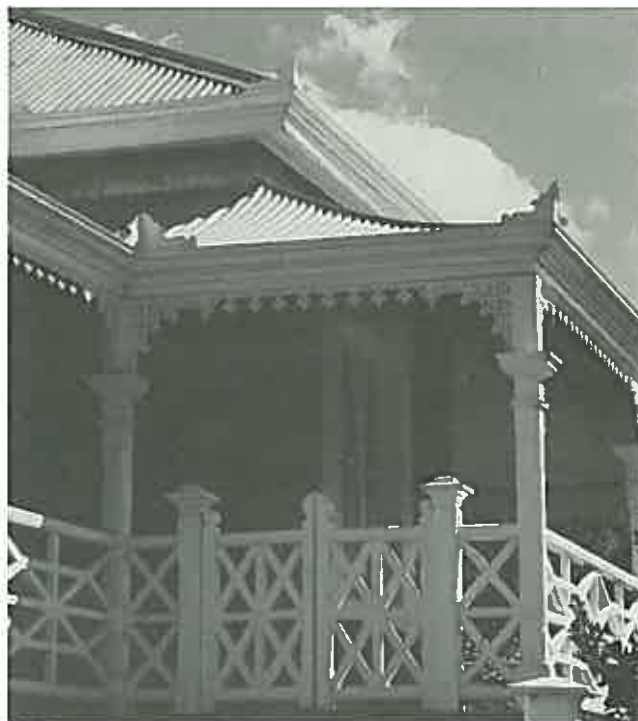
The decorative art of the roof plumber and joiner are important elements in preserving proper character.
(House, Morhead Street, Burra, S.A.)

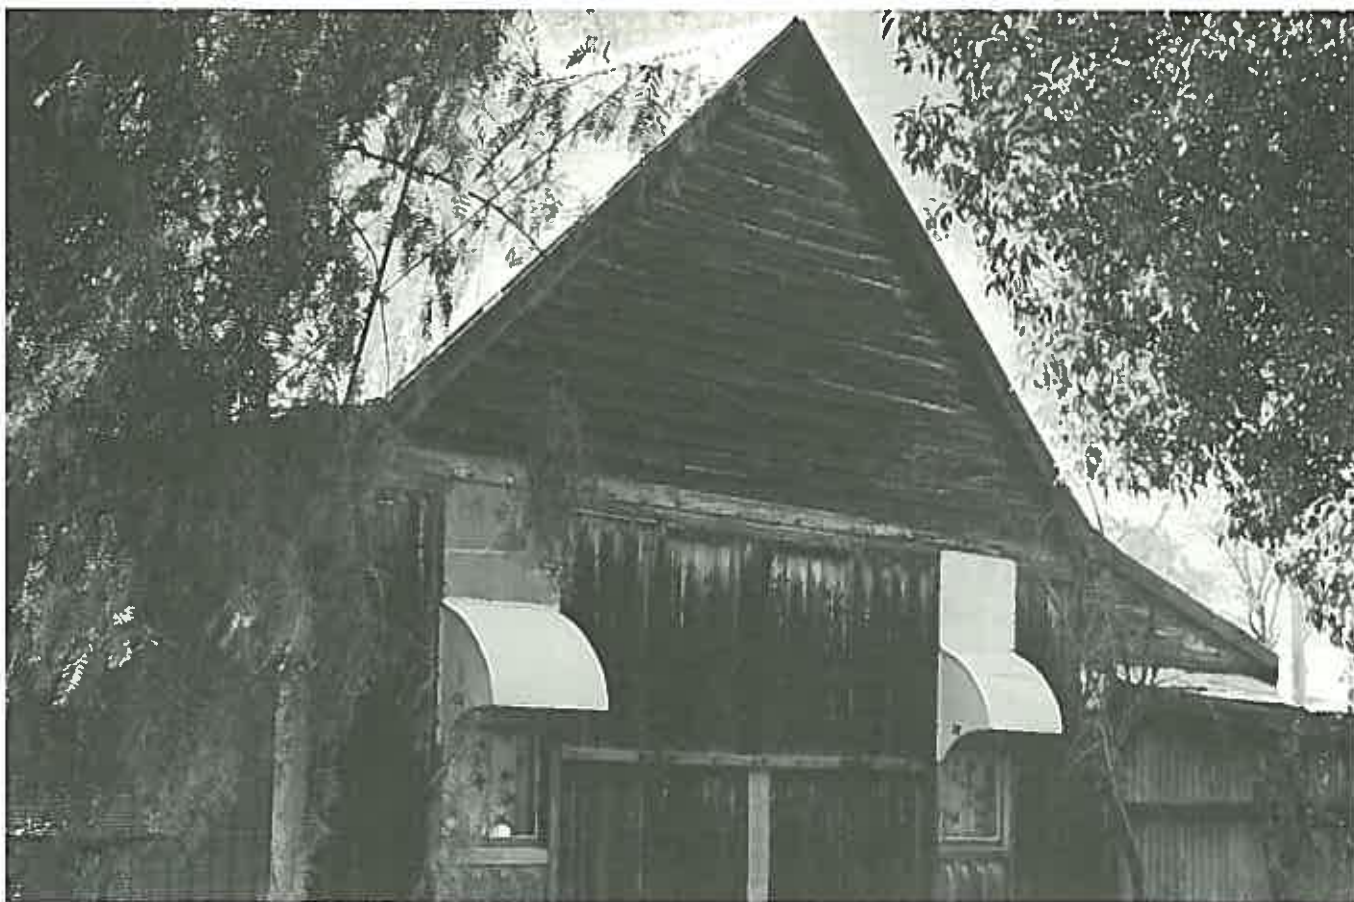
Plumbers also made up sun hoods.
(House, Tambo, Queensland. Photo: National Trust of Queensland)

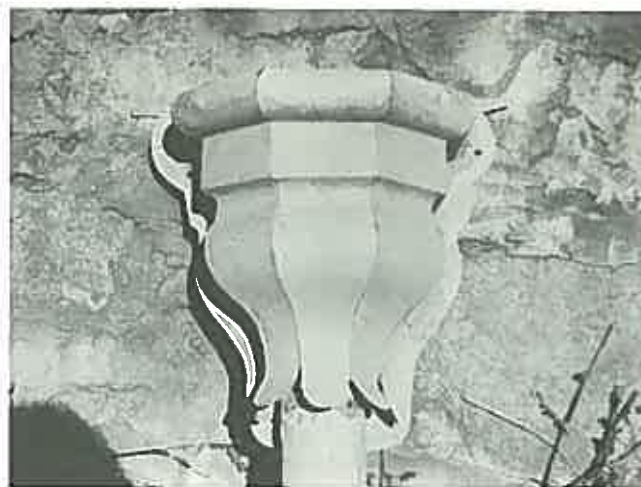
There are many forms of rainwater heads made from galvanised iron.

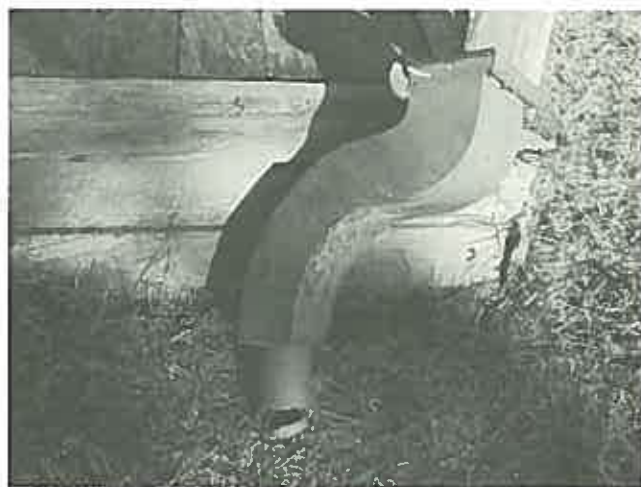
Like ventilators rainwater heads are often individual and elaborate.
(Methodist Church, Goulburn, N.S.W.)

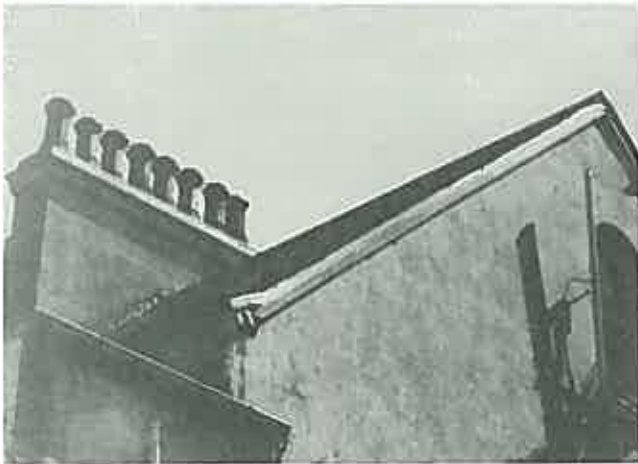
Chimneys and terra cotta pots are important features of many 19th century roofs.
(43 Arundel Street, Glebe, Sydney)

Not only are chimneys a feature of roofs but so also are their terra cotta pots which are often broken or missing.

The pots are normally of terra cotta, but sometimes they are made up of four slates gabled at the top and wired together. These present no problem for restoration but if elaborate terra cotta pots need replacing

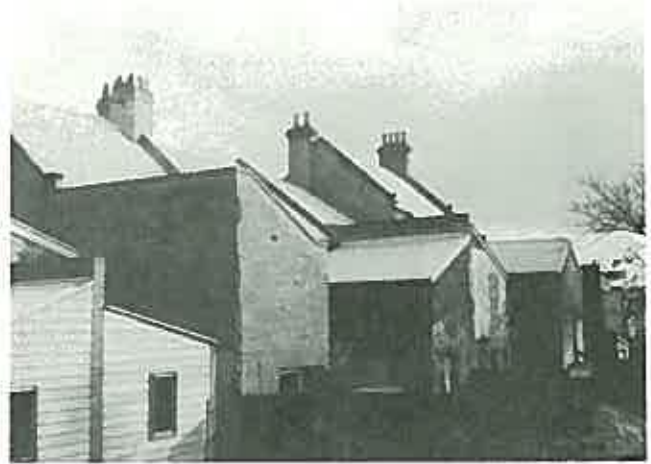
Slate chimney pots in the foreground terra cotta pots in the distance. All important to overall character.
(Houses, 110-130 Forbes Street, Woolloomooloo, Sydney
Restoration Architects: Fisher Lucas)

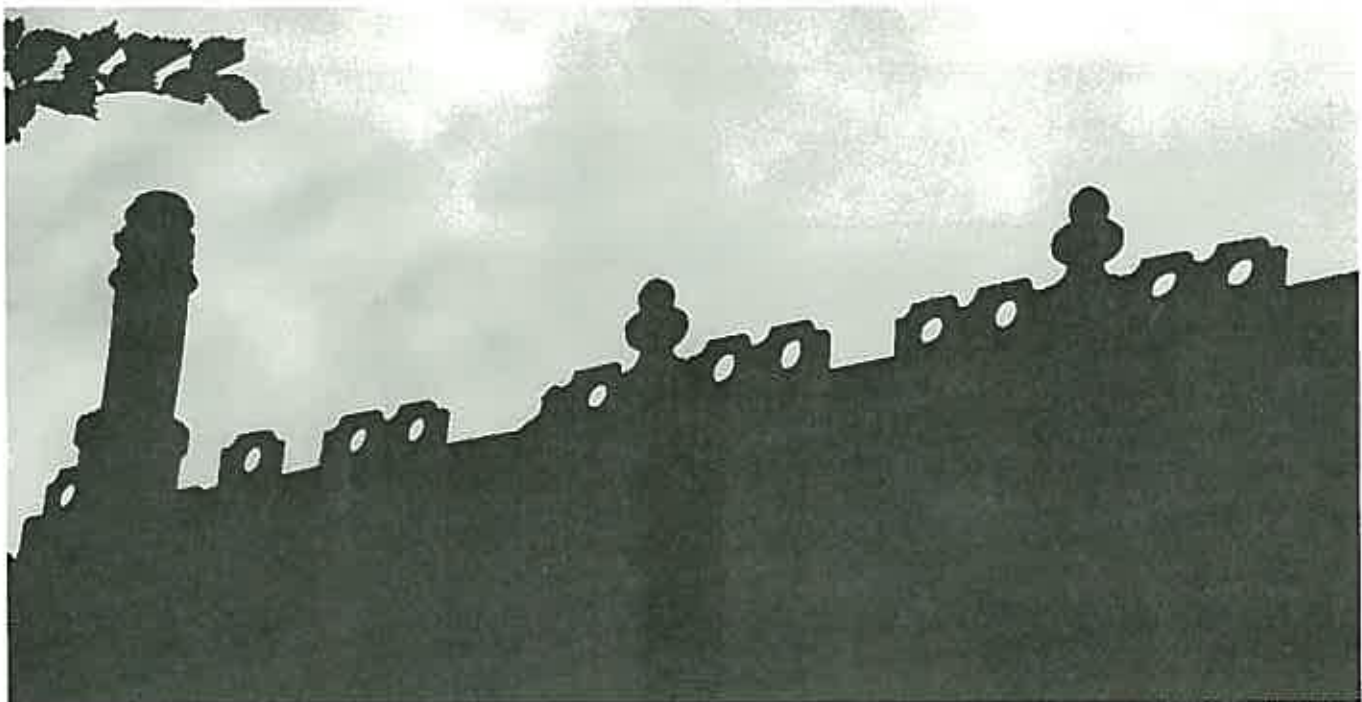
The richness and importance of terra cotta creasting and finials.
(House, Gulsons Brickworks, Goulburn, N.S.W.)

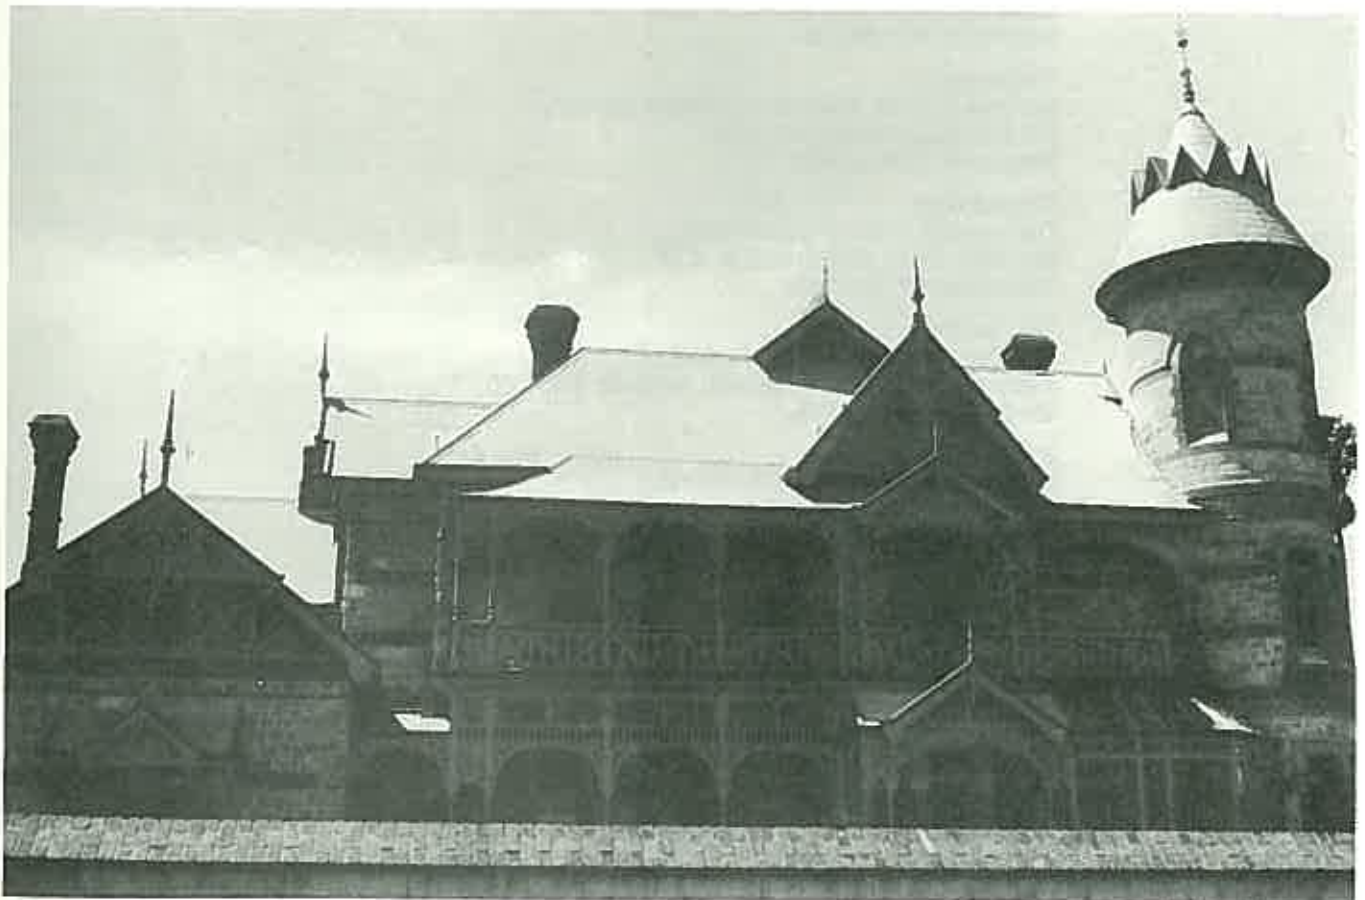
By the end of the nineteenth century corrugated iron was used on the most sophisticated buildings. It is shown here on a basically Queen Anne mansion with elaborate woodwork and crestings.
(Carlew, North Adelaide)
