PHYSICAL INVESTIGATION OF A BUILDING

TECHNICAL
BULLETIN 9.1

An Approach to the Archaeology
of Standing Structures.

By Miles Lewis.

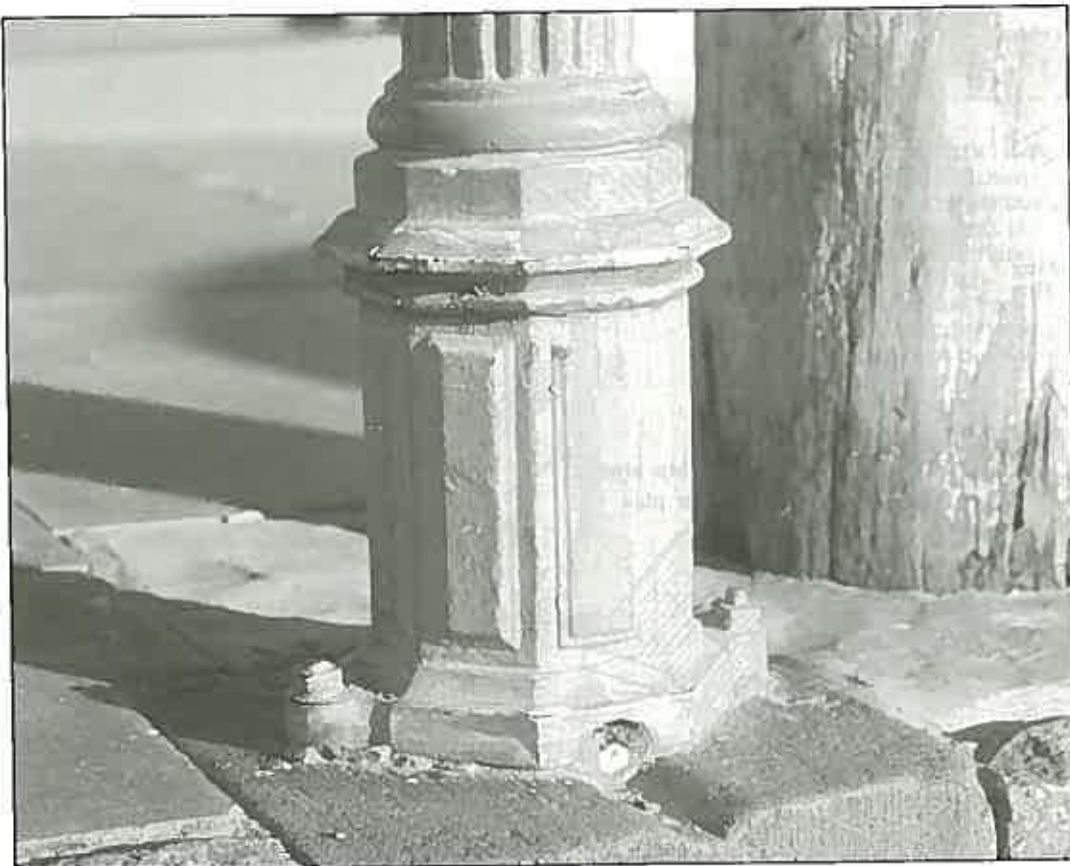
Base of a shop verandah column.

The base of the cast iron column bears lugs on two or three sides through which it is bolted down, and if the original base stone survives, then the marks of the bolts, and occasionally the whole profile of the base, can be seen. These base stones are square in plan and wider than the ordinary kerbstones, so they can be easily picked out when they survive. This is still quite common, even though some councils have zealously replaced all the kerbing in concrete. While the bases may have been displaced, this is usually obvious when you look at their spacing and

These stones are sometimes even more distinctively marked because the columns were hollow and were used to discharge rainwater from the verandah roof, so a small groove was cut in the surface of the stone to carry the water across to the street channel. Much less commonly the stones are drilled so that the water actually passes down into them and out sideways into the channel.

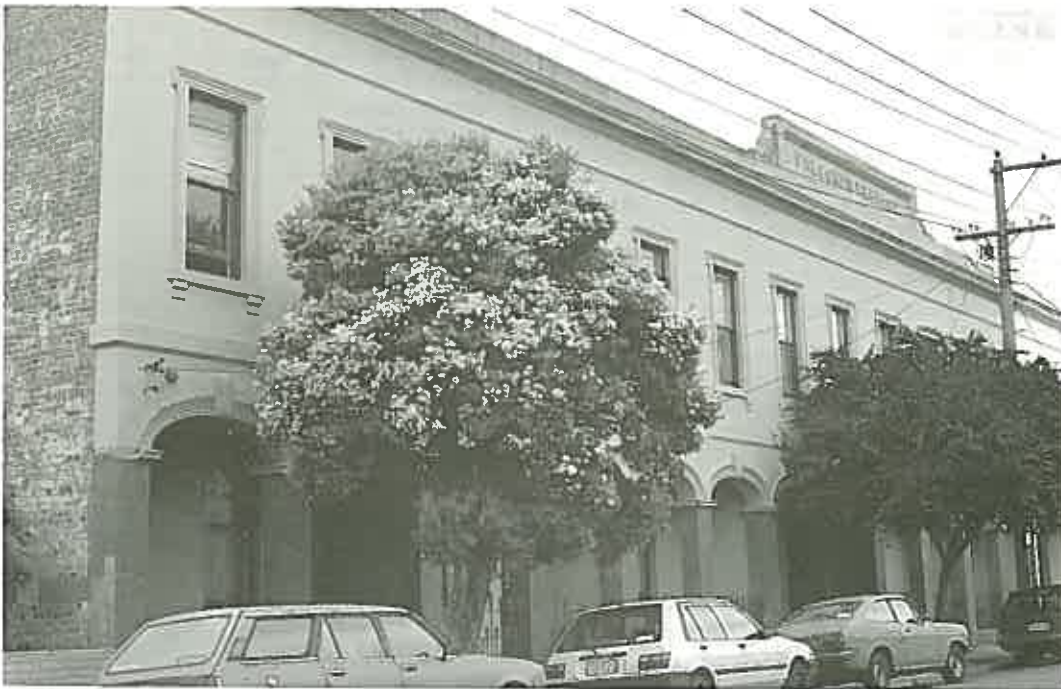
4.3

A. Detail of Falconer Terrace, 36-52 Napier Street, Fitzroy: the location of cracks in this apparently uniform facade indicates the different dates of construction. The crack or discontinuity at the junction of numbers 42 and 44 is to the right of the party wall, indicating that number 44, to the left, is the earlier portion.

Now, supposing you have found a vertical crack that seems to be the real thing, but you can't see that one side is lower than the other, there remains an absurdly simple test which even professionals overlook. The addition has usually been made against the existing wall, rather than a new wall being built against the existing one. If the addition has moved, then the wall will have stayed with the original portion. So if you can determine on the face of the building where the cross-wall is located, and if the crack is immediately to one or other side of that position, the addition is the section on that same side.

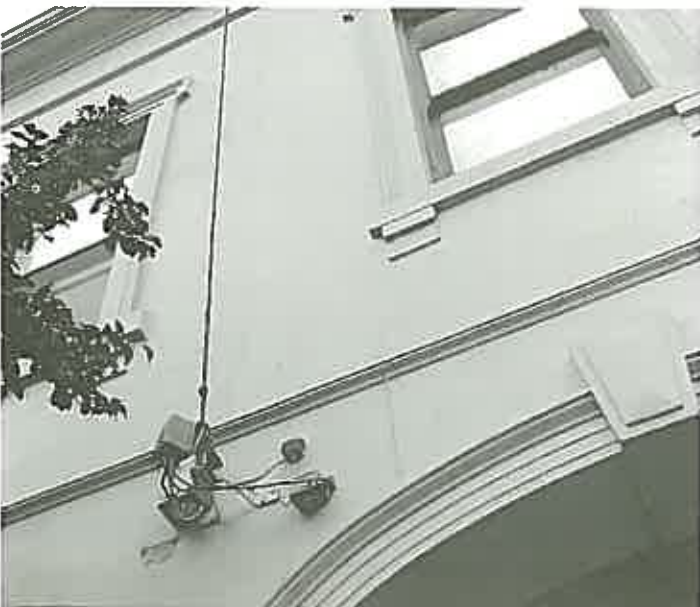
B. Facade of Falconer Terrace, crack 1 is to the left of the party wall line and crack 2, as shown in the detail, is to the right of its party wall. This shows that part B is earlier than parts A and C. This is confirmed by documentary evidence which indicates that A [no 50] dates from 1870, B [nos 48, 46, 42] from 1866, and C [no 42] is from 1872. Numbers 38 and 36, off the picture to the right, date from 1880 and 1884 respectively.

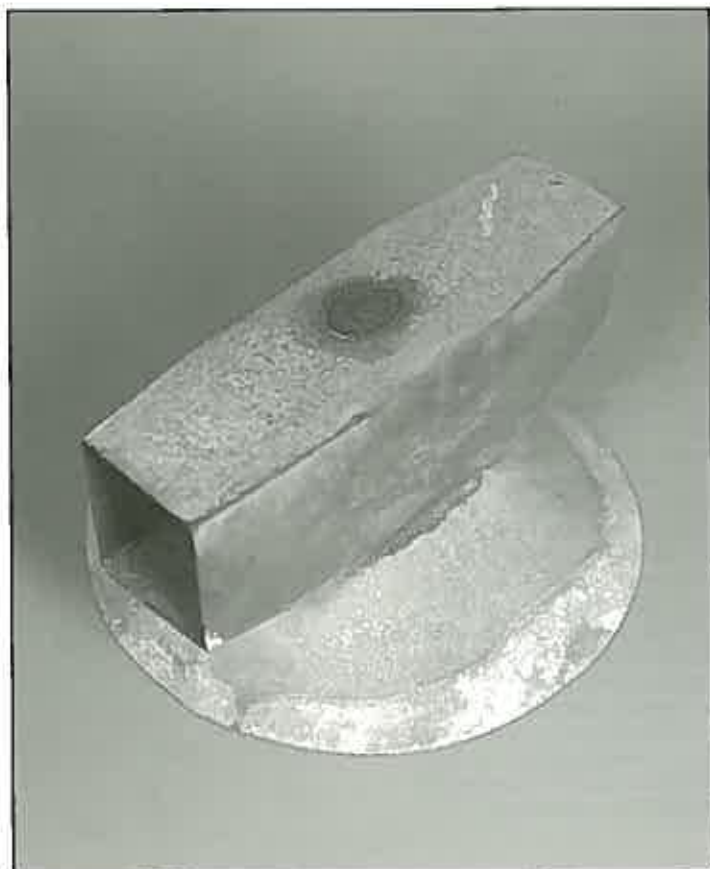
A patent ceiling ventilator found in the roof space of 'Glenfern', St. Kilda, designed to extract hot air fumes and water vapour from above a gas light fitting, and labelled as 'Murphy's Patent'. It was made by J. Murphy of Sandridge (Port Melbourne) in accordance with his patent of 1873, and dates from the installation of gas in the house in the 1870s.

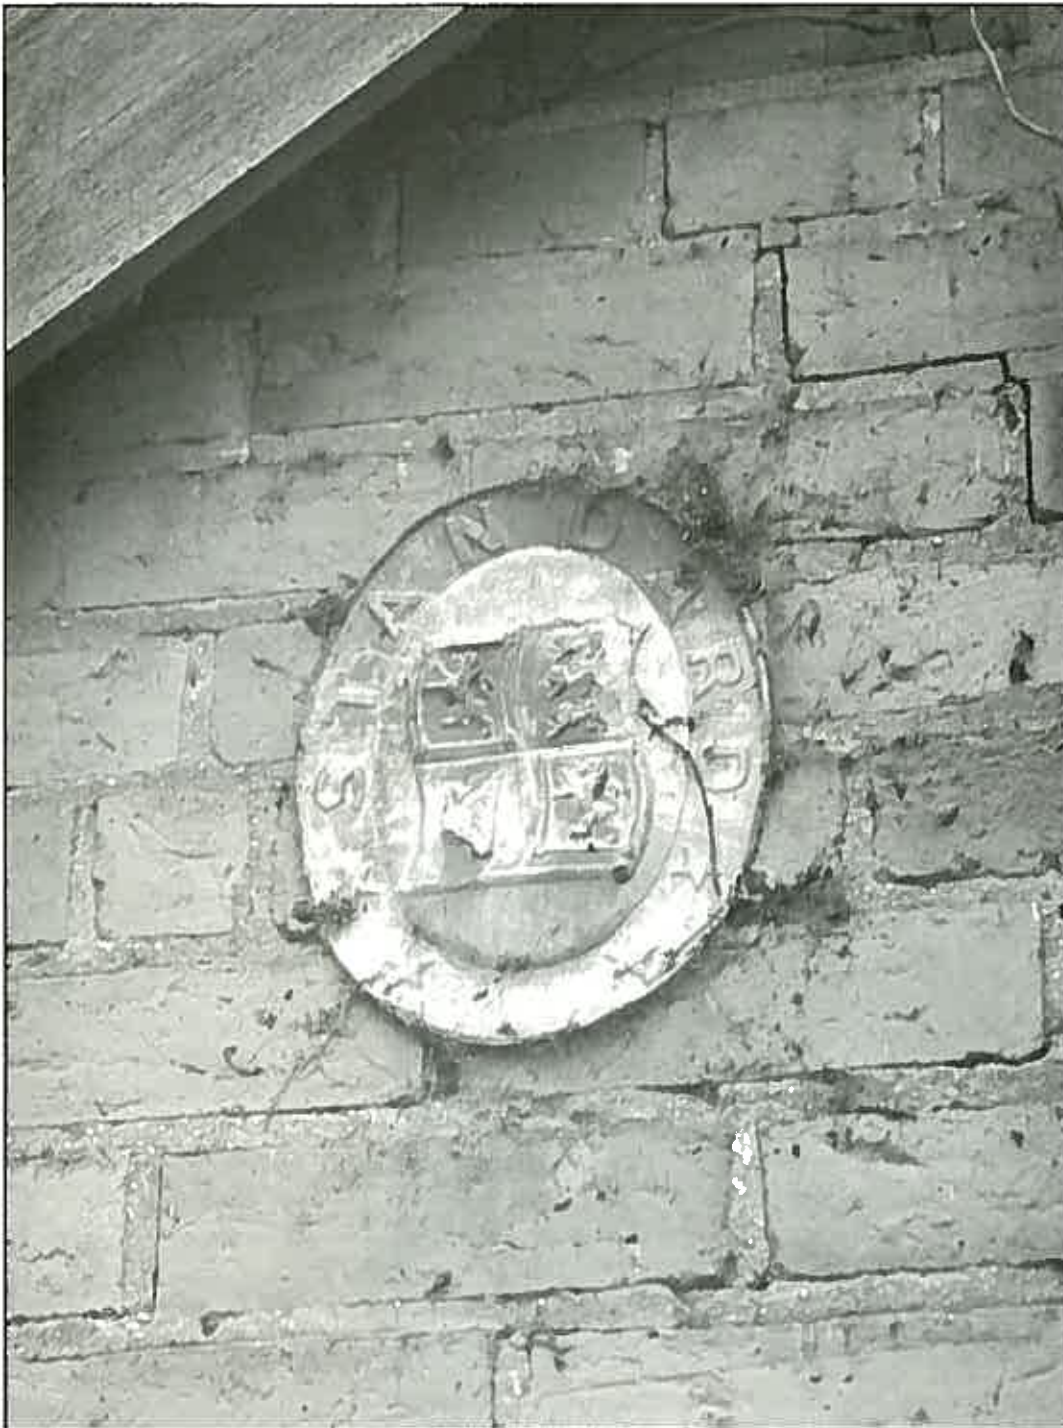
6.8

Fire marks

A fire mark is a small metal plaque bearing in relief the name and/or the symbol of a fire insurance company. This dates from the period before the 1890s, when insurance companies maintained their own brigades to attend fires only in buildings insured by them. Few marks now survive, as they have been regarded as collectibles for many years, and they usually tell little more about the building than an approximate *terminus post quem* for the date.

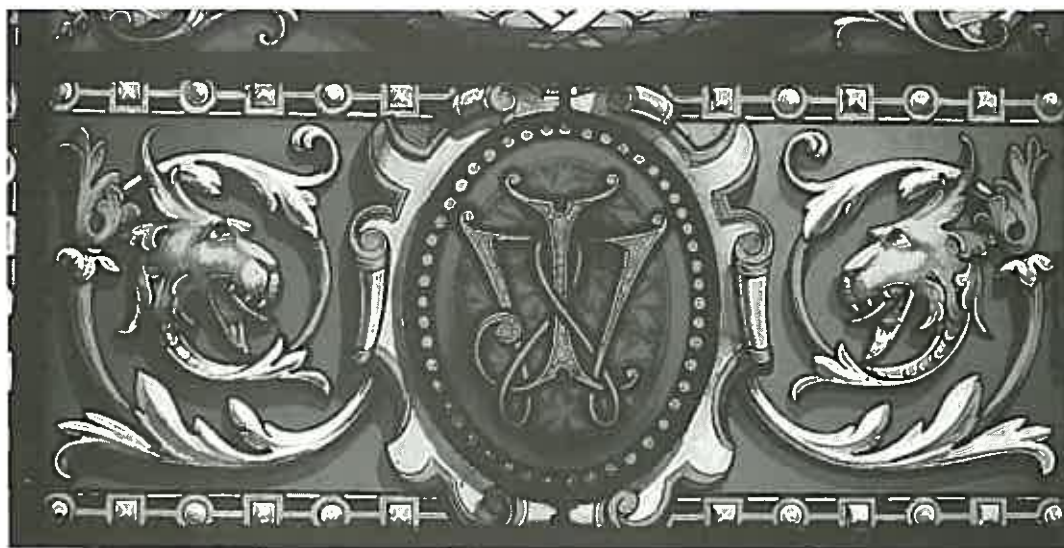
The monogram of the Wilson brothers, from the staircase window of Woodlands, near Crowlands, Western Victoria.

The monogram or coat of arms of the first owner appears sometimes on the facade or within the exterior decoration, but most commonly inside, in a stained glass window or on a painted ceiling. Although many of Victoria's wealthier families were not entitled to coats of arms, this did not inhibit them from borrowing or creating something appropriate, and of course research based on these factitious arms can prove to be frustrating or misleading.
