# CONSERVATION AND RESTORATION OF BUILDINGS

preservation of masonry walls

Australian Council of National Trusts

Compiled by Clive Lucas, O.B.E., B. Arch., FRAIA  
of the Conservation and Restoration Committee  
of the Australian Council of National Trusts.

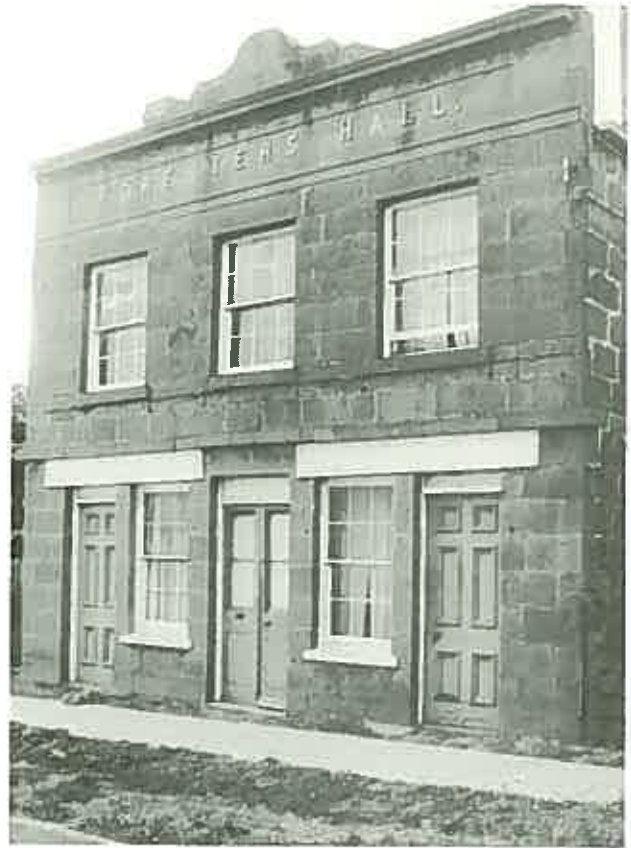
Typical of the 19th century, the dressed stone is reserved for the front wall. (*Foresters Hall, 18-20 Sackville Street, Portland, Victoria.*)

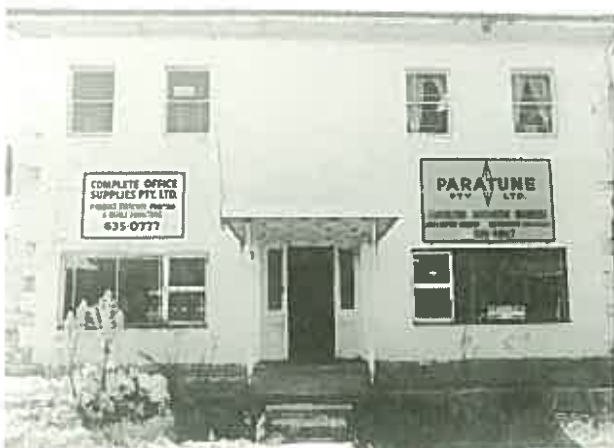
Hidden by 1950s cement render this 1820s house is unrecognisable. (*Harrisford, 182 George Street, Parramatta.*)

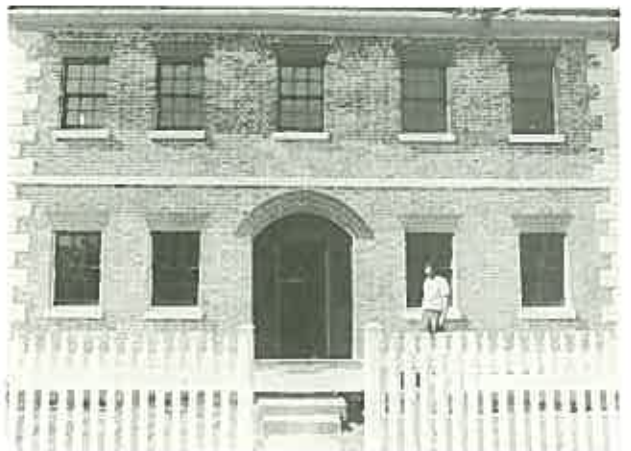
After hacking of the cement render and rebuilding the face of the wall and restoring the stone dressings and tuckpointed the brick arches the house is recognisable again as Georgian. (*Restoration architect: Clive Lucas.*)

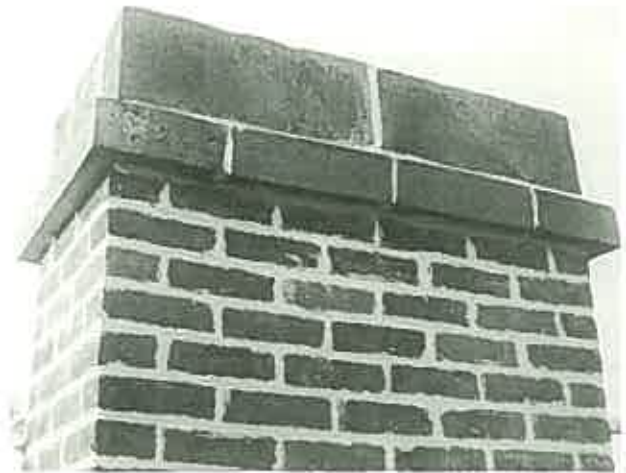
In parapets and chimneys a small amount of cement can be used to allow for more severe weathering. (Harper's House, Berrima, N.S.W.)

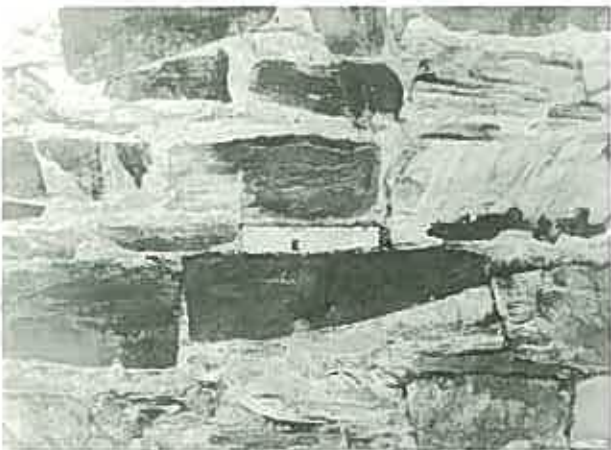
A rubble garden wall before restoration. (Brewery, Burra, South Australia.)

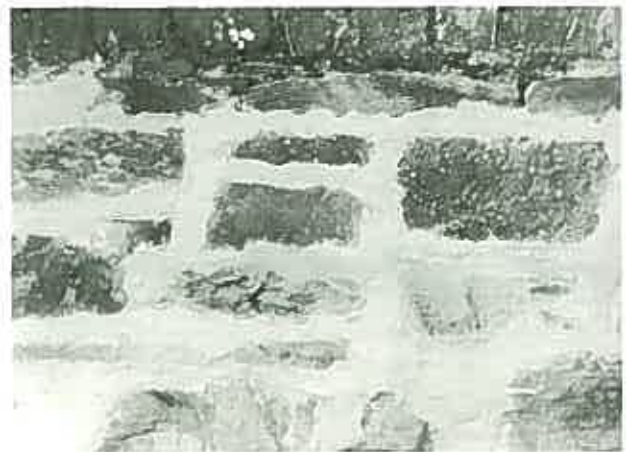
The technique used for repointing the wall shows no respect for the original material or technique. The result of unthinking repair is a disaster. (Brewery, Burra, South Australia.)

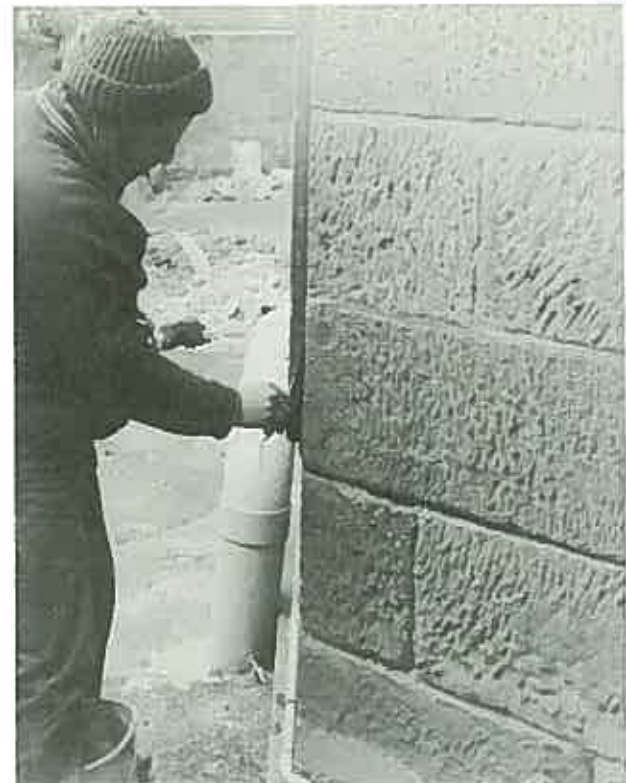
Mason raking out hard cement pointing prior to refacing certain stones and repointing the wall in lime mortar. (Government House, Hobart.)

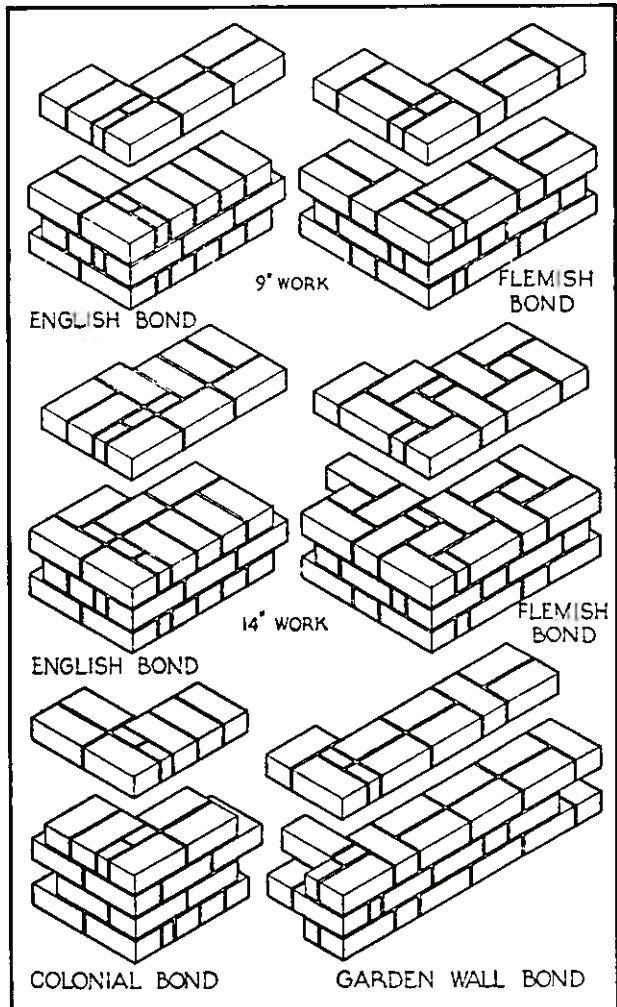
This diagram shows the three most common bonds used in 19th century Australia - Flemish, English, and Colonial.

Bricks are laid in various bonds: Flemish, English and Colonial being the commonest although various combinations and eccentric arrangements will often be found.

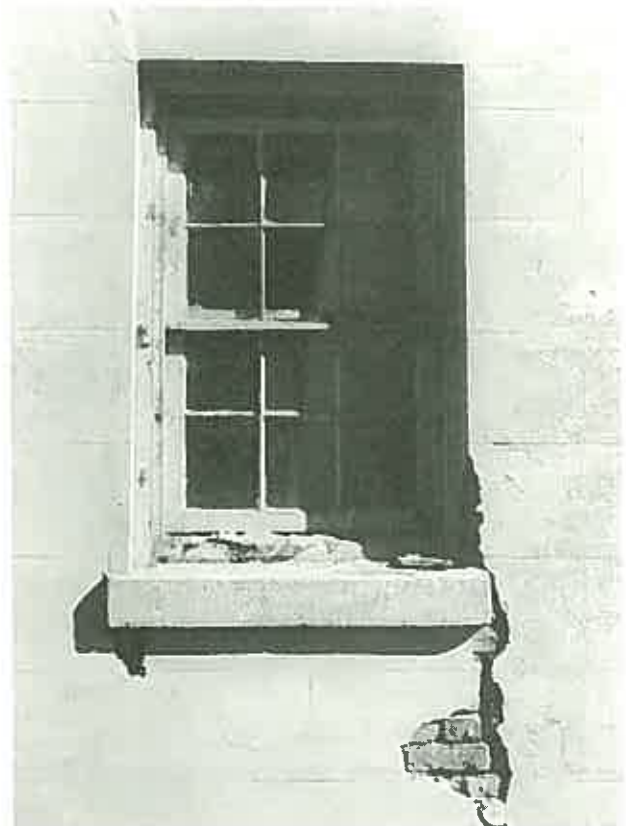
A brick wall rendered in imitation of ashlar. Only the window sill is sandstone. (Richmond Villa, Campbelltown, N.S.W.)

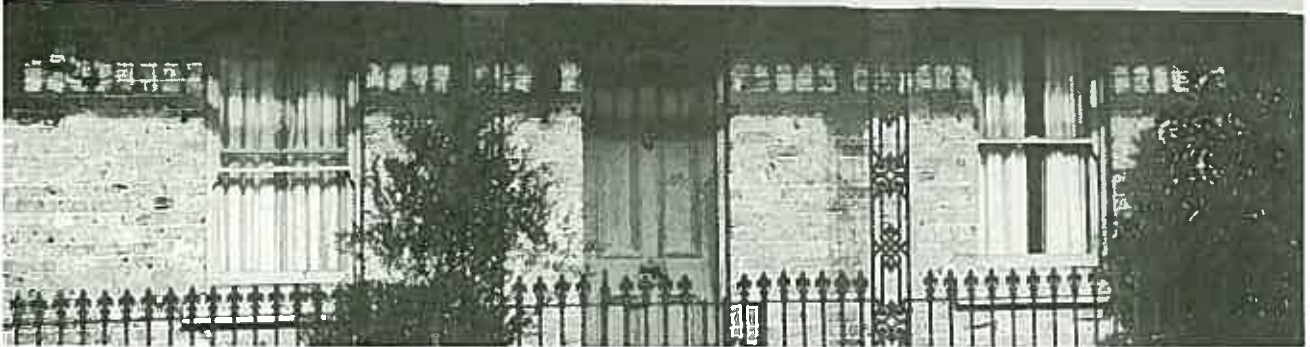
In recent years many 19th century buildings have had their protective render coat removed to expose the sandstock brickwork in the mistaken view that this is how they were originally. (45 Moncur Street, Woollahra, Sydney. Photo in possession of Mrs. S. Carter.)

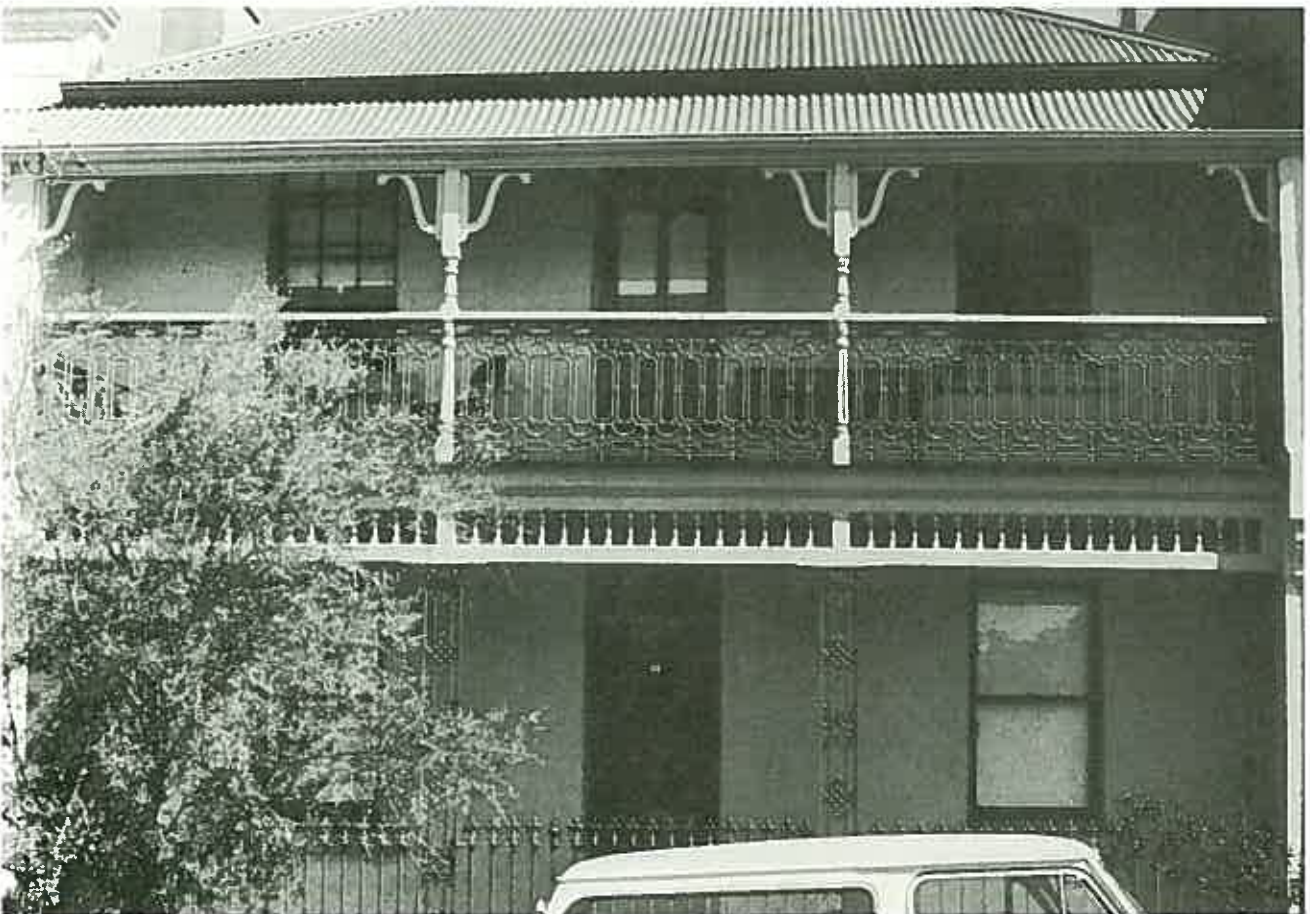
In this Sydney example the rendering has been put back, not only restoring the correct character to the house, but also making it considerably more waterproof. (Restoration architect: Clive Lucas, Photo: Jyoti Somerville.)

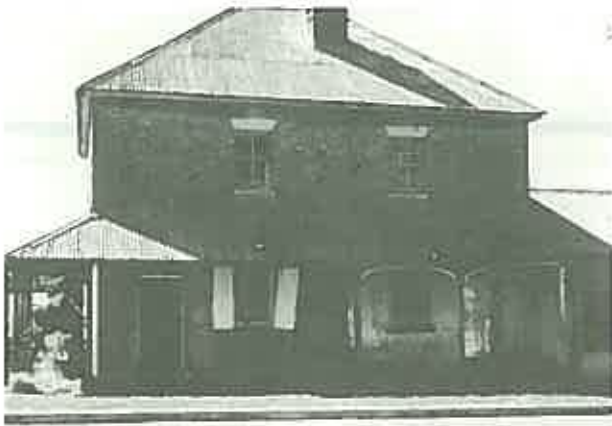
In this example of a face brick building where a small section under the verandah has been painted, paint removal can perhaps be justified. (37-39 North Street, Windsor, N.S.W. prior to restoration.)

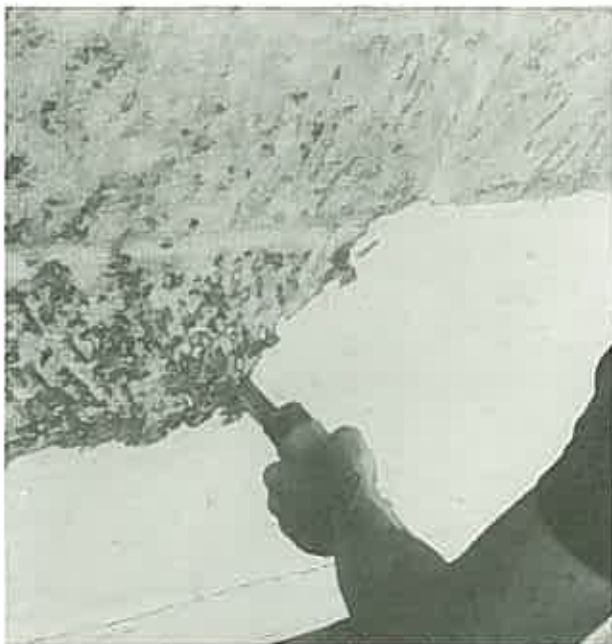
Removing paint off sandstone with a hand operated needle gun. It does not remove all the paint but in a few years what remains could well weather off.

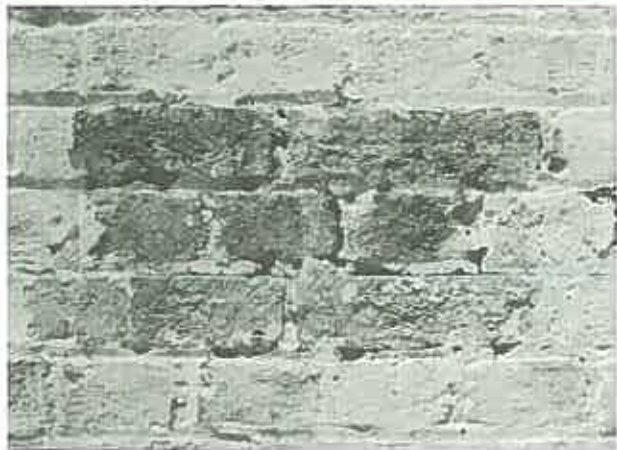
Removing paint off sandstock brickwork by water pressure removes the paint but also the soft jointing and makes the wall very wet. It would have to be repointed.

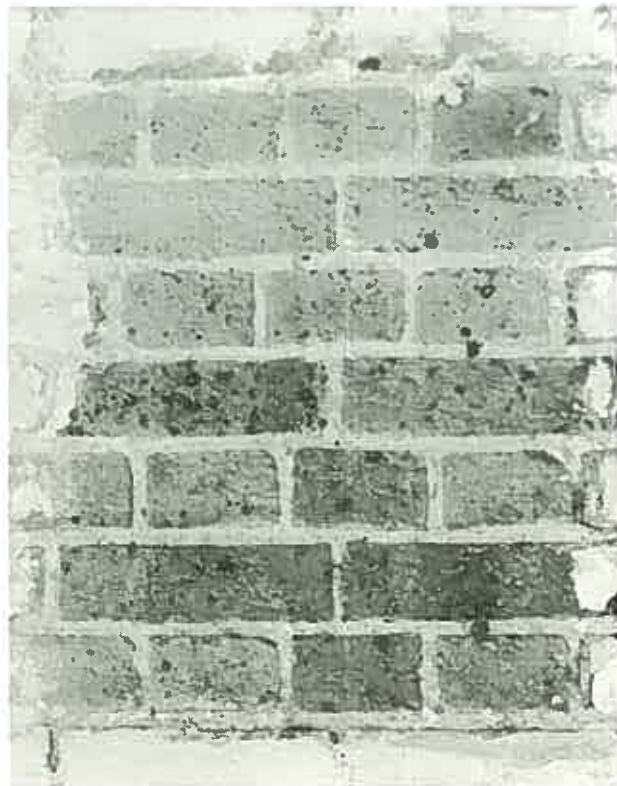
Cleaning paint off sandstock brickwork by a chemical and mechanical method removes the paint satisfactorily but the saturation of the wall may cause harmful chemical action with salts in the structure.

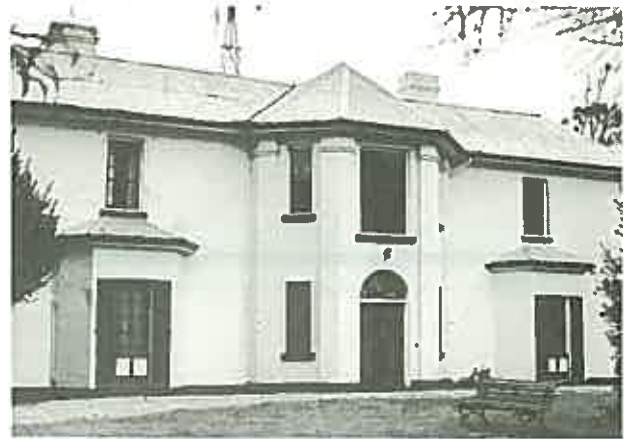
This house may well have been facebrick when it was new but it has been painted a long time, probably as much for keeping its solid walls dry as for fashion. It should continue to be painted. (*Rhodes, South Esk River, Tasmania.*)

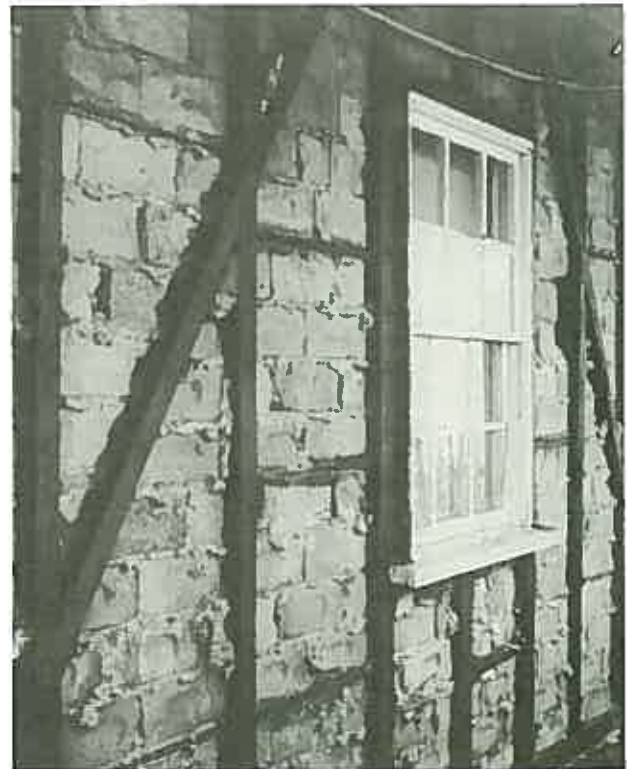
This early cottage in Sydney has had its external weatherboards removed revealing its brick nogged construction. The boards should be restored. (*Cottage, 45 Glebe Street, Glebe, Sydney.*)

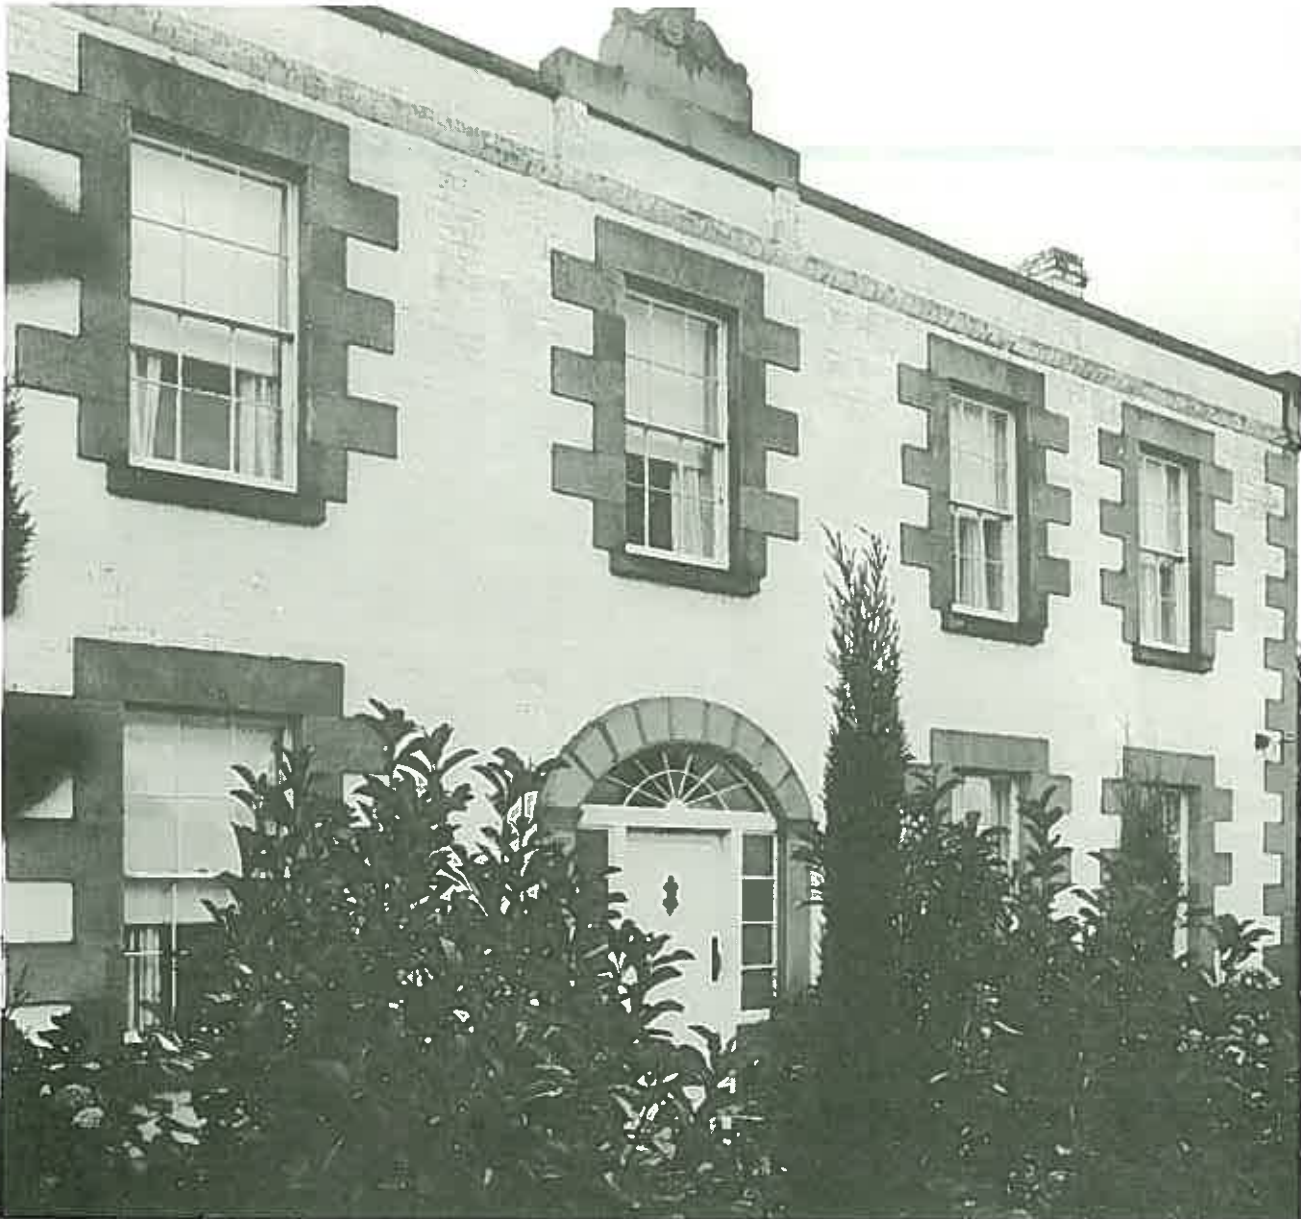
A house which combines both brick and stone in its construction to achieve a decorative effect.  
(*The Manor, Baschus Marsh, Victoria, c. 1840. Photo: Wesley Stacey.*)

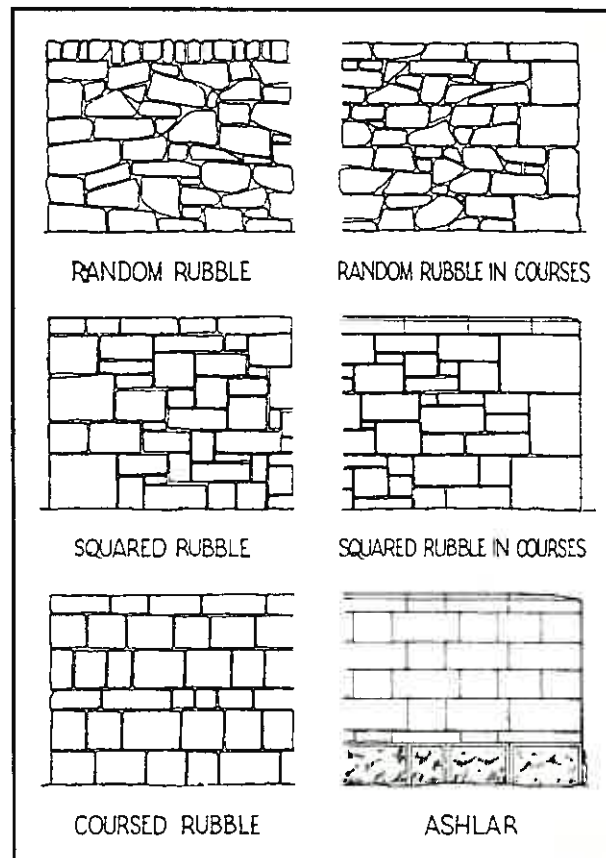
Various types of stone walling.

The basic stone wall is of random rubble, in which stones as found in the countryside are stacked up with as little shaping as possible to provide two faces, except at apertures and corners. These areas are sometimes trimmed with brickwork or another more workable building stone.

Two-faced stones were used as ties in some positions, to tie together two skins of rubble, erected simultaneously from inside and outside, the outside skin being built with selected stones which show one good face.

Coursed rubble was probably the next refinement and then ashlar walls of even courses in which the face is tooled in many different ways ranging from a surface that has been ground perfectly smooth, to rough picked and quarry face.

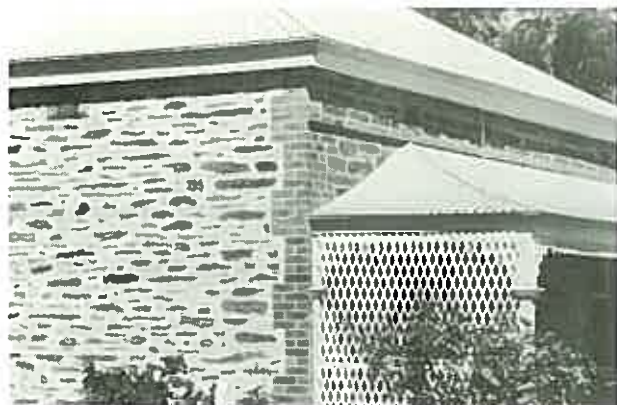
A sophisticated house of random rubble which is coursed and the front facade pointed. The corners and apertures of the house are trimmed in brick.  
(Cottage, Dundas Street, Gawler, South Australia.)

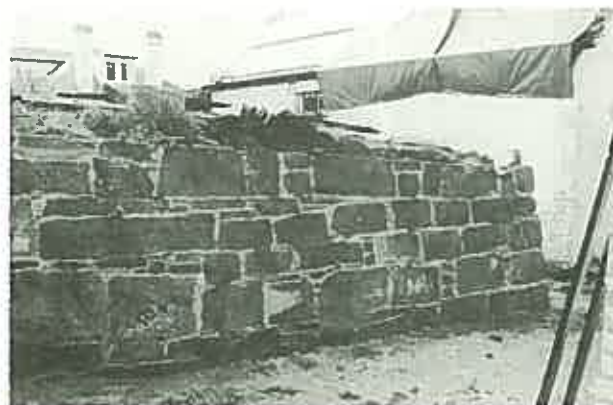
The individuality of stone walling must be appreciated as in this restored retaining wall at Port Arthur.  
(Priest's House, Port Arthur. Restoration architect: Clive Lucas.)

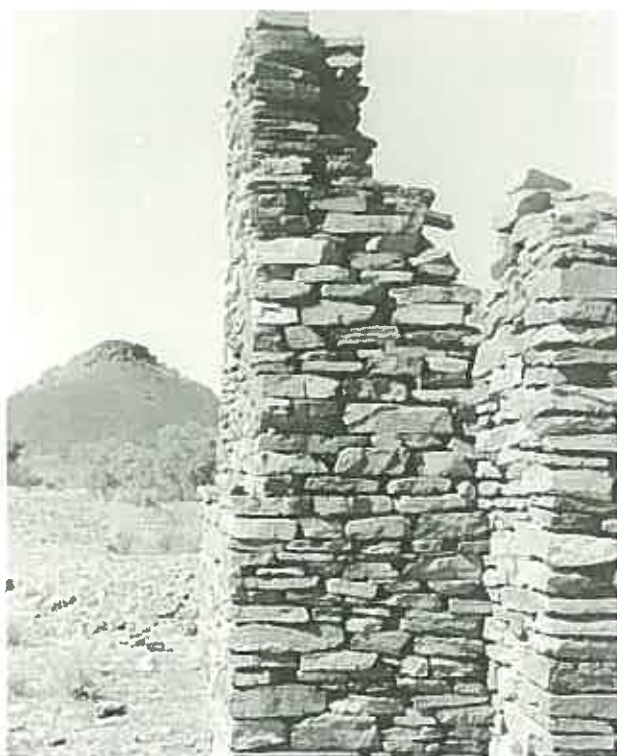
Walls built of random rubble collected from the countryside in its most basic form.  
(Miner's cottage, Arltunga, Northern Territory.)

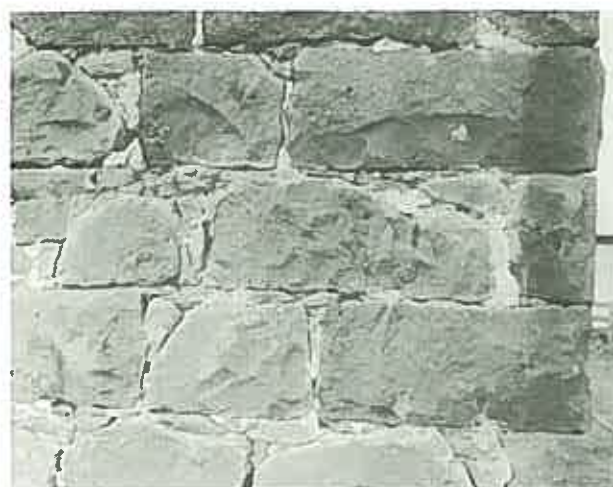
Fine bluestone rubble walling which has been squared and coursed in this western district example.  
(Shearing shed, Lyne Station, Hamilton, Victoria.)

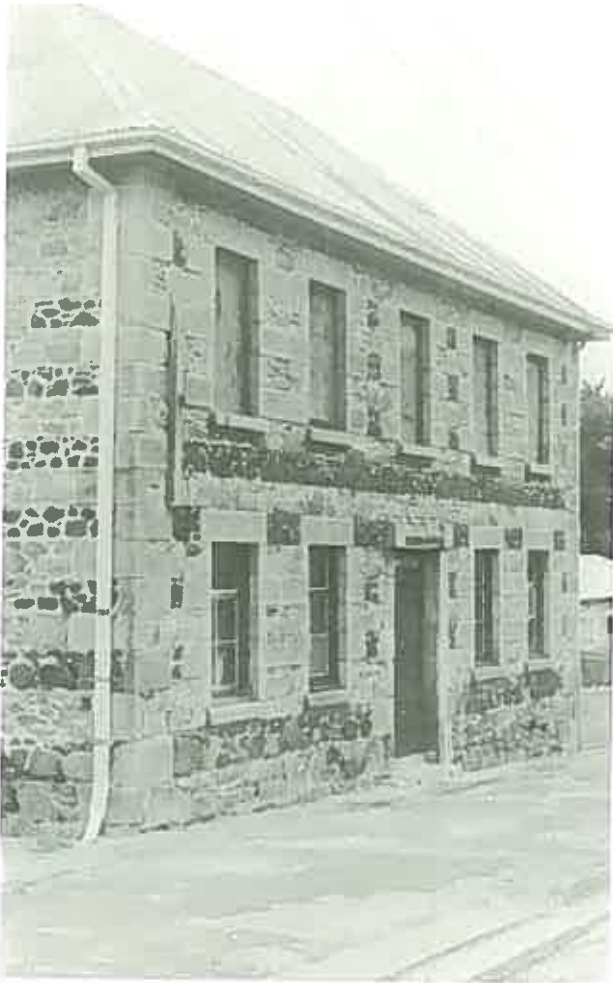
A highly individual treatment of rubble used with freestone trimming. (*Parish Hall, Avoca, Tasmania.*)

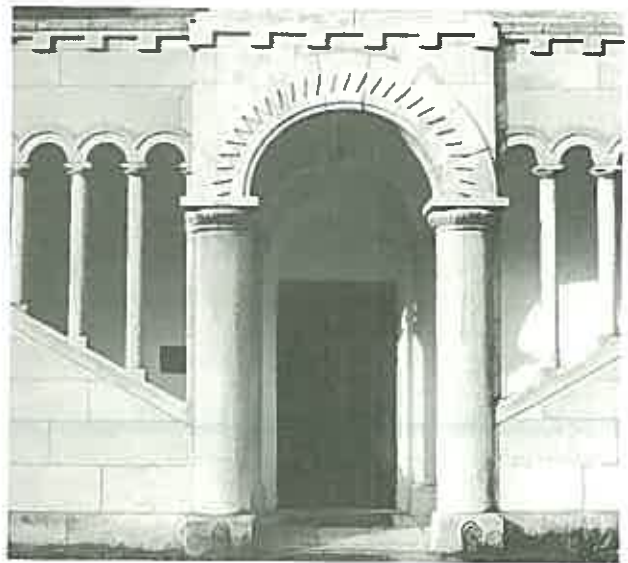
The contrast of stone tooling is part of the character of this fine building. (*St. Mark's, Pontville, Tasmania.*)

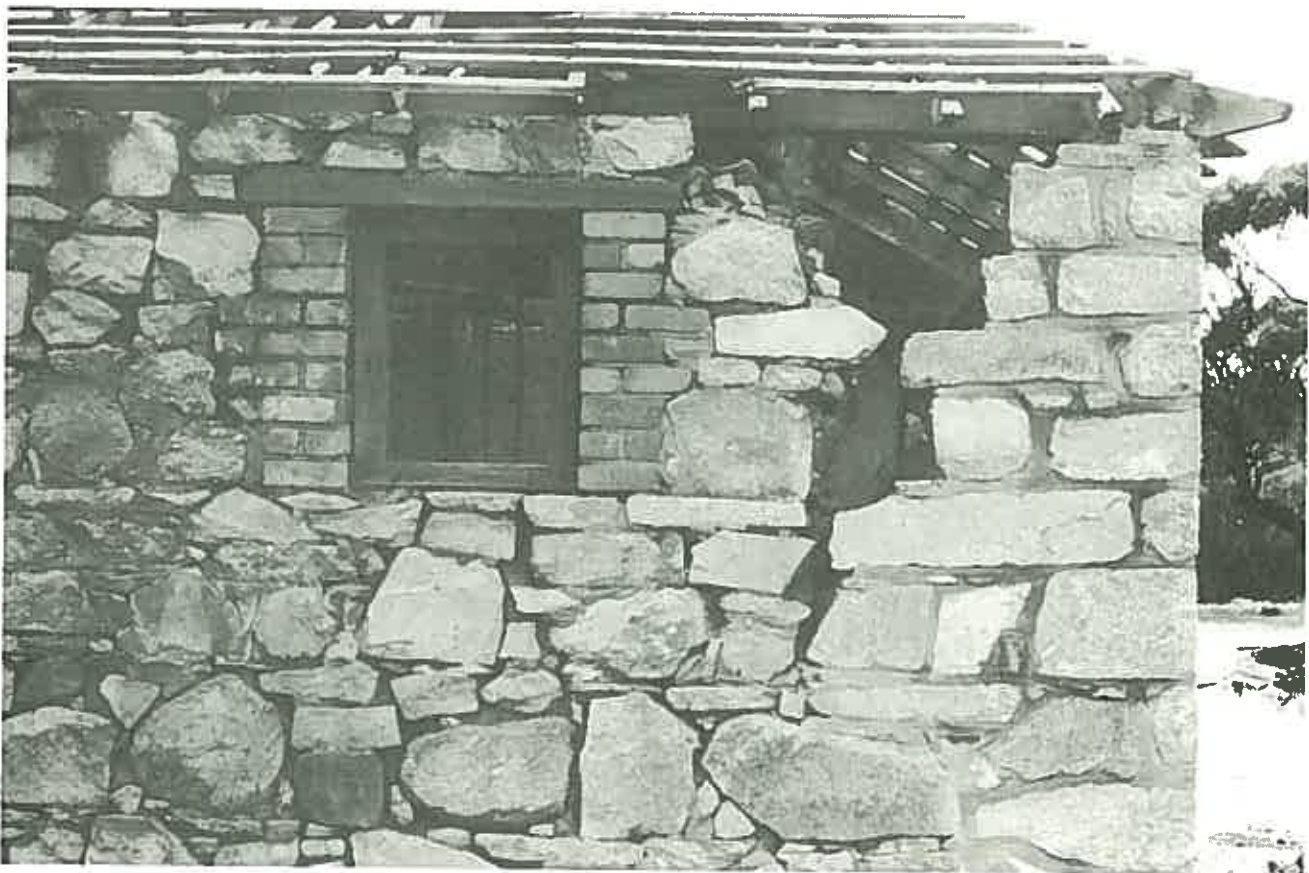
In this wall the repair has not captured the spirit of the original construction. (*Balladong, York, Western Australia.*)

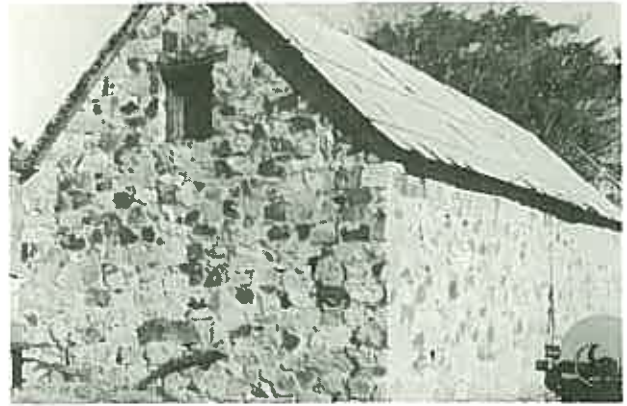
A good example of typical random rubble construction. The walls have once been limewashed so it should be understood the original quality was somewhat different. (Barn, Carcoar, N.S.W.)

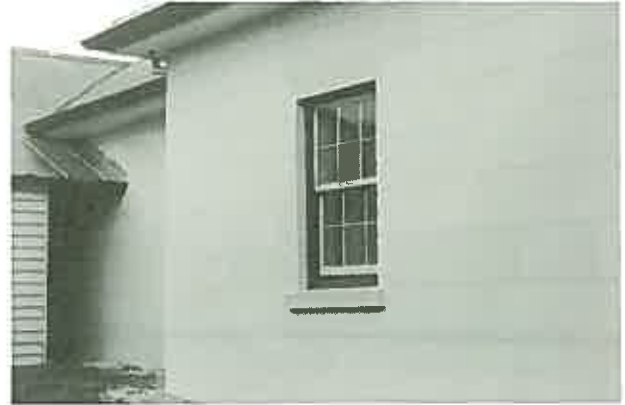
The walls of this building are brick plastered and lined out to simulate ashlar. Only the window sill is sandstone. (Cooma Cottage, Yass, N.S.W. Restoration architect: Clive Lucas)

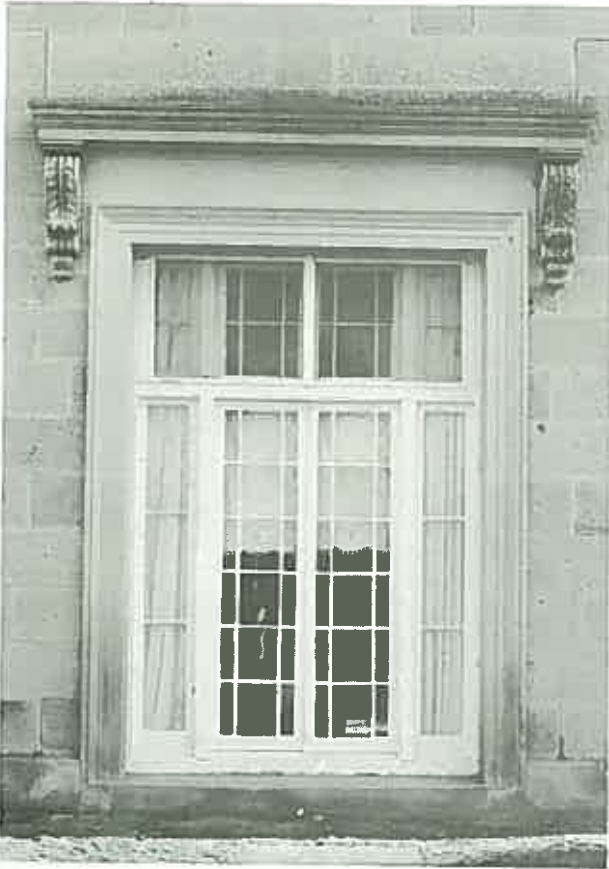
Sparrow picked ashlar with rubbed dressings produces a delightful effect. (*Wentworth House, Bothwell, Tasmania.*)

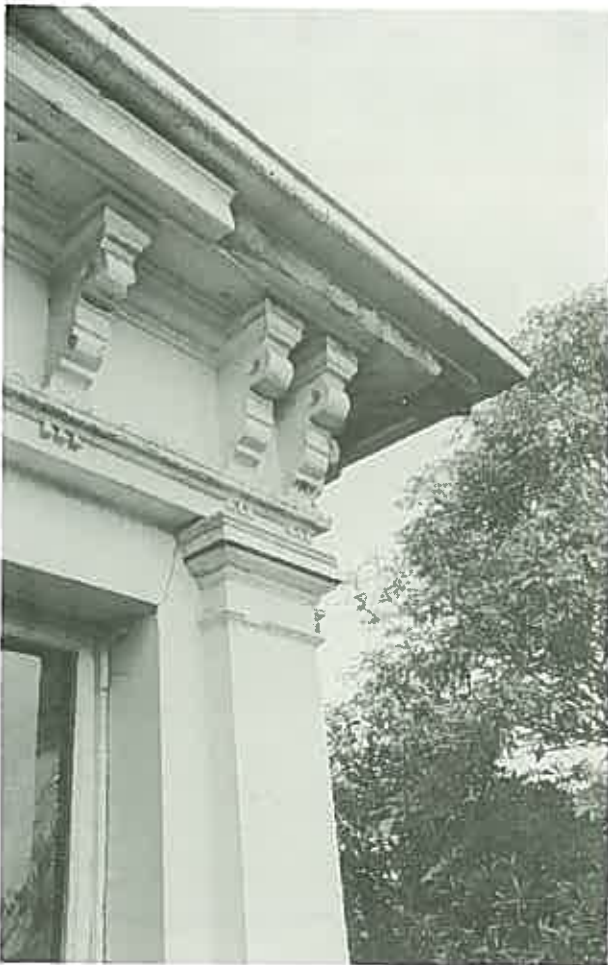
In this late Victorian house the cement rendered cornice has a core of sandstone. (*Iona, Darlinghurst, Sydney, 1890.*)

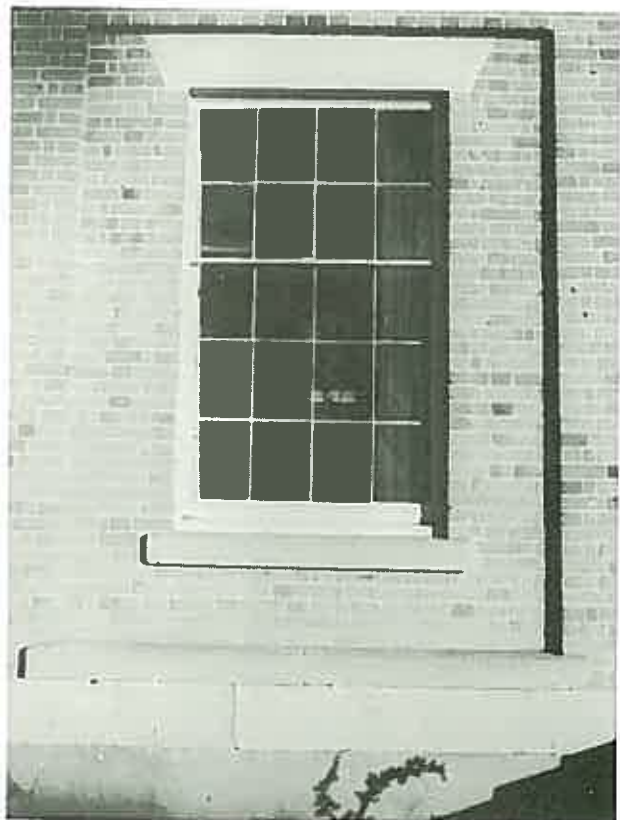
The combination of brick and stonework is an important characteristic of many colonial buildings. (*Forcett House, Fawcett, Tasmania, 1830s.*)

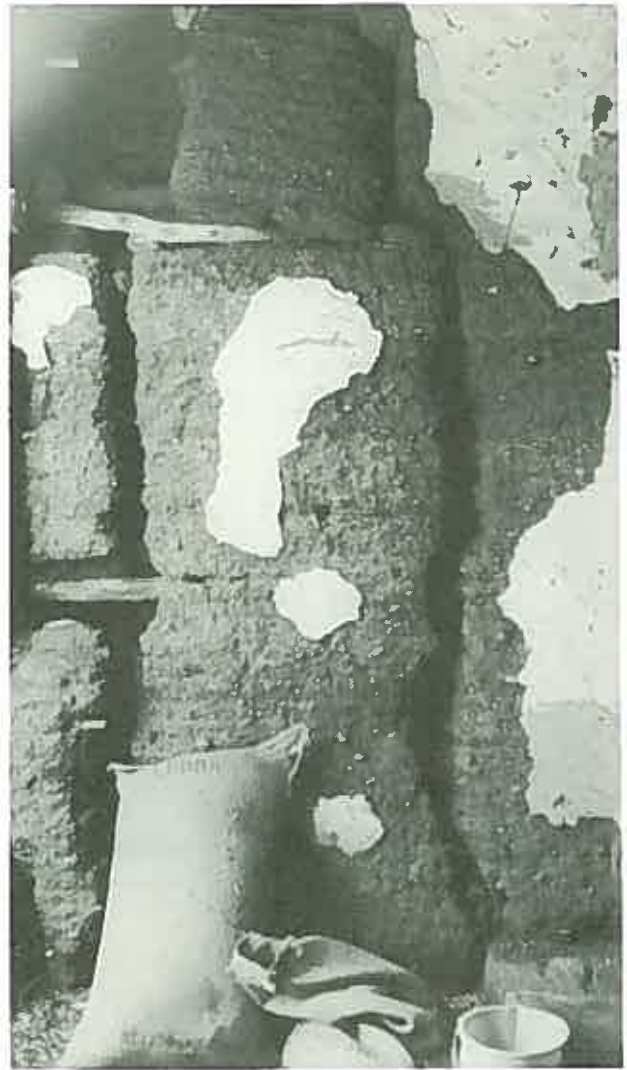
In this deteriorated pisé wall the timber reinforcing is seen. (*Stables, Boree Cabonne Homestead, Boreore, N.S.W.*)

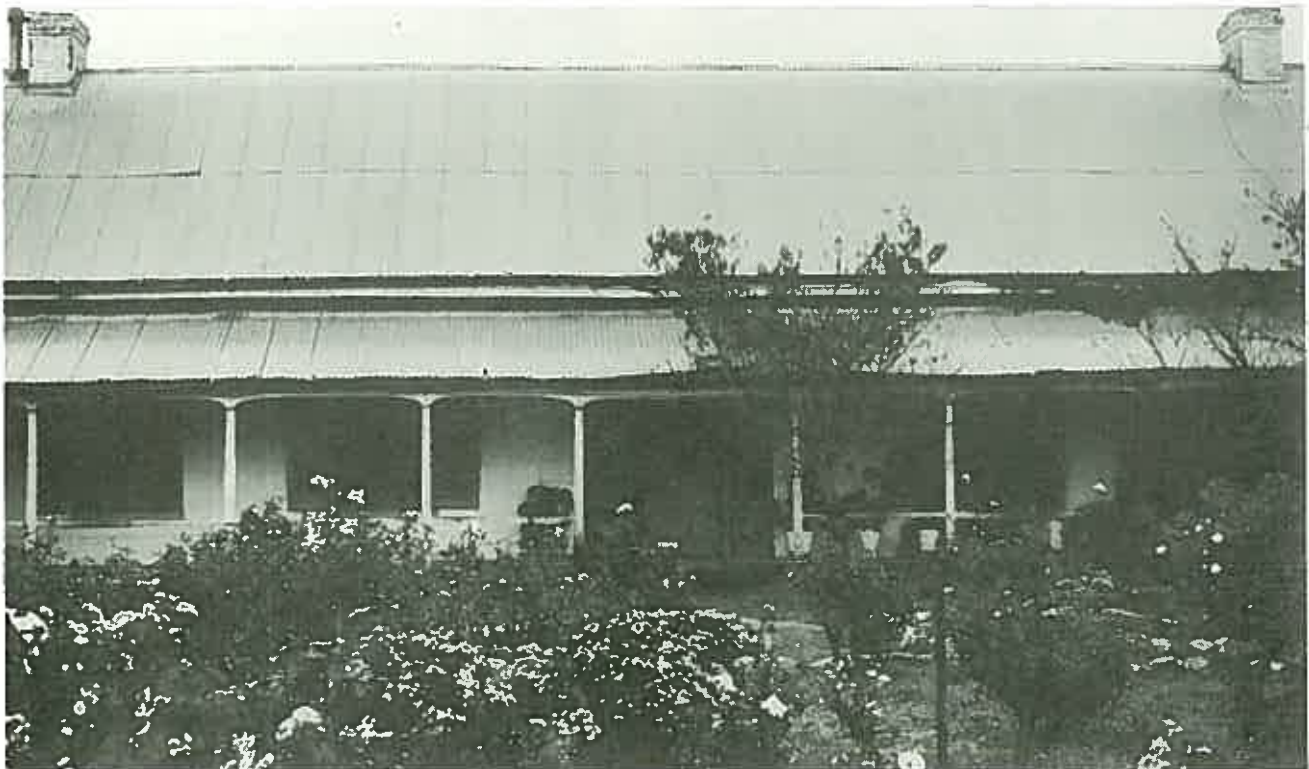
Quite substantial buildings were built of Pisé. The only way to tell is if the render is off. (*Cunningham Plains, Harden, N.S.W., 1862.*)

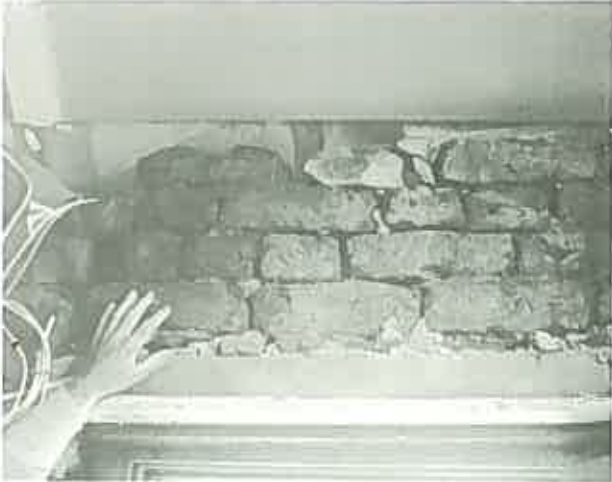
Adobe bricks used in the construction of an 1830s house near Orange, N.S.W. (*Bookanan, Byng.*)

Adobe is a primitive form of brick construction. Masonry units are made of mud and straw, sun dried, and then built up in much the same way as a brick wall. It is sometimes found combined with brick and stone or as nogging in a stud frame.

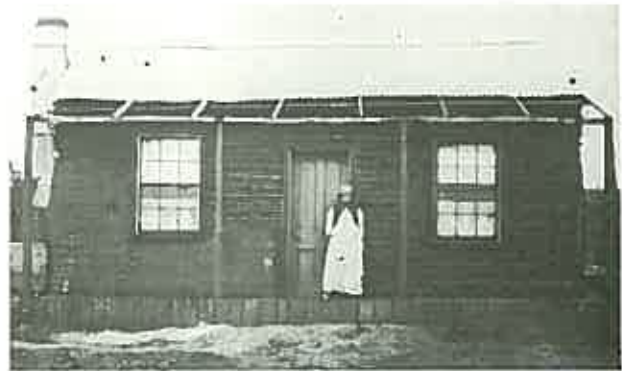
An 1870s photo of a wattle & daub cottage at Hill End, N.S.W. (*Hollermann photograph.*)

Wattle and daub is the construction of a woven mat or branch framework which is dabbed with mud on both sides and whitewashed.

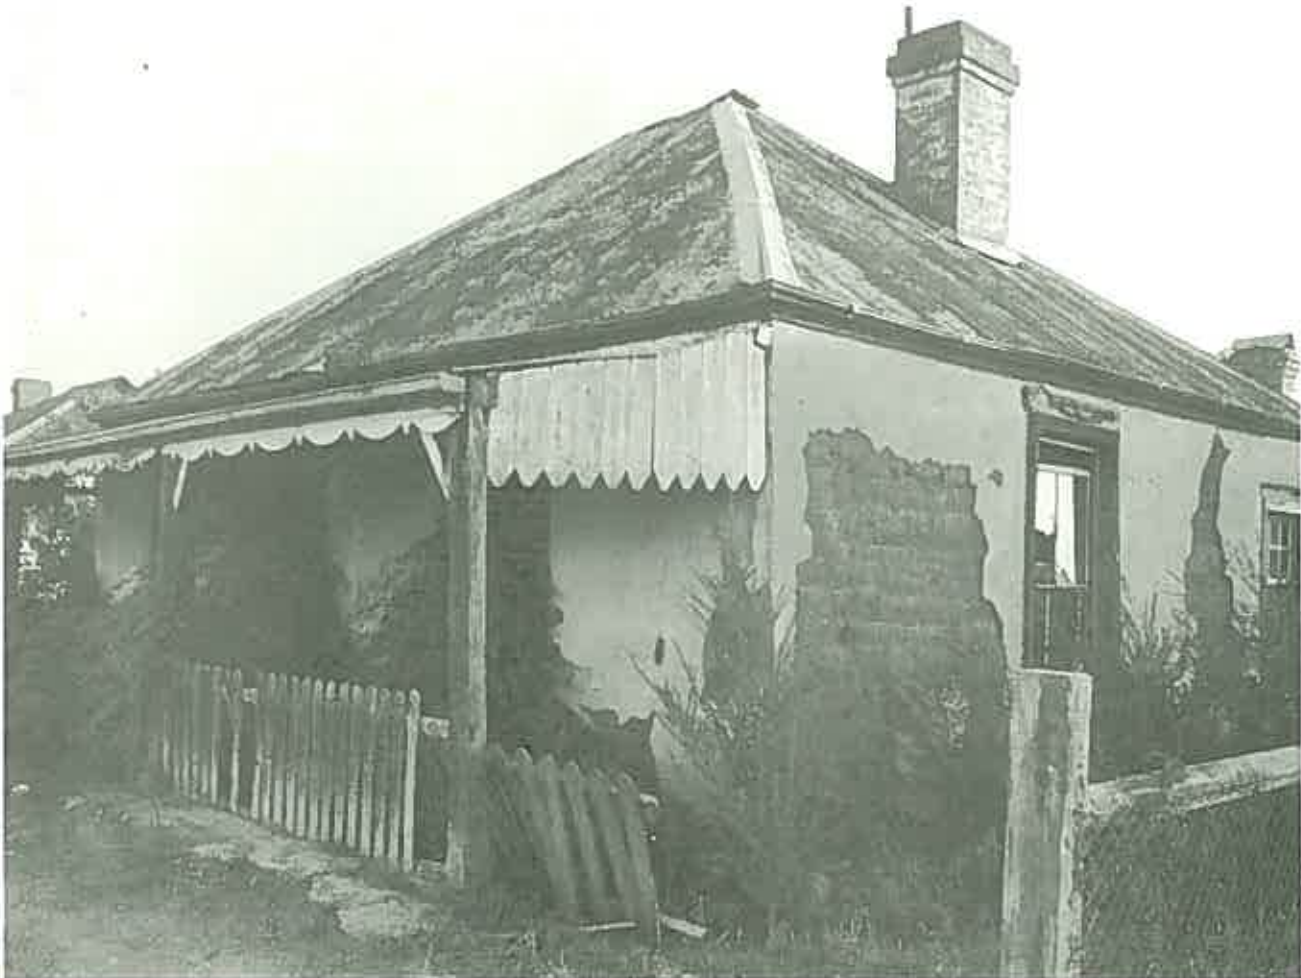
The rendering has broken down revealing that the cottage is of pise construction. (*Canowindra, N.S.W. Photo: Ian Stapleton.*)

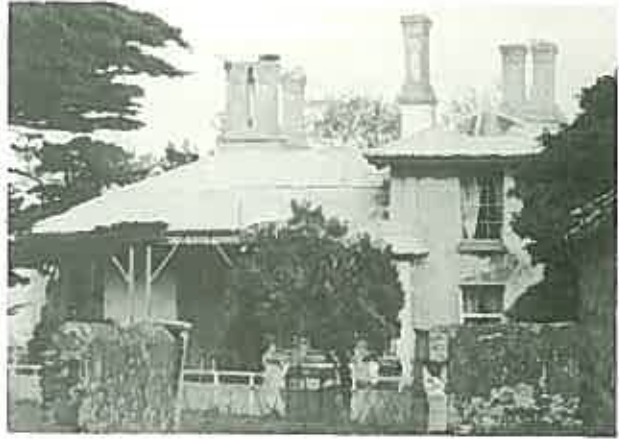
The chimneys on this 1830s house are rendered in an early patented cement. (*Highfield, Stanley, Tasmania.*)

Various patented cements seem to have been used after about 1830 but usually for external rendering rather than for mortar. Certainly as late as 1900, lime mortars seem to have been preferred although cement renders had been popular for 50 years. Cement mortars seem only to have been used in areas of stress such as arches. An early example of external cement rendering, Lyndhurst in Sydney, built between 1834-37 by the leading architect John Verge, has brick walls bedded in shell lime mortar, internal plaster of shell lime, but the external walls are rendered in a patent cement. Also, at Highfield (1835) at Stanley, Tasmania, a cement of some sort was used for rendering the decorative chimneys.

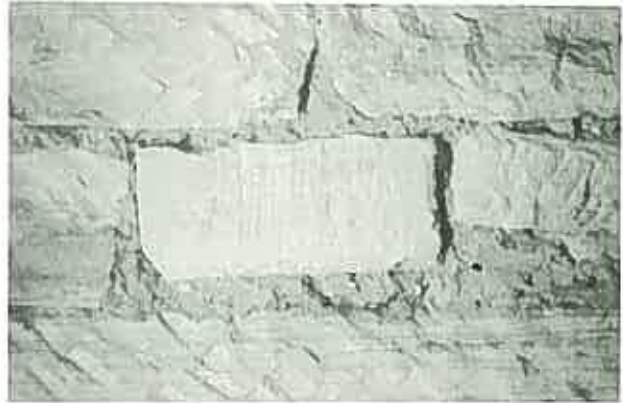
An example of shell lime mortar. Pieces of shell can actually be seen. (*Vaucluse House, Sydney.*)

As a rule, older mortars used shell lime and deposits of seashells will often be found. Later, after limestone deposits were discovered, the use of shell lime declined.

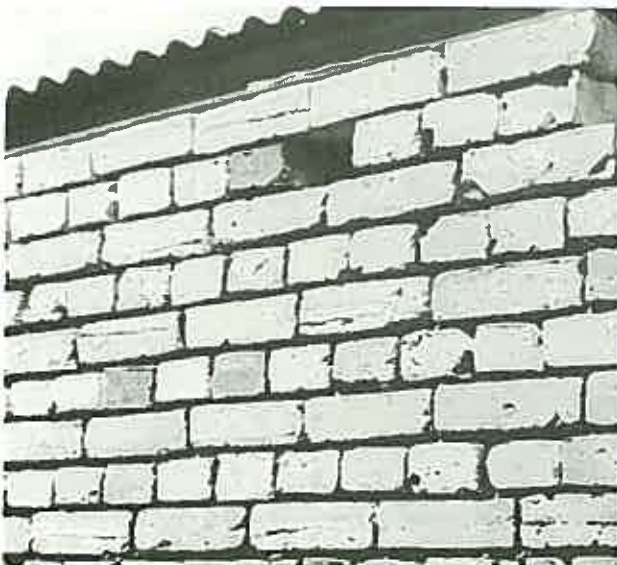
This shows the beneficial effects of a soft mortar. In this neglected wall the mortar has gone and left the bricks intact. (*Outbuilding, Parsonage, Port Arthur, Tasmania.*)

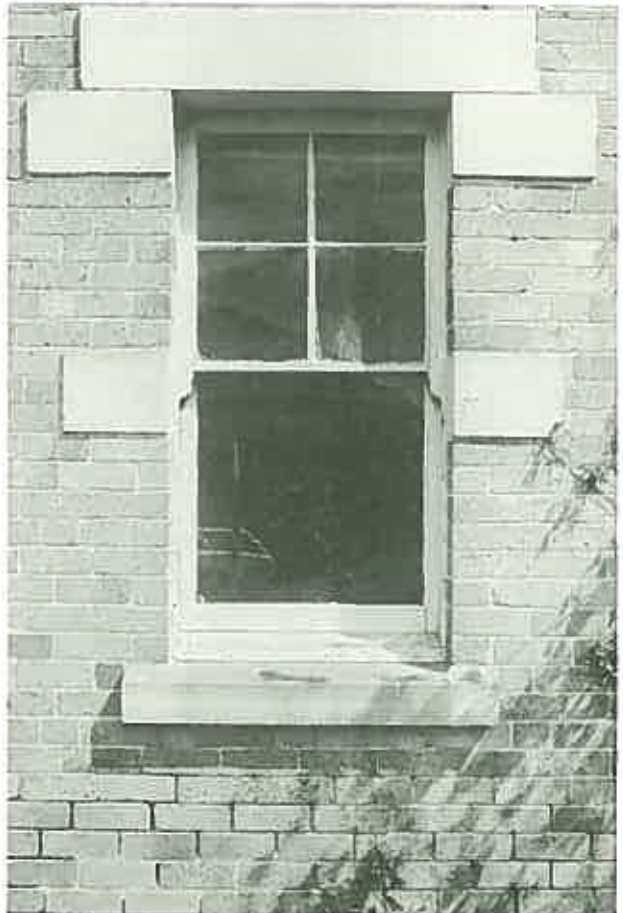
A typical example of the effect of rising damp on the exterior of a brick building. (*Beulah Vista, Church Street, Canterbury, Sydney.*)

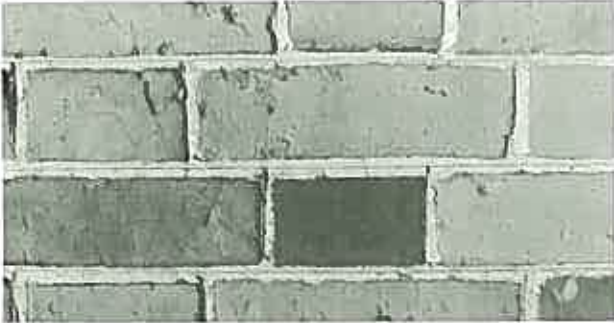
An example of pointing which has been ironed to make the joints appear finer than they are. This was a common 18th century practice. (*Forcett House, Fawcett, Tasmania, 1830s.*)

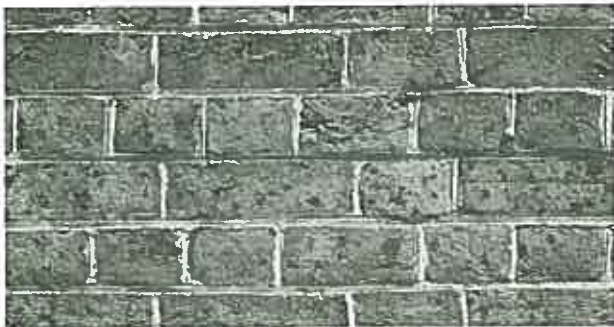
Another example of struck jointing. (*St. Thomas's Church, Narellan, N.S.W.*)
