# CONSERVATION AND RESTORATION OF BUILDINGS

preservation of masonry walls

Australian Council of National Trusts

Compiled by Clive Lucas, O.B.E., B. Arch., FRAIA  
of the Conservation and Restoration Committee  
of the Australian Council of National Trusts.

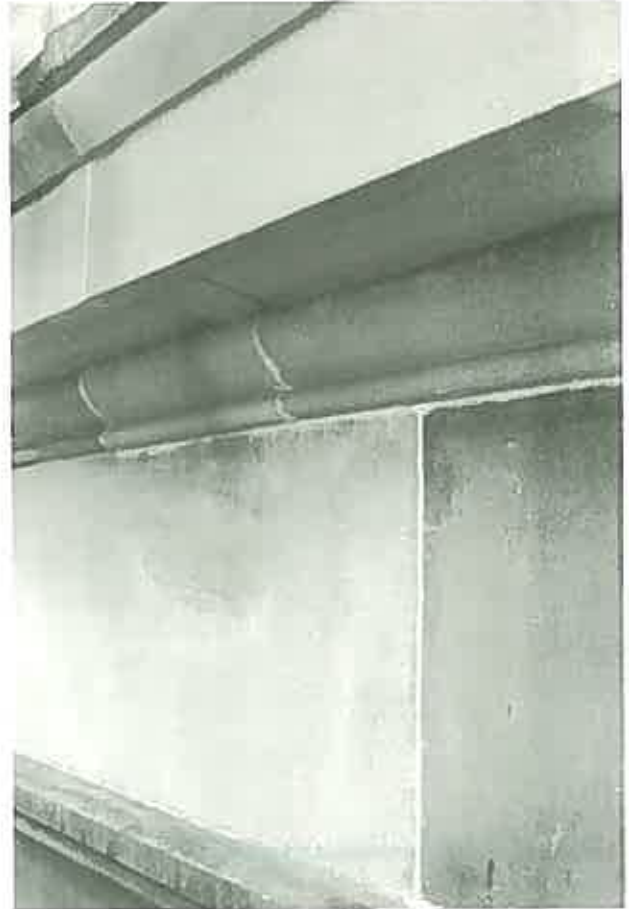
In finely rubbed work a mason's putty joint is usually employed. (*Pitt Street Parish Church, Sydney.*)

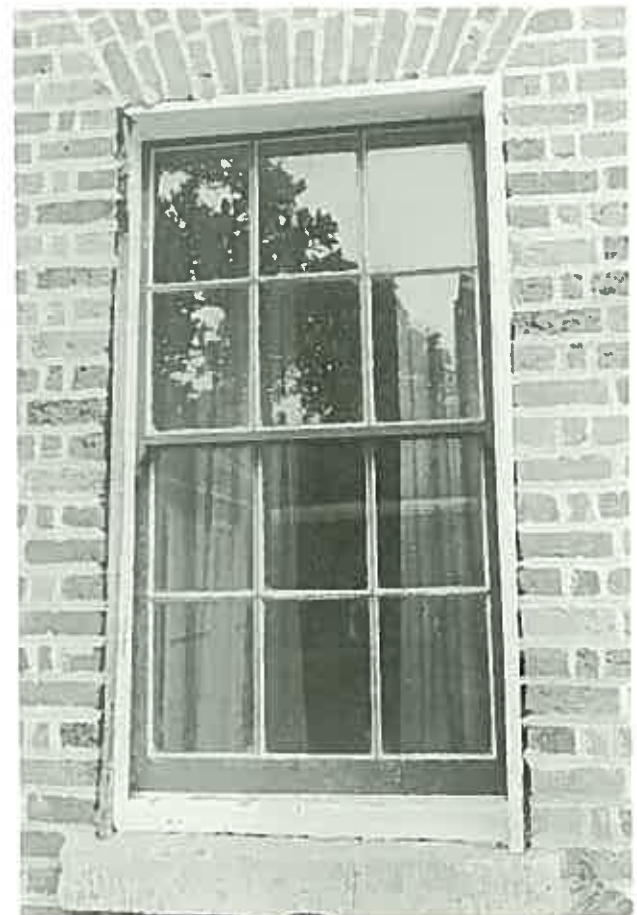
An example of badly repointed brickwork. Cement has been used and there has been no attempt to strike the joints. (*Bob's Hall, Lancer Barracks, Parramatta.*)

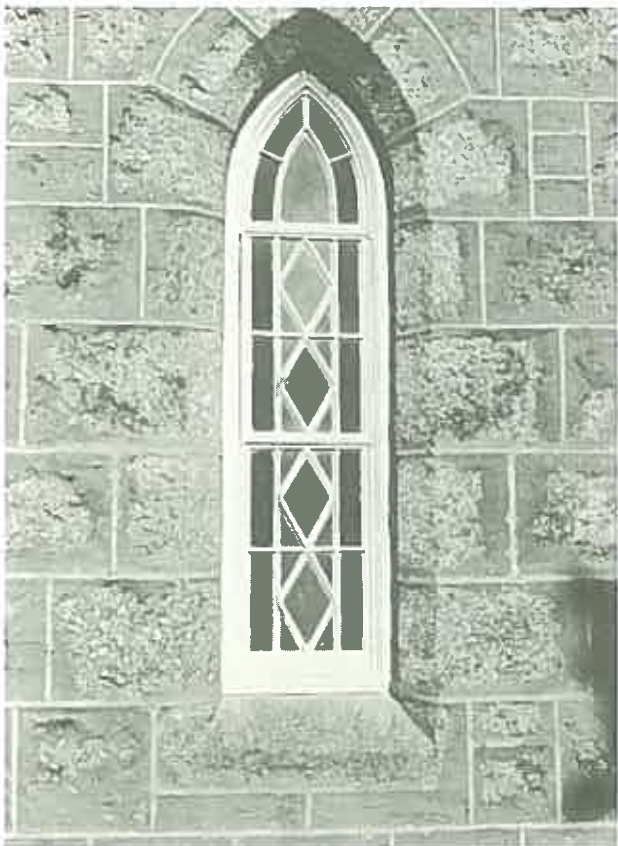
In this example tuckpointing has been used to make the masonry appear finer than it is. (*Uniting Church, Beechworth, Victoria.*)

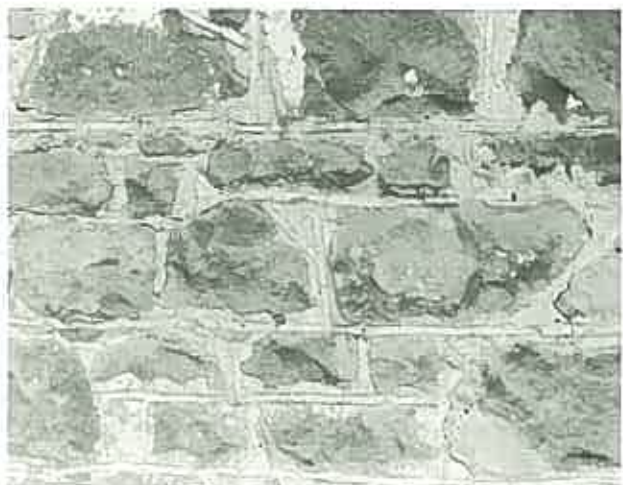
An example of rubble walling improved in appearance by the ironing of the mortar joints. (*Lyne Station, Hamilton, Victoria.*)

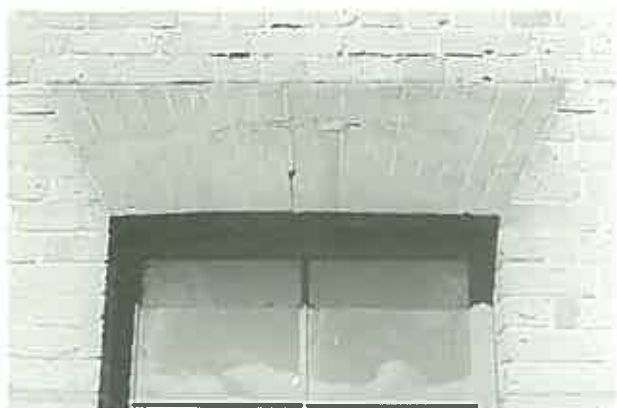
Early brick arches were often covered in red ochre and tuckpointed. As with all tuckpointing it is an attempt to make the jointing appear finer than it is. (*Outbuilding, Strathmore, Nile, Tasmania.*)

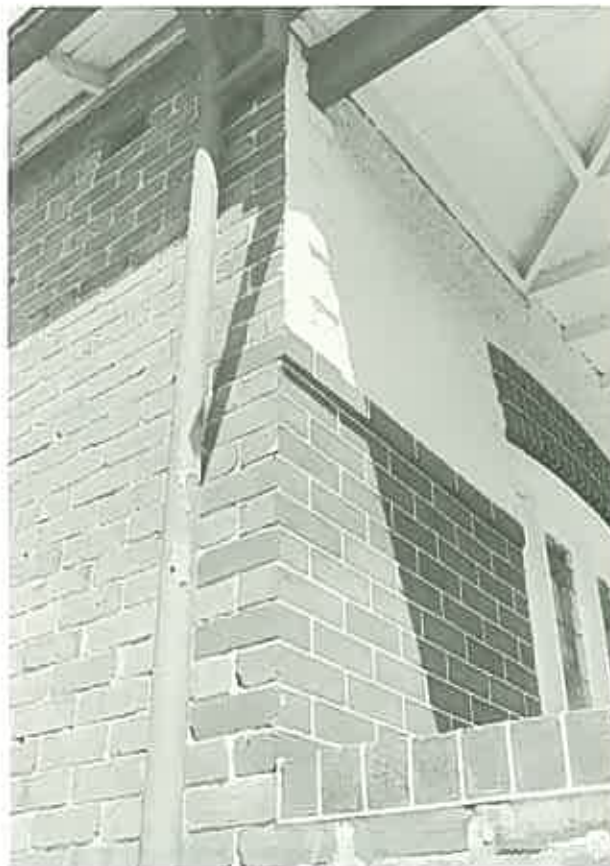
The emphasis on the front wall continued into the period between the wars, better quality bricks and tuckpointing being popular. (*Cottage, Haberfield, Sydney.*)

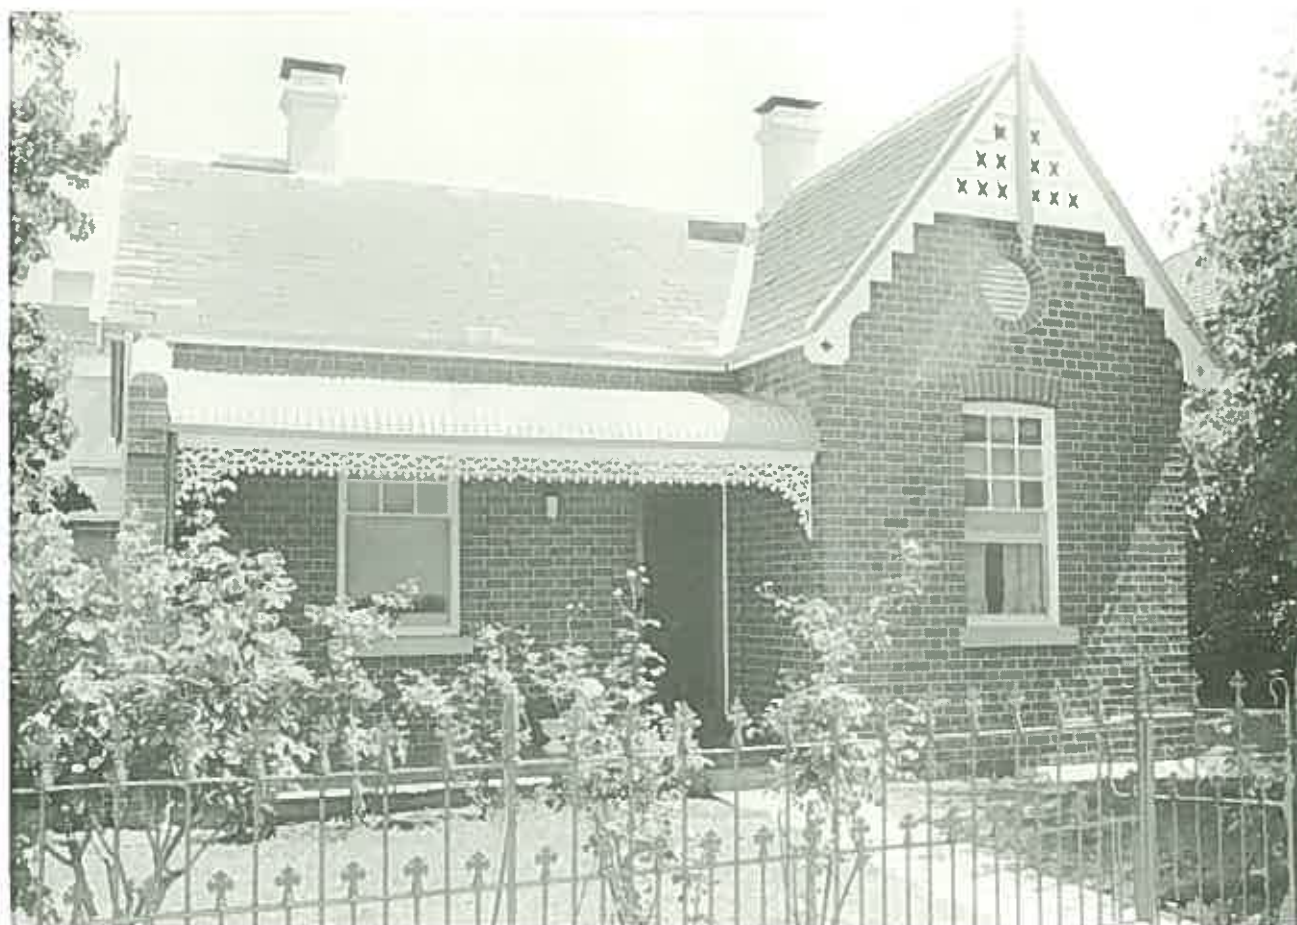
Most Edwardian brick buildings have their front wall tuckpointed. (*Verger's Cottage, St. John's, Parramatta.*)

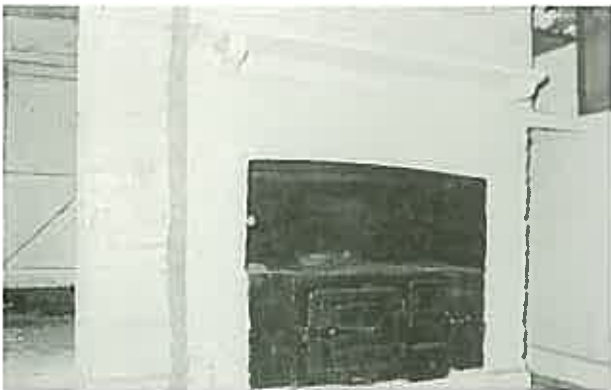
Face brick interiors were almost always painted. (*Kitchen in terrace house, 26 Derwent Street, Glebe, Sydney.*)

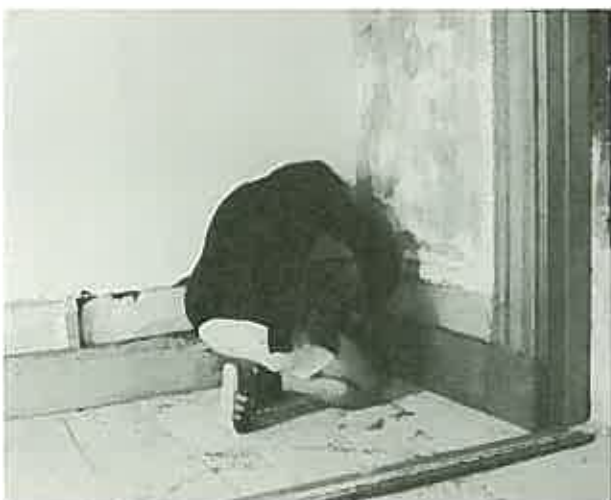
Architraves and skirtings are fitted to protect the soft plaster. (*Lyndhurst, Sydney. Restoration architect: Clive Lucas.*)

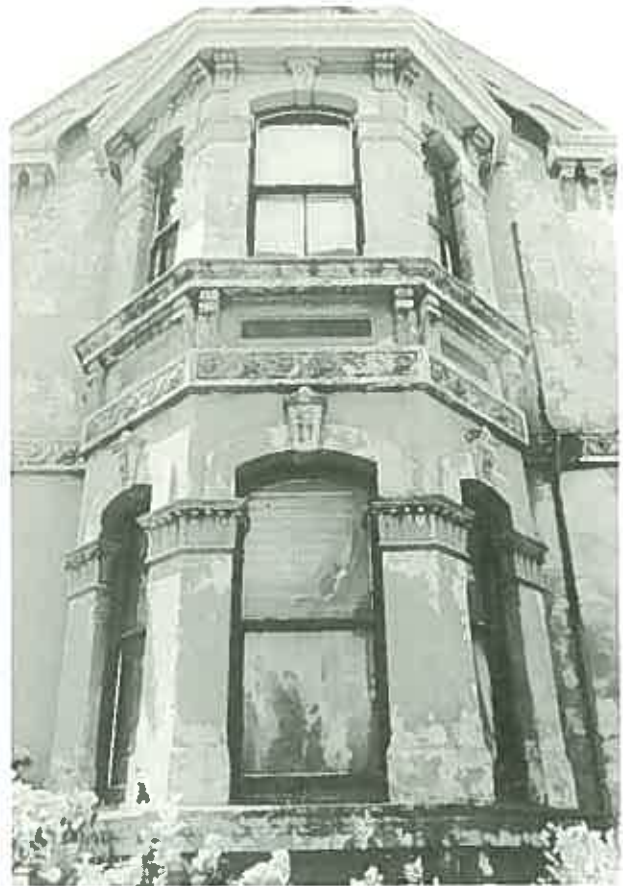
A late Victorian brick house encased in elaborate cement decoration. (House, 3 Arundel Street, Glebe, Sydney.)

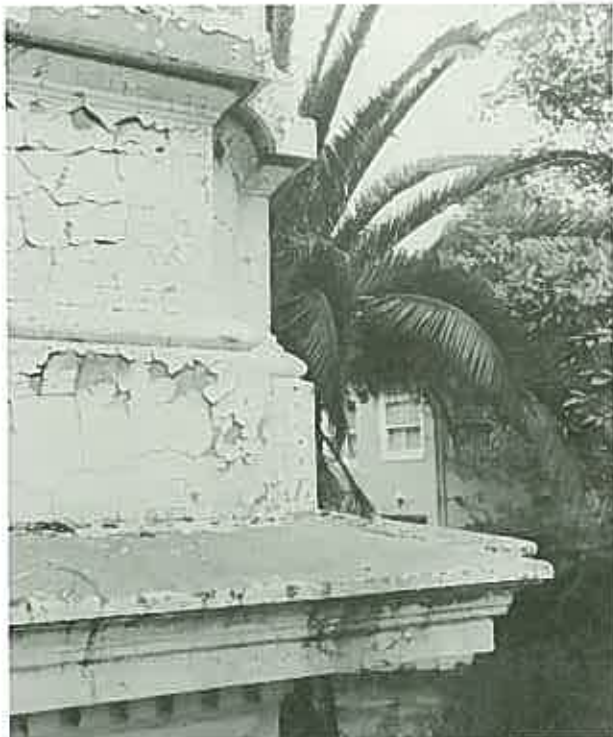
The masonry walls are cement rendered and marked out to look like detailed stonework. (Iona, Darlinghurst, Sydney, 1890.)

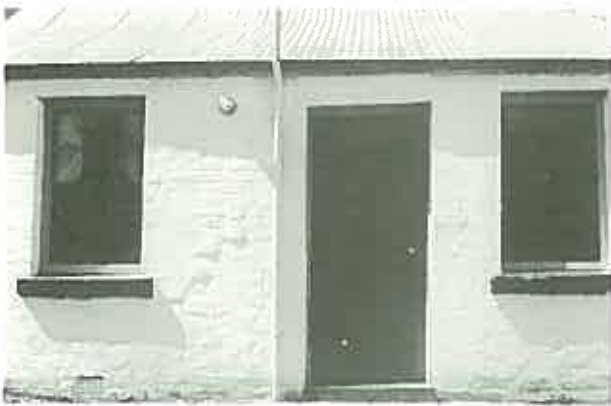
A fresh coat of limewash is the best traditional finish for soft sandstock brickwork. (267 George Street, Windsor, N.S.W. Restoration architect: Clive Lucas.)

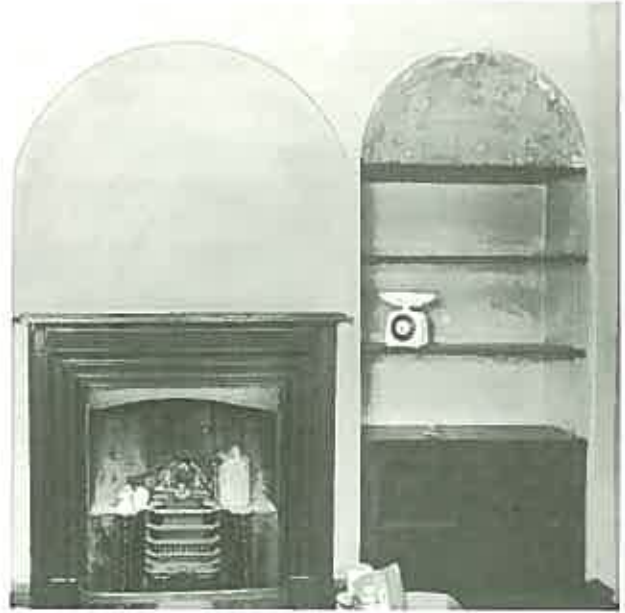
A fresh coat of distemper. (Harrisford, Parramatta.)

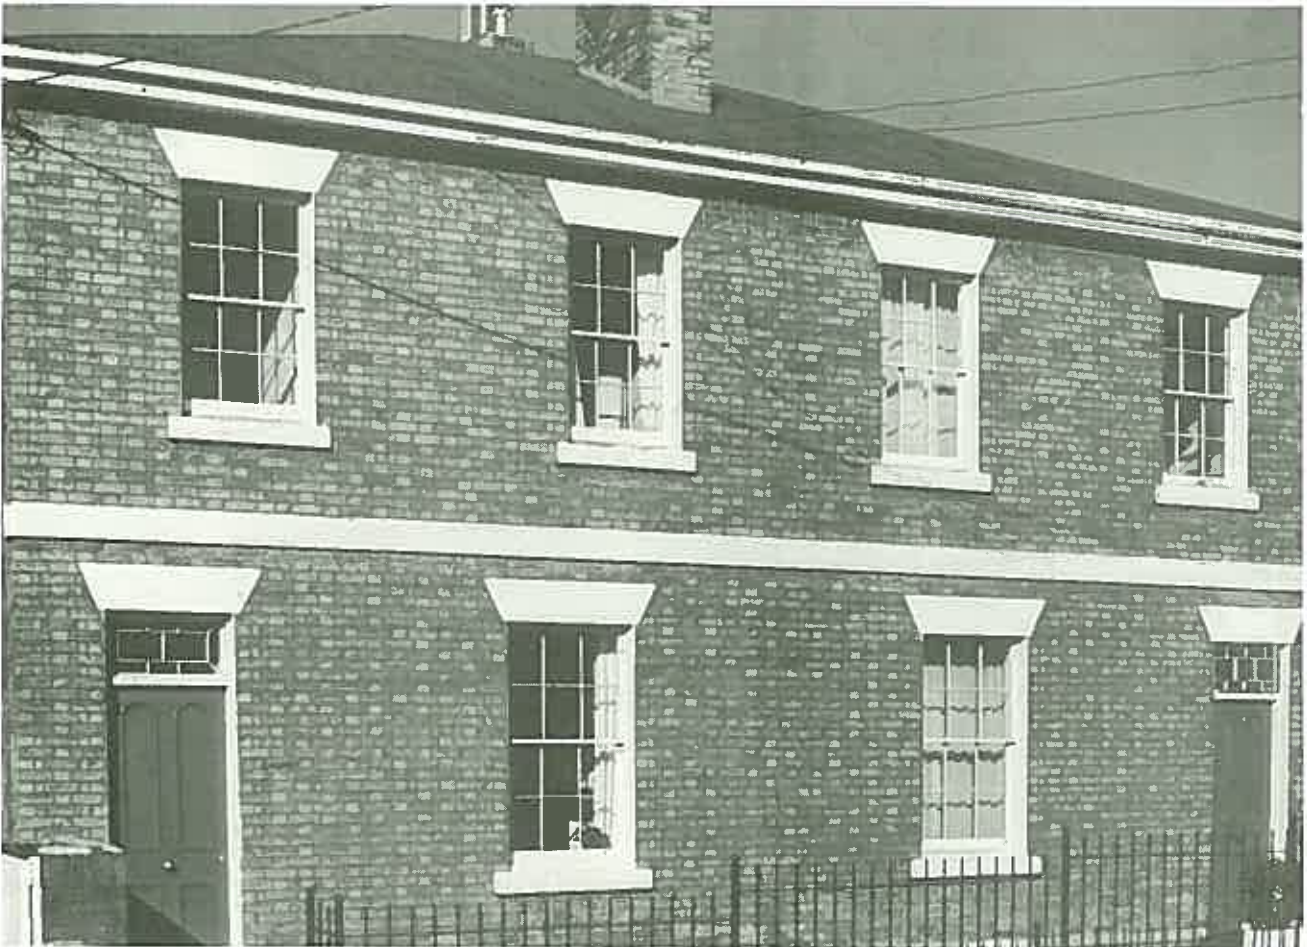
Finished in red ochre and oil to help waterproof the porous brickwork. (50 Hampden Road, Battery Point, Hobart. Photo: Wesley Stacey.)

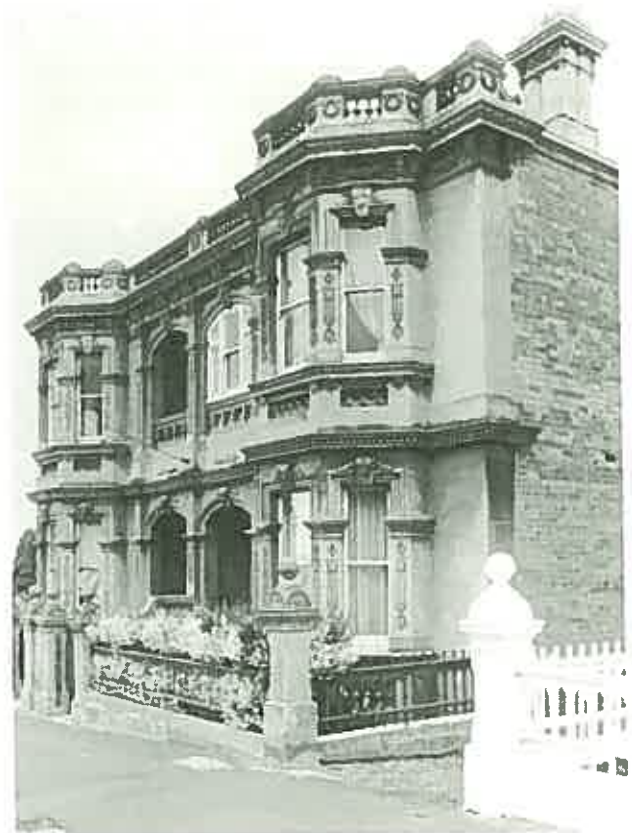
Cement became appreciated for itself and in many late Victorian buildings was left unpainted. (6-8 Church Street, Hobart.)

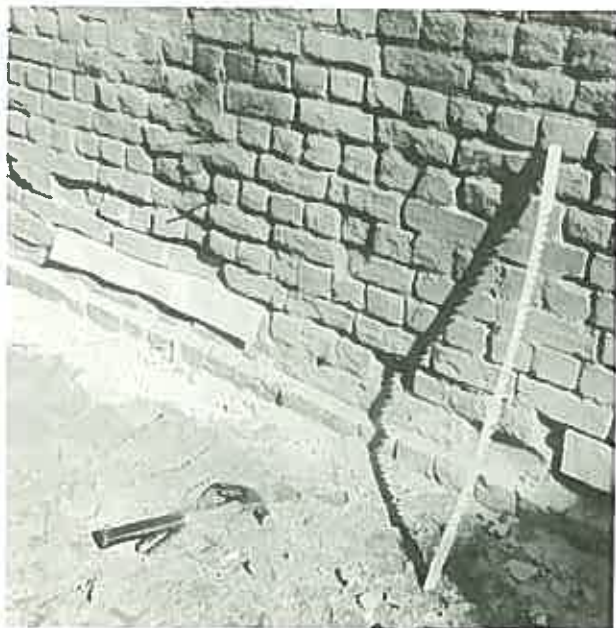
Cutting in a dampcourse in a 9" wall by the means of a masonry saw. (Cooma Cottage, Yass, N.S.W.)

The best way to prevent rising damp is undoubtedly to cut in a traditional damp course. In the past slate, bitumen and lead were used. Today we mainly use bitumen coated lead, copper or aluminium. Aluminium is most common, but P.V.C. and polythene coated aluminium are being used increasingly. If the wall is brick of 14" or less thickness it is a reasonable proposition to cut in a traditional damp course as low down in the wall as possible. This can be done with a saw or by breaking holes in the wall and gradually working around. Both techniques, however, require great skill. In thicker walls the building will probably be lowered by 3mm ( $\frac{1}{8}$ " ) by these processes. However, many walls are of rubble stone or extremely thick and it is not possible to cut in a damp course by the above methods. Diamond saws are being used in Europe but so far this has not been tried here. There is one technique being used here which cuts a slot by means of a water jet. However, as with the use of moisture to remove paint films, this technique can lead to other problems and side effects.

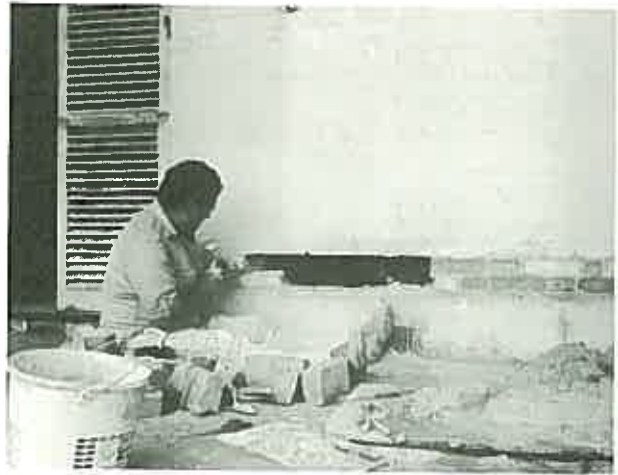
Cutting in dampcourse by removing sections of the wall. (Willandra, Ryde, Sydney.)

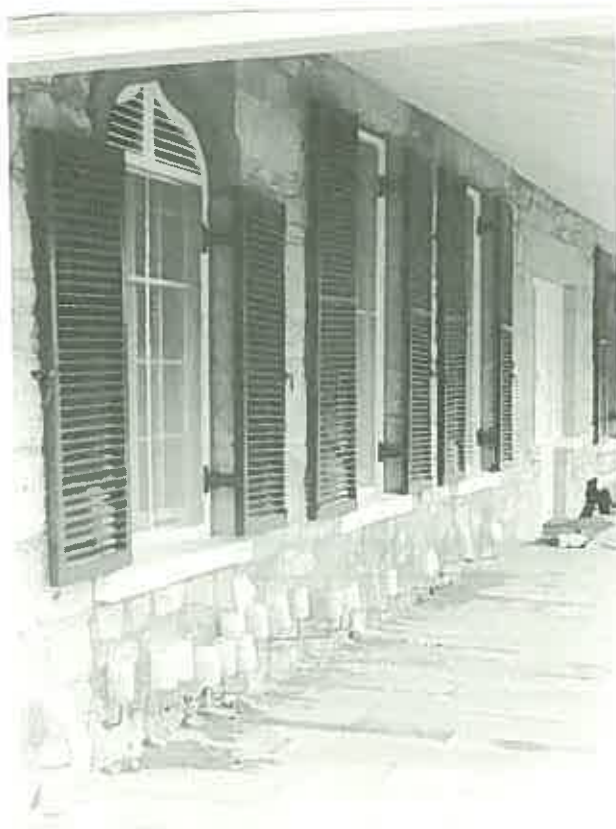
Injecting walls with a fluid is one patented attempt at stopping rising damp. (Malahide, Fingal, Tasmania.)

There are numerous patented systems for curing damp such as impregnating the wall with various fluids which are absorbed, in effect making a section of the masonry an impermeable barrier. The problem is of course that the core of the wall may be full of voids, creating many weaknesses. It is probably best to regrout the base of the wall before trying this system.

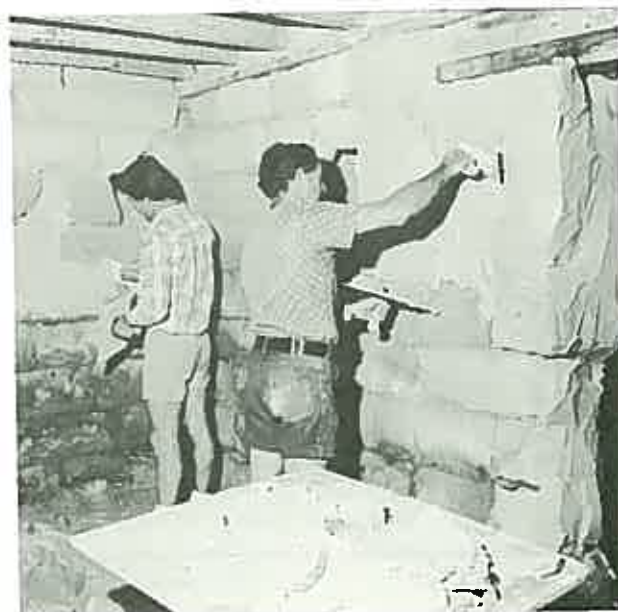
Fitting sacrificial plaster to salt contaminated walls will draw off the salt. (Cellar walls, Lyndhurst, Sydney.)

Once the moisture is cut off, the wall above the damp course will begin to dry out. If the wall is salty this will mean that the masonry will start to break down as the salts are brought to the surface unless precautions are taken. A sacrificial coat of plaster is probably best applied to both faces of the wall before the insertion of the damp proof course. The salts are brought to the surface of the plaster and it breaks down. Eventually the plaster can be removed. Such plasters should be a weak mixture of lime and sand, say 1 to 4 or even weaker.

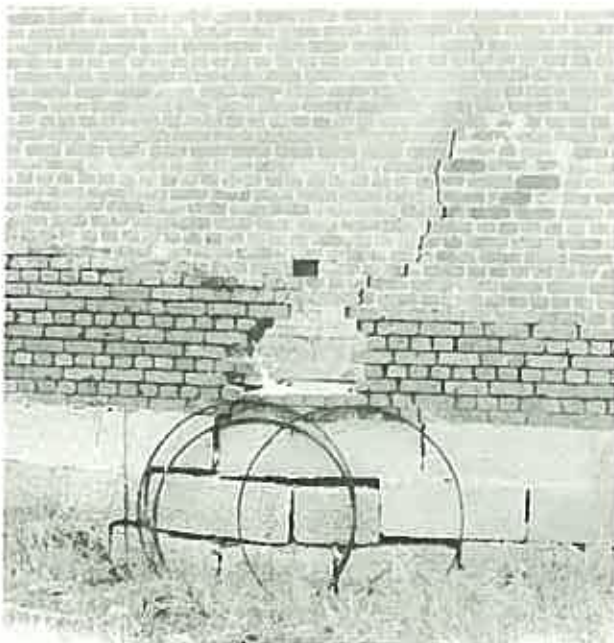
Inadequate footings plus the effects of rising damp lead to wall collapse. (Coolangatta, Berry, N.S.W.)

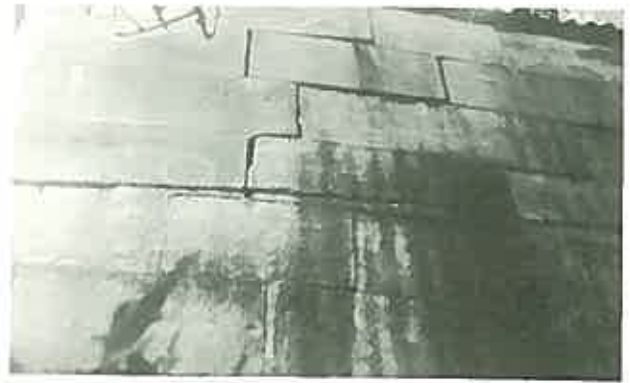
Structural movement such as this will probably mean the services of an engineer are required. (Goldfinders, Kurrajong, N.S.W.)

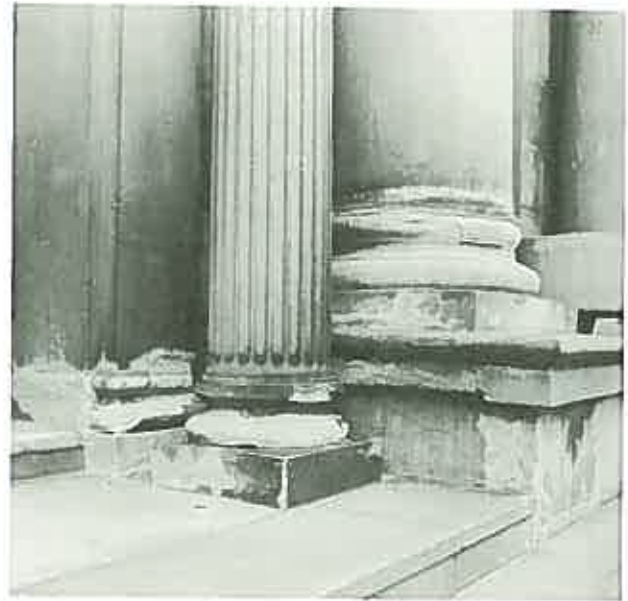
The effects of inappropriate repairs and rising damp. (Pitt Street, Parish Church, Sydney.)

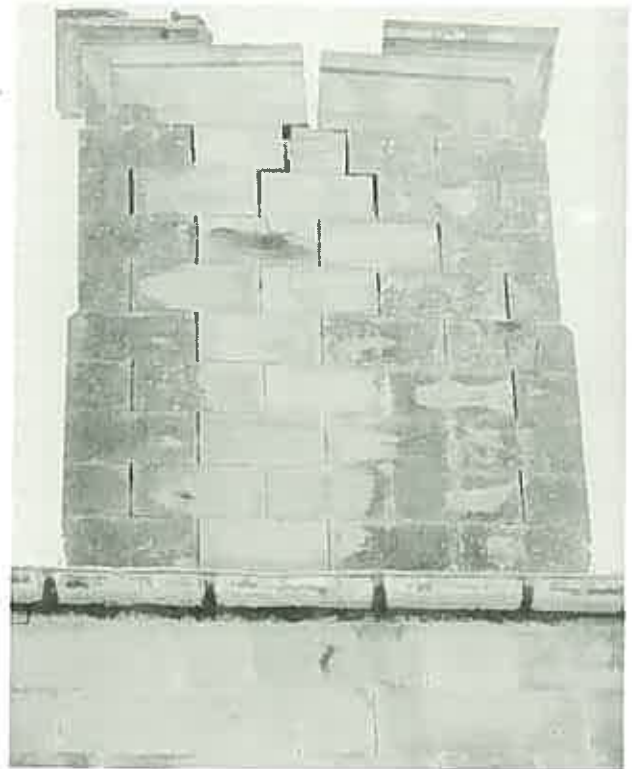
The coping has long gone and the chimney has reached the point where collapse is imminent. (Aberglasslyn House, Maitland, N.S.W.)

Once the pointing, particularly in copings to parapets and chimneys has failed, this leads in the first place to spalling and deterioration of masonry and in the long term to the eventual spreading or disintegration of the wall. Thus a neglected chimney will be wider at the top than further down. If the neglect is not halted then of course collapse takes place. Rubble walls are particularly vulnerable to collapse, resulting from moisture getting in at the top and into the porous core of the wall.

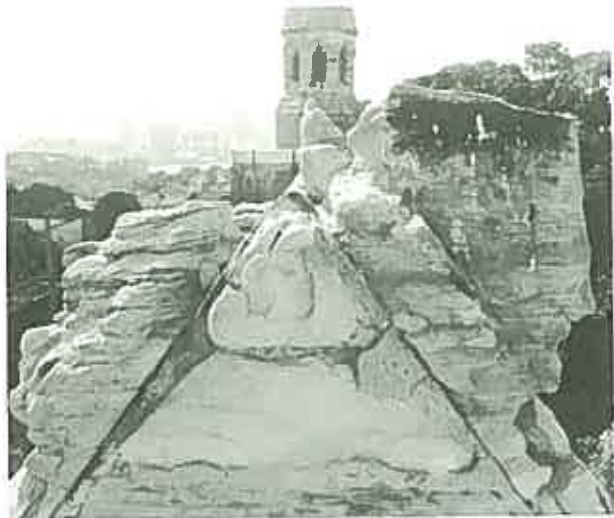
Exposed Sydney sandstone after a century of weathering in an urban environment. (*St. Andrew's, Balmain, 1855.*)

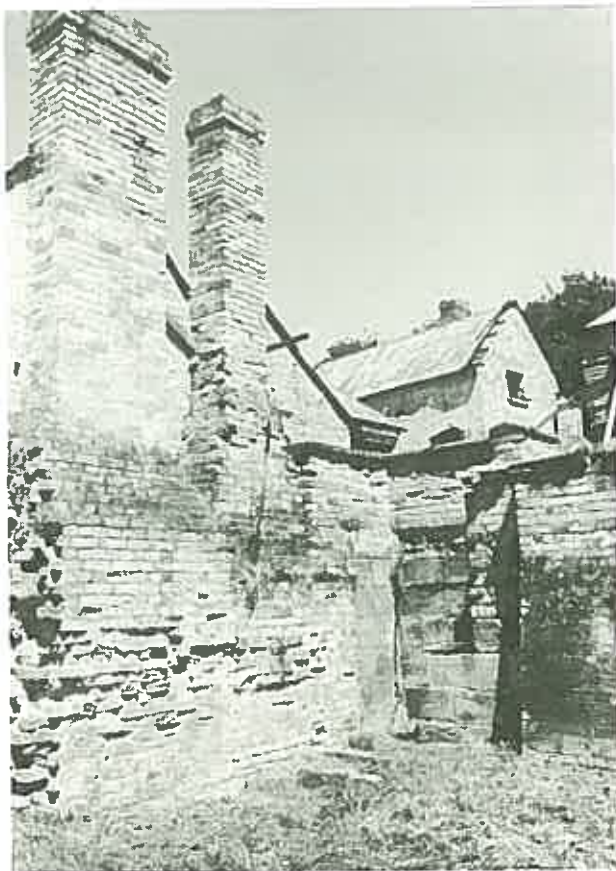
Severely neglected brickwork in which the effects of rising and falling damp can be seen. (*Commandant's House, Port Arthur.*)

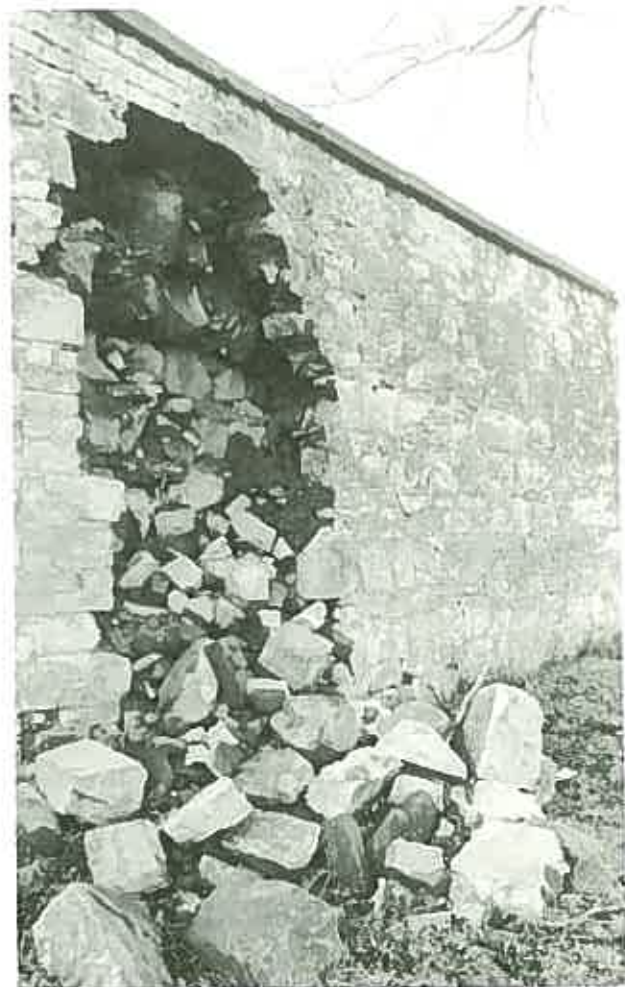
The breakdown of the coping has led to water entering the core which ends with collapse. (*Garden Wall, Rosedale, Campbell Town, Tasmania.*)

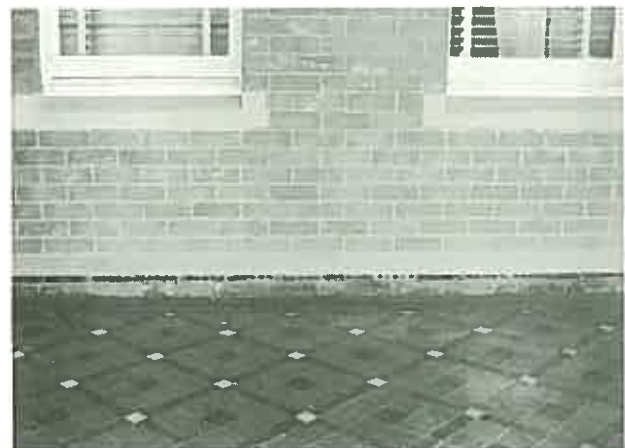
A similar dampcourse to Taylor's employed in a New South Wales Public building. (Kenmore Hospital, Goulburn, N.S.W.)

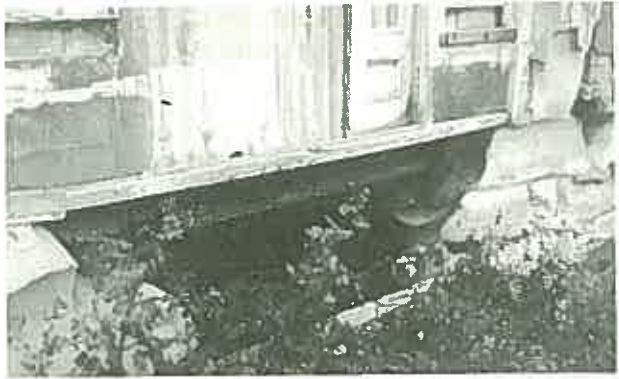
Advanced decay at a cellar opening caused by draught on severely salt contaminated masonry. (Lyndhurst, Sydney.)

If extensive work below floor level is being carried out the opportunity should be taken to increase ventilation wherever possible. It should be appreciated, however, that deterioration of masonry is caused by the process of drying where salts are present. Thus if the wind draught is too severe it will encourage drying where it passes across the surface of the wall. At door jambs and reveals one often sees more serious deterioration than elsewhere. So try not to disturb too much the traditional equilibrium of the building. Never cement render in an attempt to repair fretted masonry. This merely makes the problem worse by driving the moisture further up the wall. Cement is one of the greatest enemies in the fight against damp in solid masonry walls.

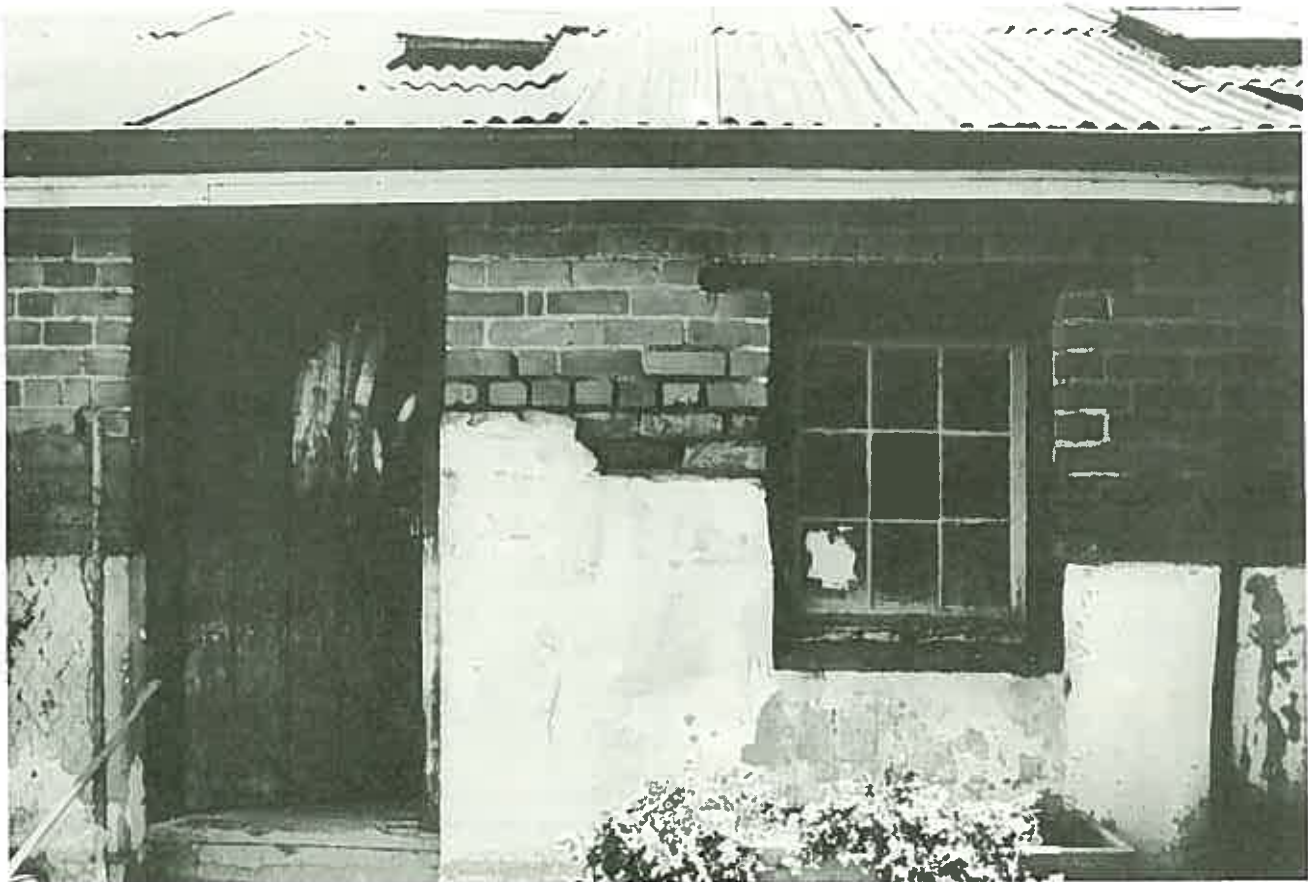
Rendering walls only drives the rising damp further up the wall. (Faversham, York, W.A.)
